F1 (Fukushima Daiichi Nuclear Power Station) Issues

**As of 5 September, 2013
Nuclear Regulation Authority (NRA), Japan**

I. Current situation of contaminated water leakage

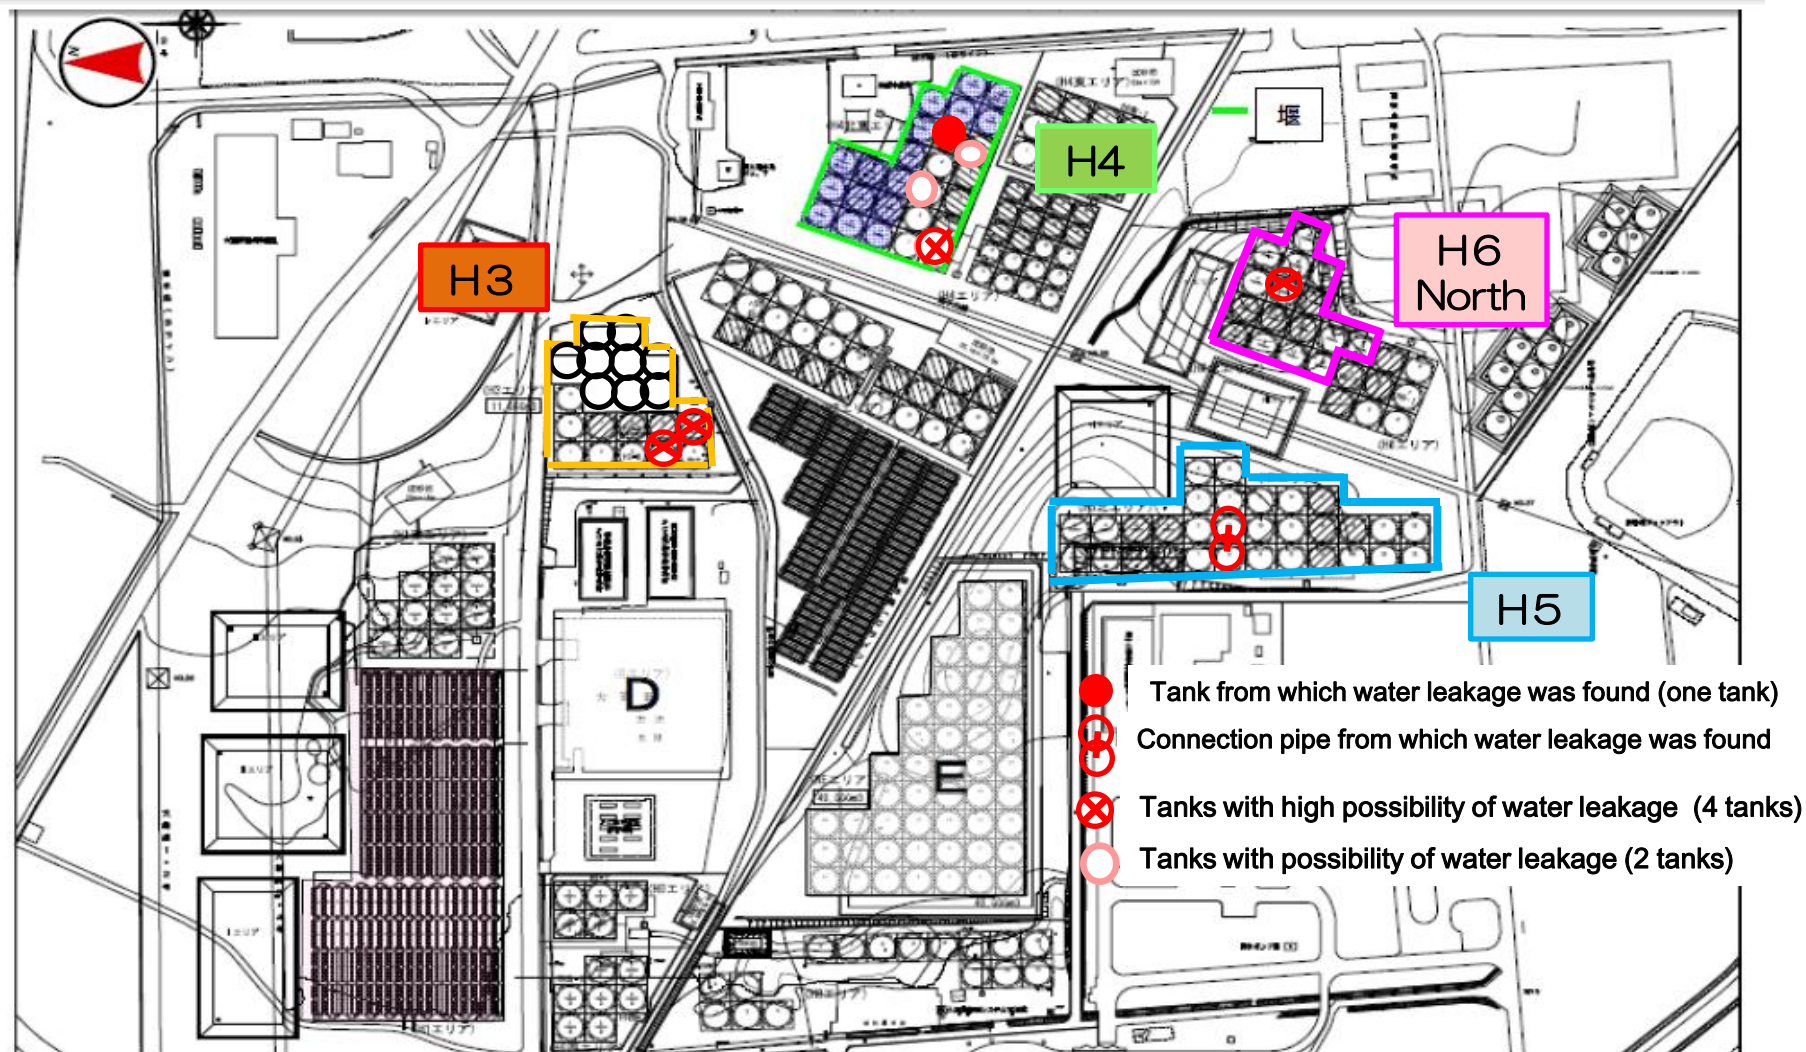
Location of Storage Tanks

There are 305 bolted-joint storage tanks for contaminated water at the Fukushima Daiichi Nuclear Power Station. According to the TEPCO's reports to the NRA, one of 305 bolted-joint storage tanks had an incident of water leakage, four storage tanks have the high possibility of water leakage, and one connection pipe between bolted-joint storage tanks had an incident of water leakage. **[Attachments 1 and 2]**

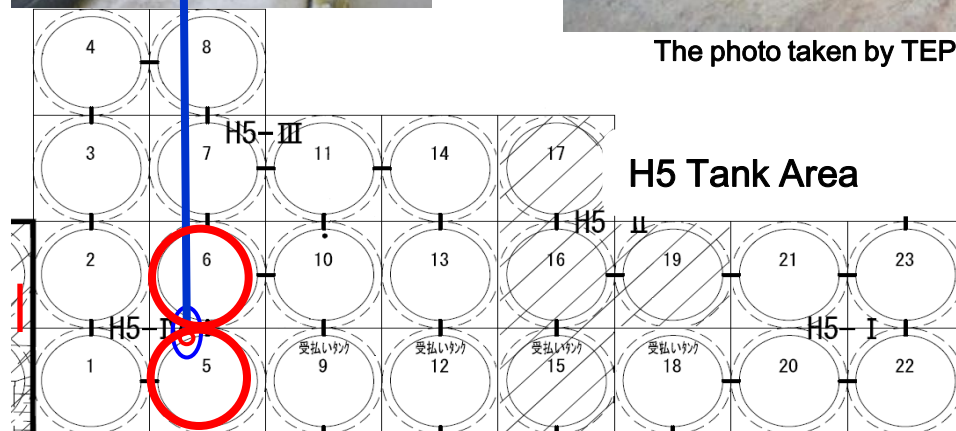
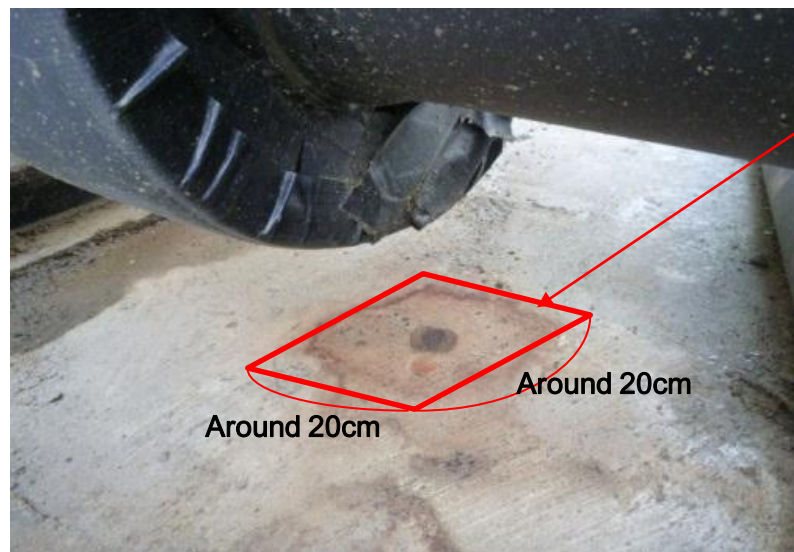
Water Leakage from Connection Pipe between Storage Tanks (H5 Tank Area)

Puddle trace (20 cm x 20 cm)

The photo taken by TEPCO on 31 August

At the point 5cm from the surface of the puddle trace 230 mSv/h * of β rays was detected by TEPCO on 31 August.

It was found by TEPCO that one drop of contaminated water fell every 90 seconds after the cover stuff of the flange was removed, and then this water drop has stopped by TEPCO's tightening up the bolts of flange on 1 September.

Radioactivity (Sampling date: 31 August 2013)

Nuclide	Concentration (Bq/cm ³)
Cs-134	25
Cs-137	61
Total Beta	3.0×10^5

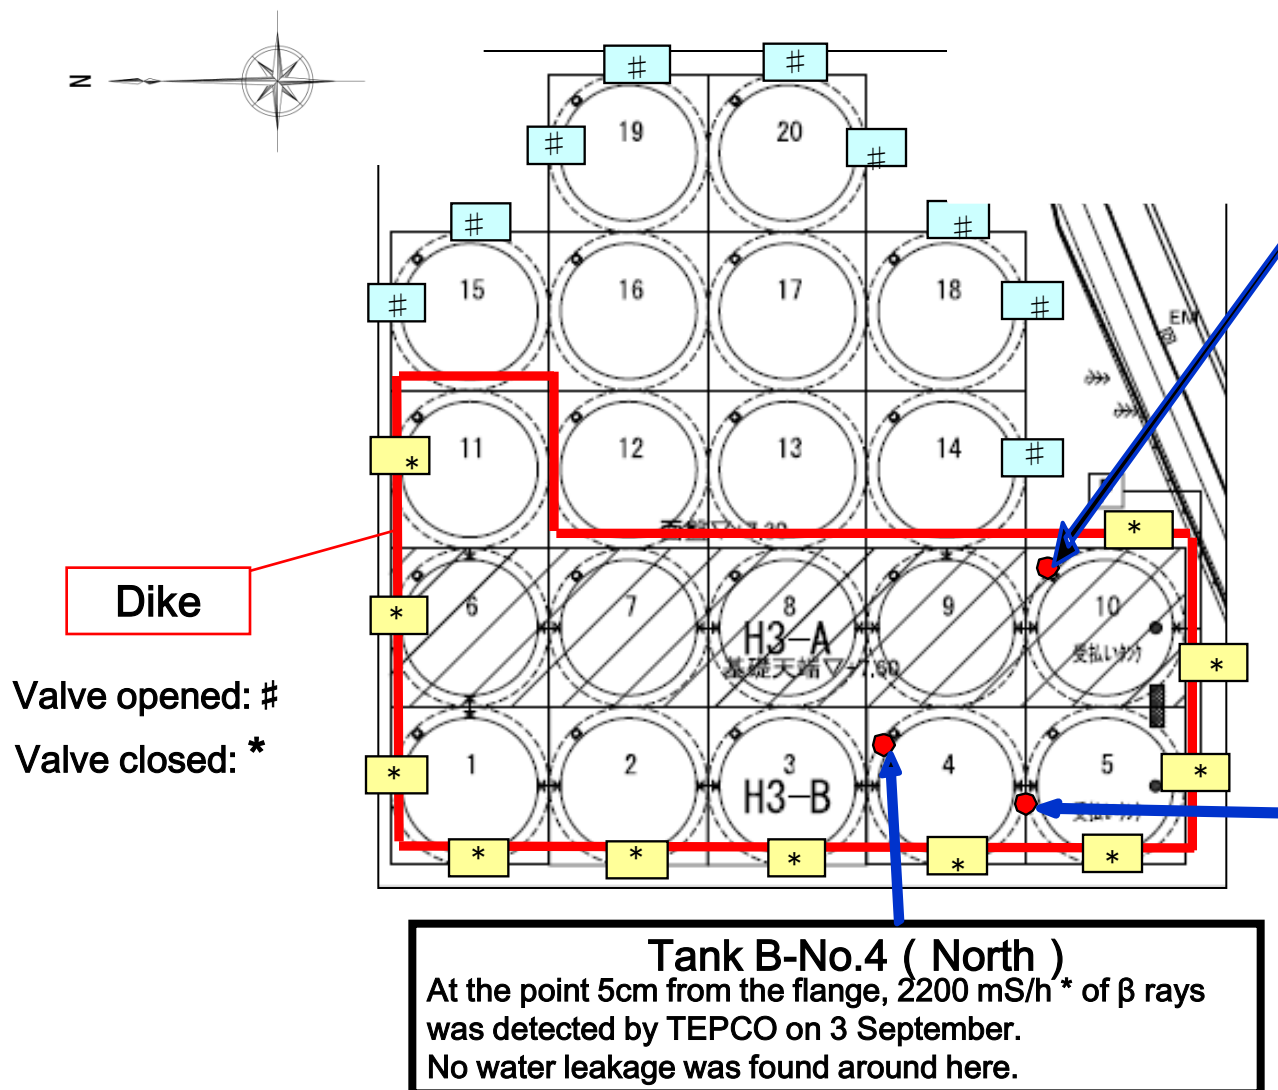
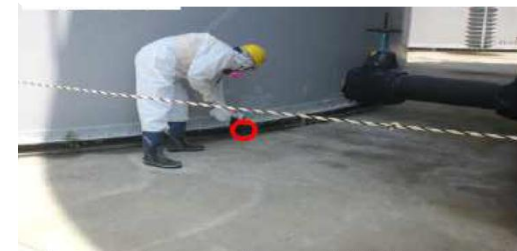
Four storage tanks (two tanks in H3 Tank Area **[Attachment 4]**, one tank in H6 Tank Area **[Attachment 5]** and one tank in H4 Tank Area **[Attachment 6]**) have the high possibility of water leakage. In addition, other two storage tanks in H4 Tank Area have the possibility of contaminated water leakage. **[Attachment 6]**

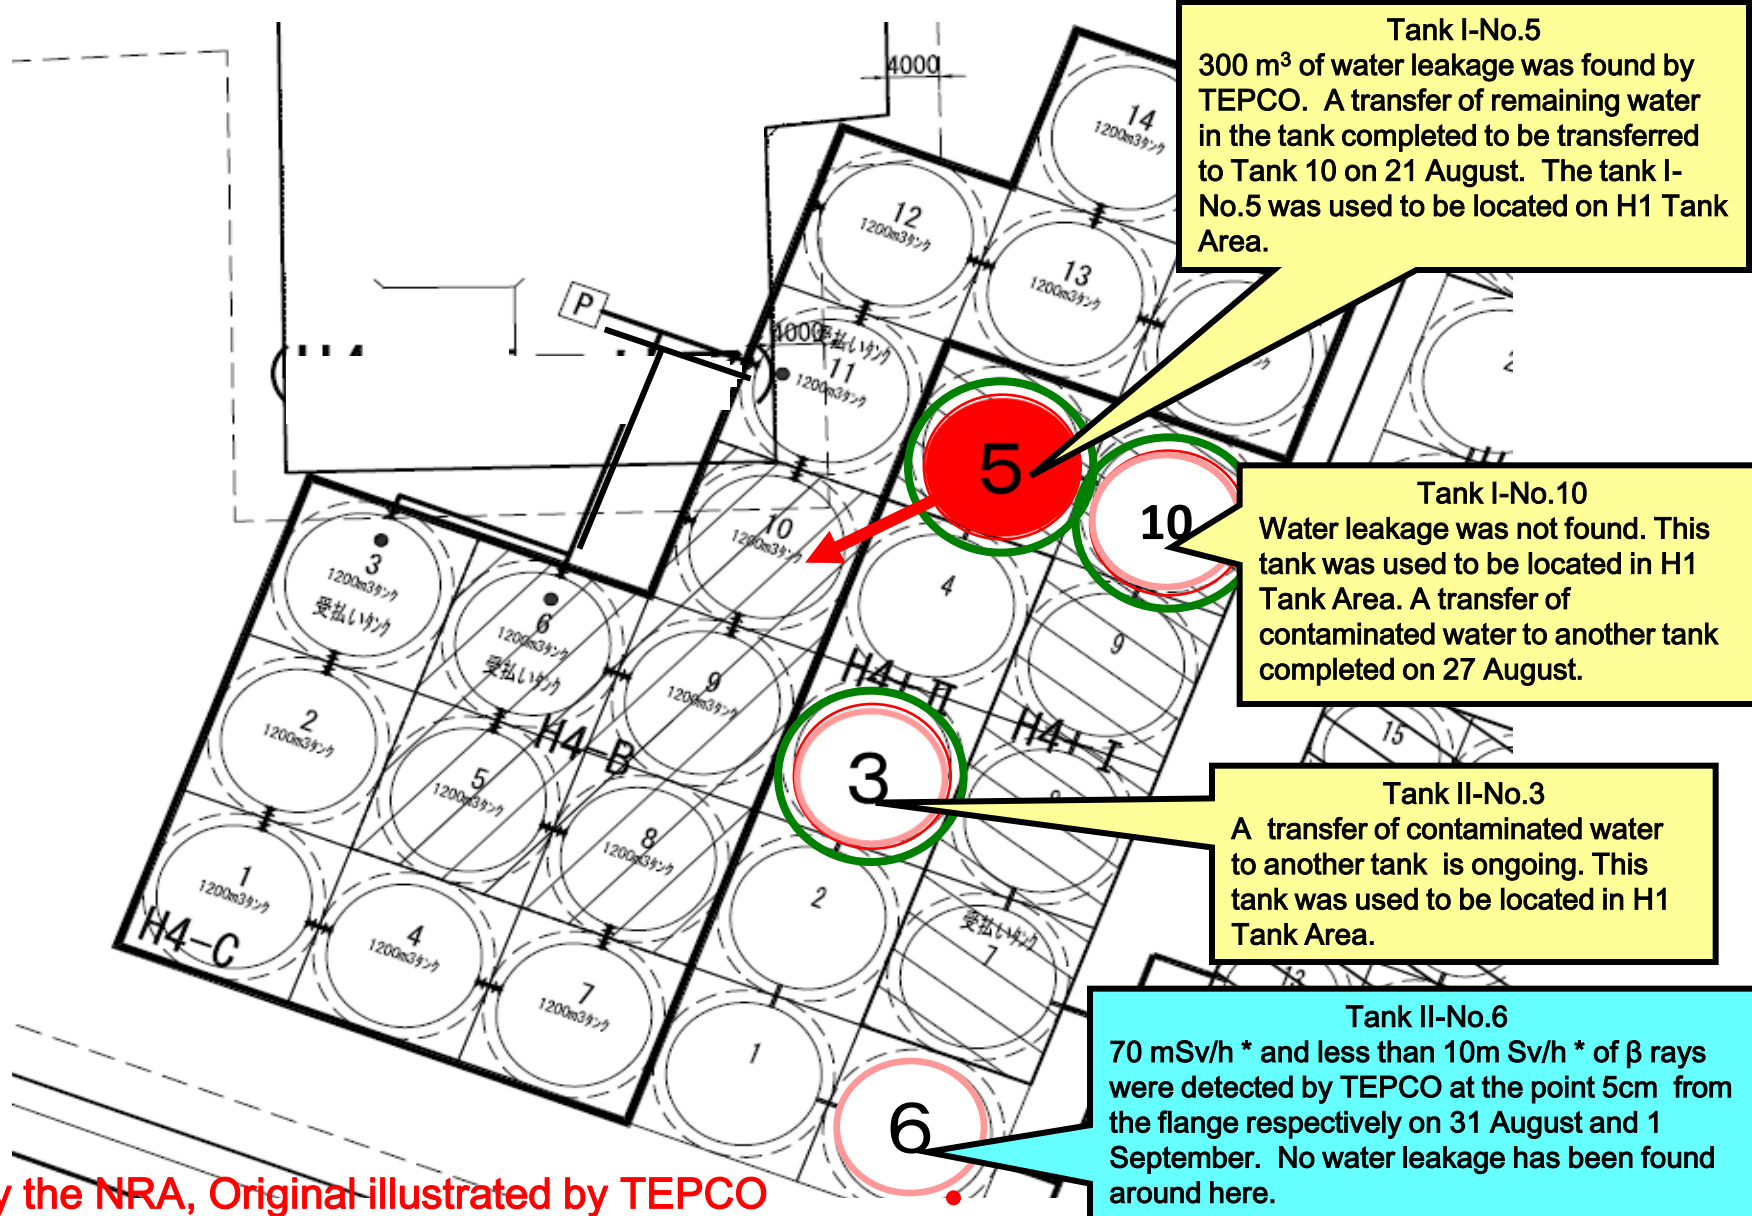
H 4 Tank Area

Contaminated water leakage (approximately 300 tons) in H4 Tank Area was found by TEPCO on 19 August, and falling-down of drops of contaminated water from the connection pipe between storage tanks in H5 Tank Area was found by TEPCO. **[Attachment 3]**

Regarding contaminated water leakage from the tank in the H4 Tank Area that was found by TEPCO on 19 August, the radioactivity (sampling date: 19 August) of some water retained in the dike installed surrounding the tank was as follows:

Cesium-134: $4.6 \times 10^1 \text{ Bq/cm}^3$
 Cesium-137: $1.0 \times 10^2 \text{ Bq/cm}^3$
 Total Beta: $8.0 \times 10^4 \text{ Bq/cm}^3$
