Current Status and Recent Topics of Fukushima Daiichi NPS

March 4th, 2015

TOKYO ELECTRIC POWER COMPANY

Unit 2 Reactor Building and Large Carry-in Entrance Rooftop Accumulated water Quality Results

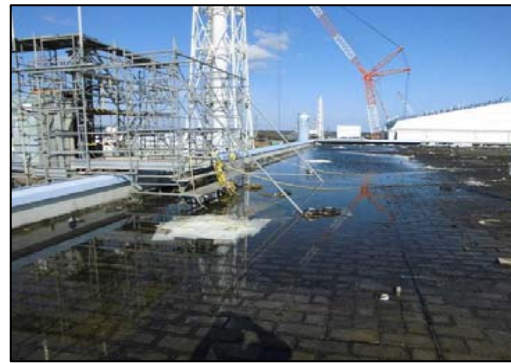
Photo② : Unit 2 Reactor Building rooftop

- Rainwater on the rooftop of the reactor building, located upstream of the branch pipes which flow into "Drainage K", were analyzed.
- Because of the high dosage in the reactor building roof and concern over the radiation exposure to workers in a comprehensive investigation, the analysis was limited to the 2 R/B rooftop and large delivery rooftop, which were chosen based on accessibility and atmospheric radiation.
- As a result of the investigation, the rainwater found on the large carry-in rooftop contained a relatively high density of radioactive materials.

No.	place	Cs134	Cs137	Gross β	Sr90	H-3	Sampling date
①	Unit 2 R/B rooftop (north)	200	650	920	10	ND(<100)	2015.1.16
②	Unit 2 R/B rooftop (center)	340	1,100	1,900	12	ND(<100)	2015.1.16
③	Unit 2 R/B rooftop (south)	300	990	1,900	20	ND(<100)	2015.1.16
④	Large carry-in entrance rooftop	6,400	23,000	52,000	Under analysis	600	2015.2.19
⑤	Vertical drainage pipe of carry-in (east)	920	3,200	9,700	Under analysis	ND(<100)	2015.2.18

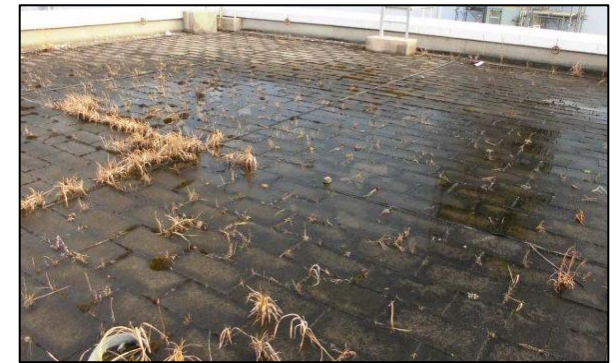
Photo④ : large carry-in entrance rooftop

- Given this result, the company inspected the upstream branch pipes of "Drainage K" and found that **a puddle on the rooftop of the large carry-in entrance of the Unit 2 reactor building showed a relatively high concentration** (e.g. 23,000 becquerels per liter of Cesium 137).
- Regarding the dosage at the mouth of "Drainage K", the levels monitored were lower (around ten to several hundred becquerels per liter of Cesium 137) than that of the rooftop of the large carry-in entrance of the Unit 2 reactor building, and **there was also no substantial concentration rise identified in the seawater around the south drainage release point, called Point T-2-1.**

■ Preventive measures were carried out for rainwater contamination on the rooftop of the large carry-in entrance at Unit 2 reactor building.

- Place Zeolite packed bags around the drainage opening on the rooftop. (to be carried out once prepared)
- Block the roof likely to be the contamination source, and remove the ballasting, etc. from the roof. (to be carried out before the end of March)
