Conditions of Fukushima Dai-ichi Nuclear Power Station Unit 1 (As of 5:00 April 6th, 2011)

Discharge of the Wastewater with the Concentration of
Radioactive Materials above the Regulation Limit

Seismic Damage Information (the 75th Release)
(As of 16:00 April 5th, 2011)

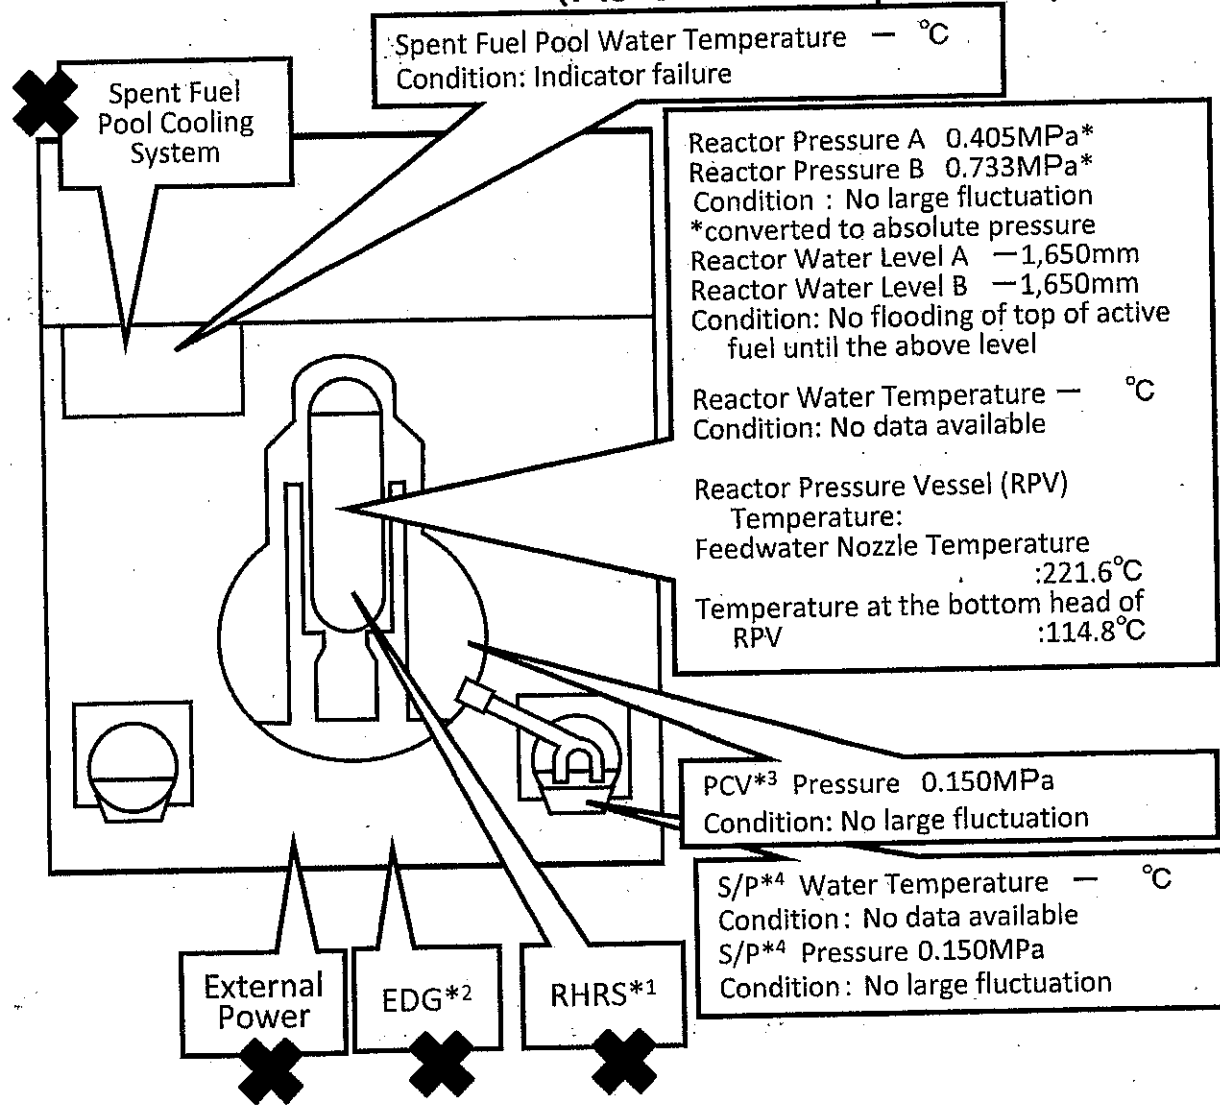
- 11th 14:46 Under operation, Automatic shutdown by the earthquake
- 11th 15:42 Report based on the Article 10 (Total loss of A/C power)
- 11th 16:36 Occurrence of the Article 15 event (Inability of water injection of the Emergency Core Cooling System)

- 12th 01:20 Occurrence of the Article 15 event (Unusual rise of the pressure in PCV)
- 12th 10:17 Started to vent.
- 12th 15:36 Sound of explosion
- 12th 20:20 Started to inject seawater and borated water to core.

Current Conditions : Fresh water is being injected to the Spent Fuel Pool and the core

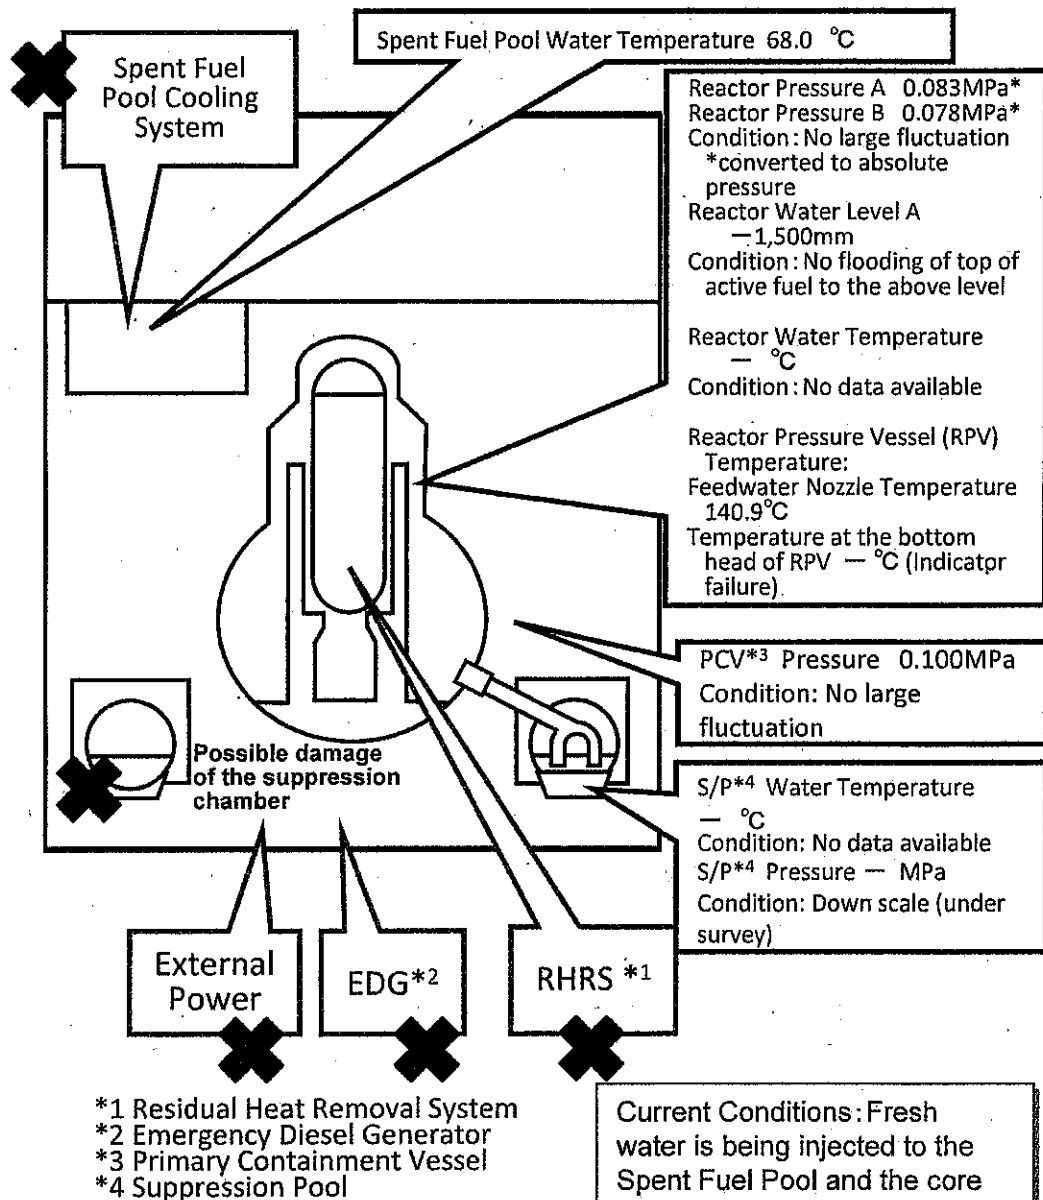
Conditions of Fukushima Dai-ichi Nuclear Power Station Unit 2 (As of 5:00 April 6th, 2011)

- 11th 14:46 Under operation, Automatic shutdown by the earthquake
- 11th 15:42 Report based on the Article 10 (Total loss of A/C power)
- 11th 16:36 Occurrence of the Article 15 event (Inability of water injection of the Emergency Core Cooling System)

- 13th 11:00 Started to vent.
- 14th 13:25 Occurrence of the Article 15 event (Loss of reactor cooling functions)
- 14th 16:34 Started to inject seawater to the Reactor Core.

- 14th 22:50 Occurrence of the Article 15 event (Unusual rise of the pressure in PCV)
- 15th 00:02 Started to vent.
- 15th 06:10 Sound of explosion
- 15th around 06:20 Possible damage of the suppression chamber

- 1st 14:56~17:05 Injection of fresh water from FPC to SFP using the temporary motor-driven pump.
- 2nd around 9:30 The water, of which the dose rate was at the level of more than 1,000mSv/h, was confirmed to be collected in the pit located near the Intake Channel of Unit 2. The outflow from the lateral surface of the pit into the sea was also confirmed.

- 5th 14:15 Tracer is confirmed to outflow through the permeable layer around the pit into the sea.
15:07 Started to inject coagulant.
- 6th around 5:38 The water outflow from the lateral surface of the pit was confirmed to stopped.

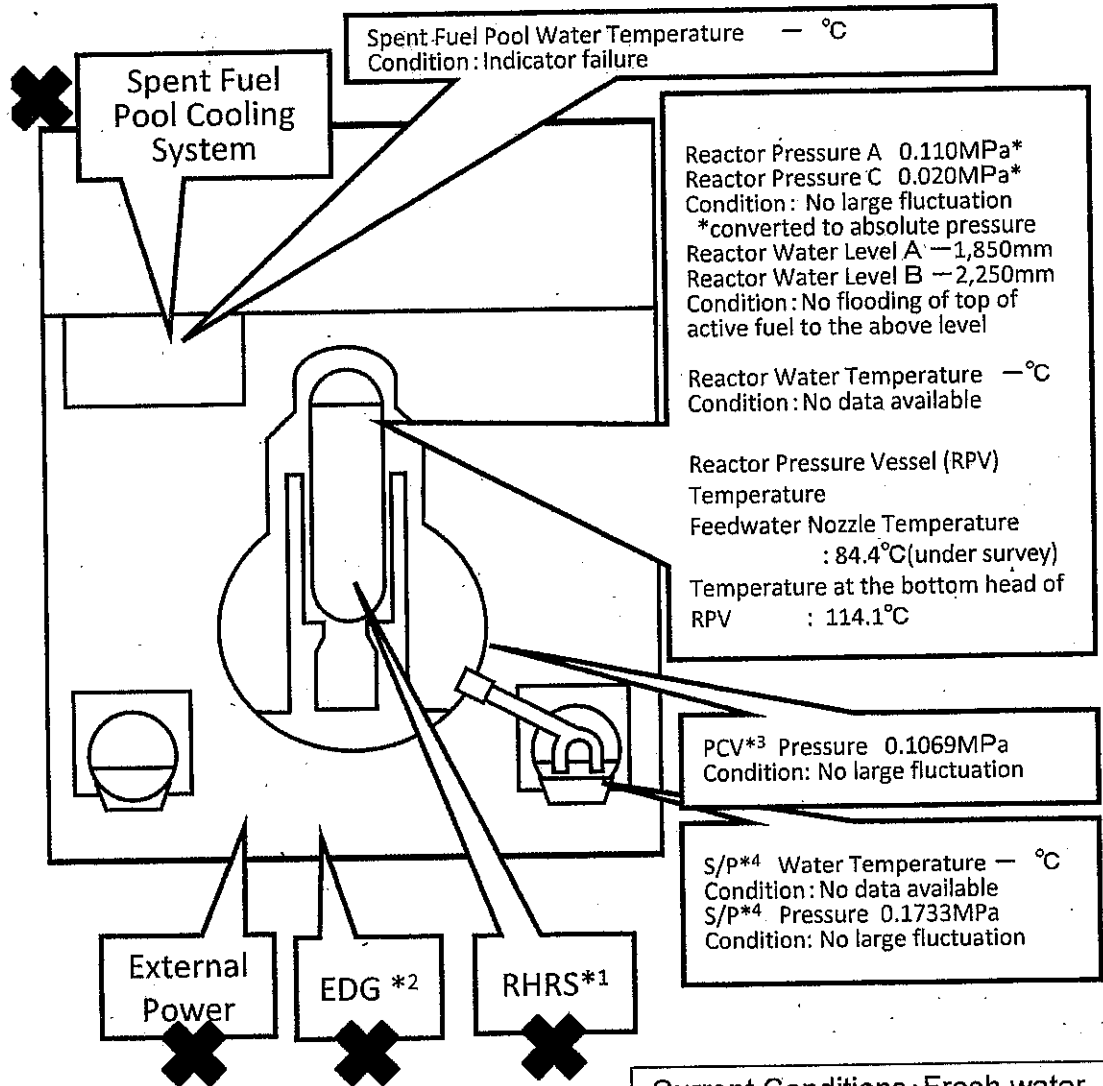
Conditions of Fukushima Dai-ichi Nuclear Power Station Unit 3

Current Conditions: Fresh water is being injected to the Spent Fuel Pool and the core

- 11th 14:46 Under operation, Automatic shutdown by the earthquake
- 11th 15:42 Report based on the Article 10 (Total loss of A/C power)
- 13th 05:10 Occurrence of the Article 15 event (Inability of water injection of the Emergency Core Cooling System)

- 13th 08:41 Started to vent.
- 13th 13:12 Started to inject seawater and borated water to core.
- 14th 05:20 Started to vent.
- 14th 07:44 Occurrence of the Article 15 event (Unusual rise of the pressure in PCV)

- 14th 11:01 Sound of explosion
- 16th around 08:30 White smoke generated.
- 17th 09:48 ~ 10:01 Water discharge by the helicopters of Self-Defense Force
- 17th 19:05 ~ 19:15 Water spray from the ground by High pressure water-cannon trucks of Police

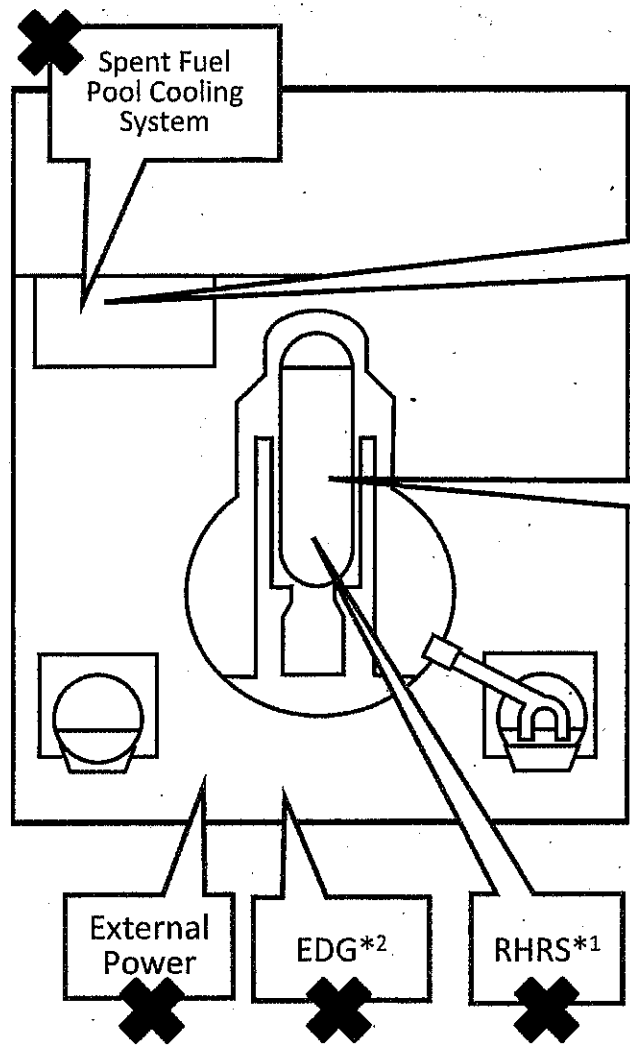
Conditions of Fukushima Dai-ichi Nuclear Power Station Unit 4 (As of 5:00 April 6th, 2011)

Spent Fuel Pool Water Temperature — °C
Condition: Indicator failure

In periodic inspection outage when the earthquake occurred
 14th 04:08 Water temperature in the Spent Fuel Pool (SFP), 84°C
 15th 06:14 Confirmed the partial damage of wall in the 4th floor.
 15th 09:38 Fire occurred in the 3rd floor. (12:25 extinguished)
 16th 05:45 Fire occurred. TEPCO couldn't confirm any fire on the ground. (06:15)
 20th 08:21~09:40 Water spray over SFP by Self-Defense Force
 20th around 18:30~19:46 Water spray over SFP by Self-Defense Force
 21st 06:37~08:41 Water spray over SFP by Self-Defense Force
 21st around 15:00 Work for laying cable to Power Center was completed.
 22nd 10:35 Power Center received electricity.
 22nd 17:17~20:32, 23rd 10:00~13:02, 24th 14:36~17:30, 25th 19:05~22:07, 27th 16:55~19:25 Water spray by Concrete Pump Truck
 25th 06:05~10:20 Sea water injection to SFP via the Fuel Pool Cooling Line (FPC)
 29th 11:50 Lighting in the Central Control Room was recovered.

Current Conditions: No fuel is in RPV*3.
Fresh water is being injected to the Spent Fuel Pool.
