Fukushima Daiichi Nuclear Power Station

Fuel Removal from Reactor 4 Spent Fuel Pool

November 2013

Tokyo Electric Power Company, Inc.

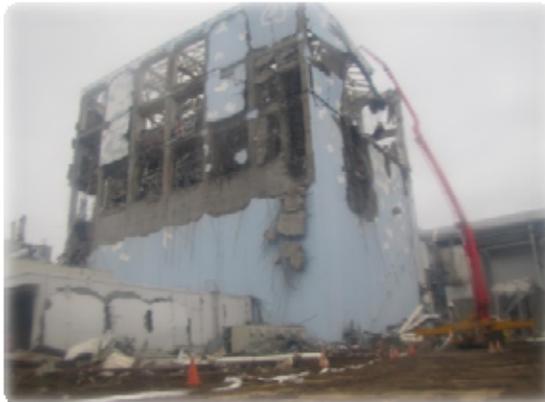
Reactor 4 when the accident occurred

When the accident occurred, Reactor 4 was not in operation; **it was under regular inspection**. All fuel was removed from the reactor vessel and **stored in spent fuel pools**.

All 1,500 fuel units **did not show fuel melting**, but a hydrogen explosion, possibly caused by hydrogen coming in from Reactor 3, occurred.

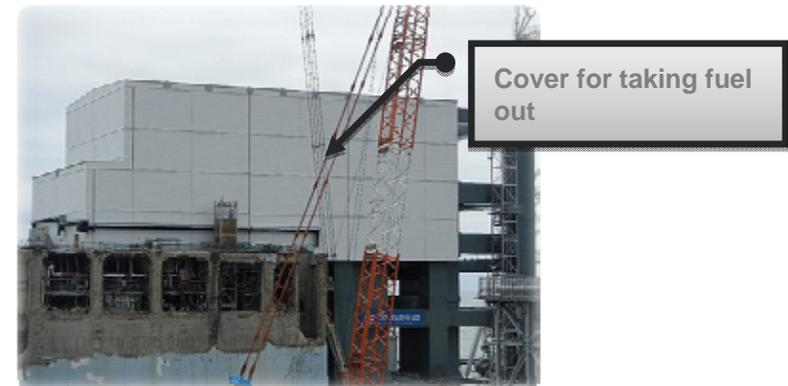
Reactor 4 with external walls and ceiling panels installed

- We are now preparing for removing fuel from the spent fuel pools. This is to be carried out by removing debris on top of the building and installing external walls around the building, and covering its ceiling. Actual works will start in November 2013.

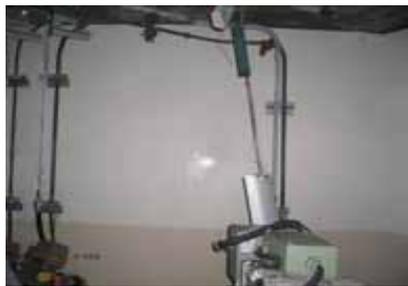
Wall supporting the spent fuel pool

Verification is made by visual checks to make sure there is no damage within the reactor building.

- Periodic observations are being cautiously made by visual checks, such as verification of concrete floors and wall cracks.
- Appropriate maintenance is being conducted as needed.

Periodic inspections are being conducted 4 times a year, and the integrity of the reactor building and spent fuel pool are verified.

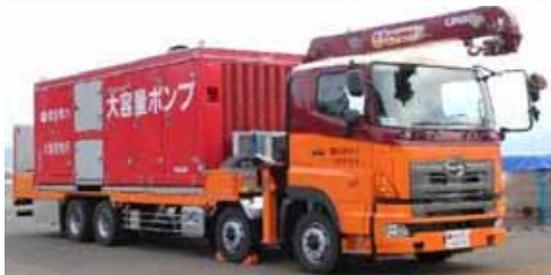
Secure supply of water for the reactor and steam generator by deployment of fire pumps

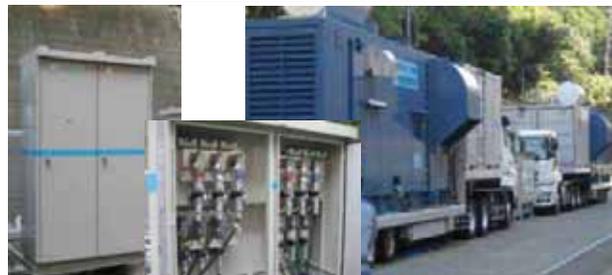
Secure power source for the central control room by deploying power source cars

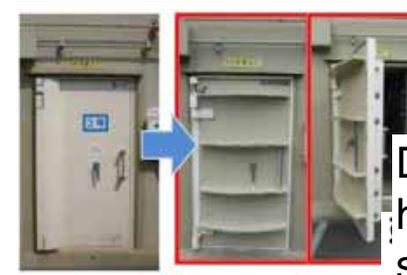
Waterproof measures implemented for power boards, batteries, pumps etc

Doors and holes are sealed

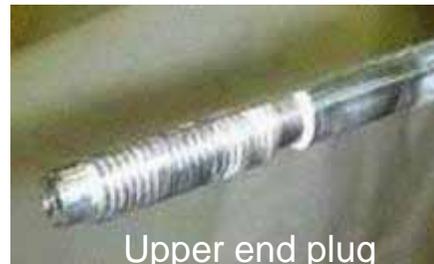
Investigation of unused fuel in Reactor 4 fuel pool (Removed two assemblies of fuel in July, 2012)

- In July 2012, unused fuel were removed from the Reactor 4 fuel pool and were inspected.
- It was confirmed that there were no significant damages or corrosion on the surface of the removed fuel.
- Slight corrosion was detected on the part of lower tie plate, but it was not significant.

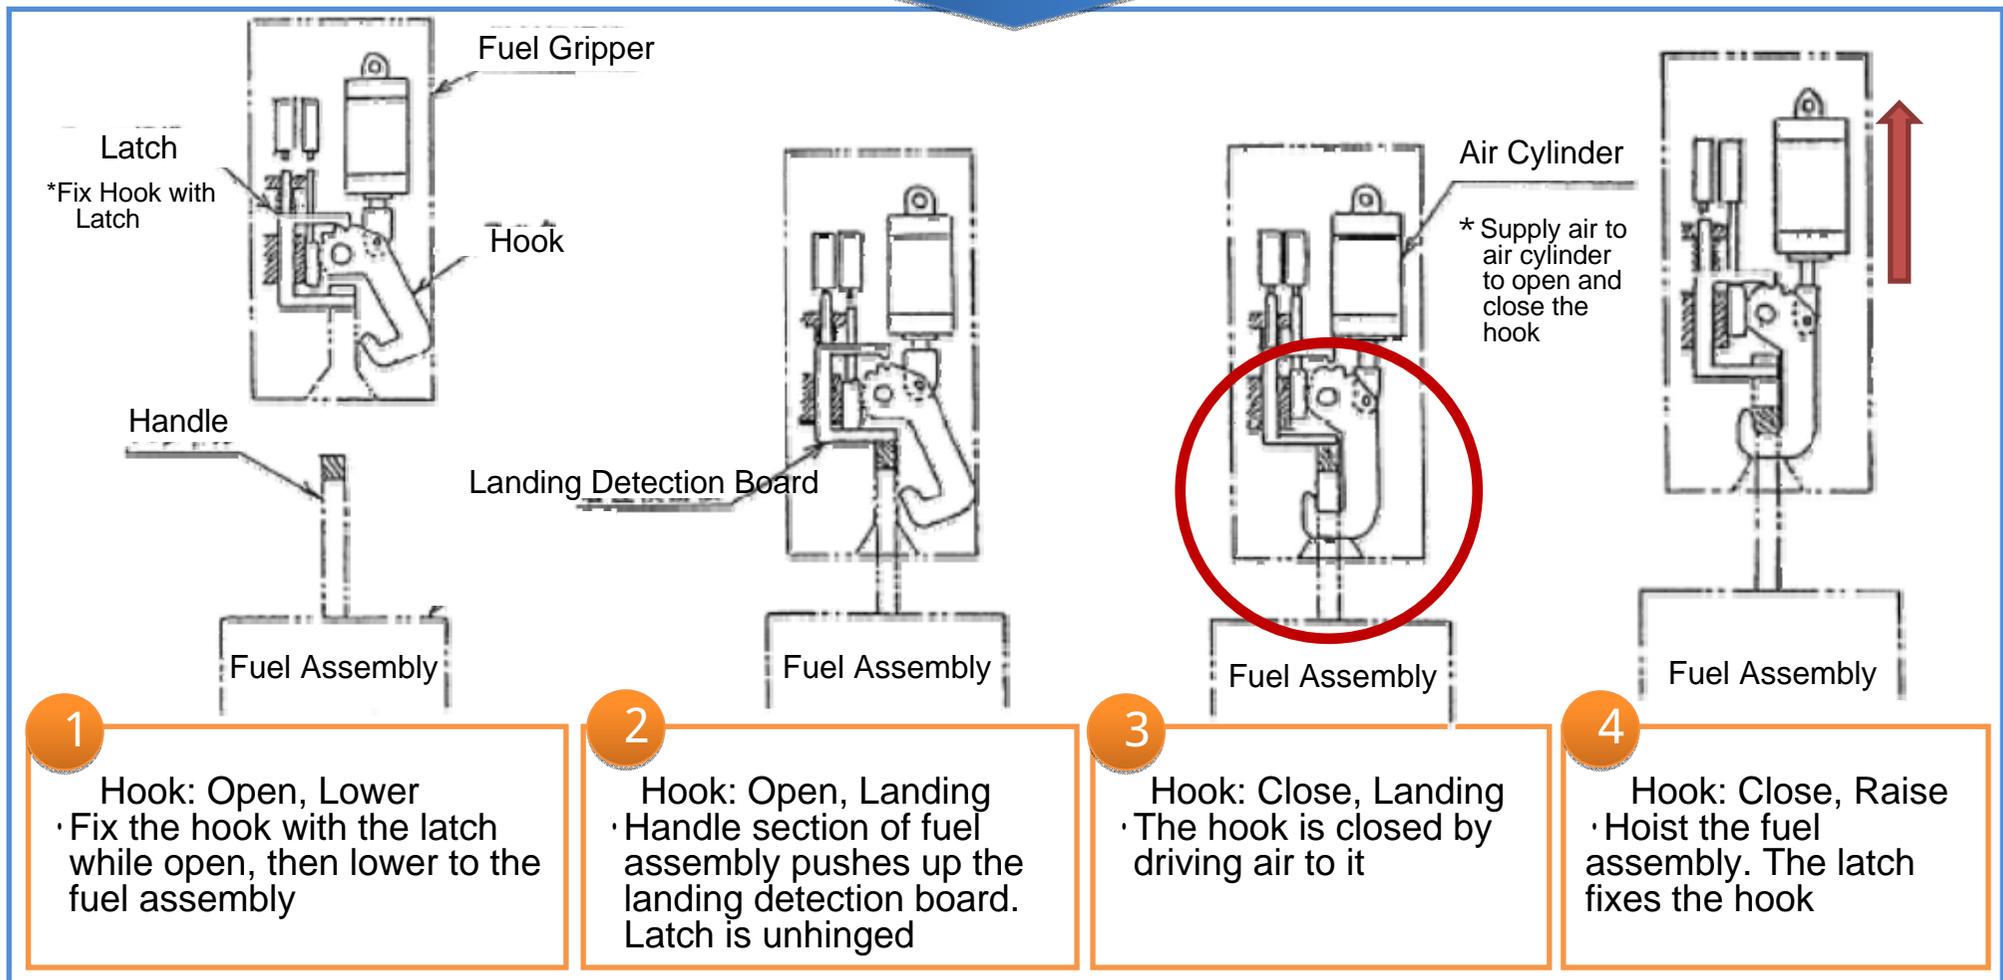
Interlock system: If the gripper is not holding the fuel handle correctly, the hoist operation will stop automatically.

Operator control panel: Operators can confirm each step, such as "Hoisting preparation complete" and "Hoisting complete" on the panel.
