XXXIV ANTARCTIC TREATY CONSULTATIVE MEETING - BUENOS AIRES JUNE 20TH - JULY 1ST, 2011

Japanese Inspection Report 2010

Inspections under Article VII of the Antarctic Treaty and Article 14 of the Protocol on Environmental Protection

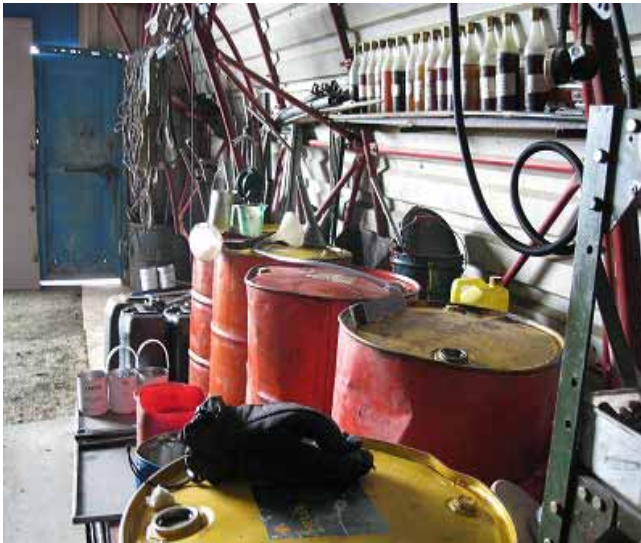
Vehicles were being refueled from a 10,000-liter vehicle fuel tank installed near the Vehicle Workshop.

Oil for servicing vehicles in the garage

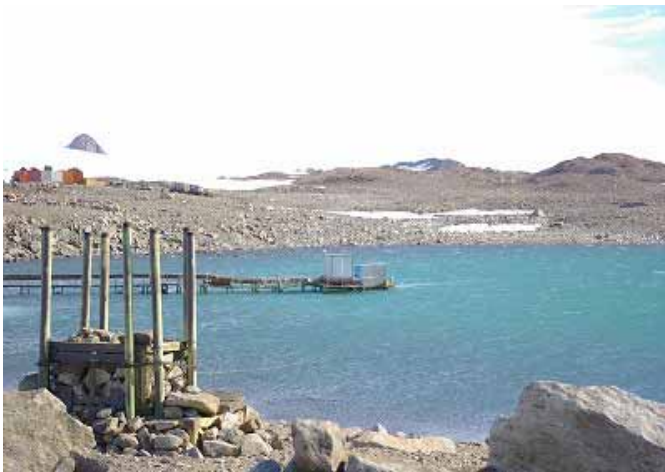
The station was using water pumped from a nearby lake (Lake Priyadarshini). The station was equipped with two water tanks with the capacity of 5,000 liters. Water usage was 40 liters per person per day.

Water intake

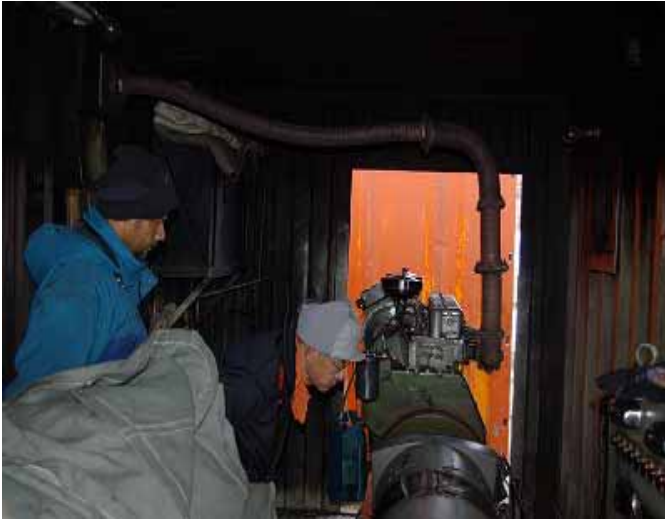
The station was using an air-cooled power generator. The generator was being monitored 24 hours a day, with two persons working in 12-hour shifts.

Air-cooled power generator

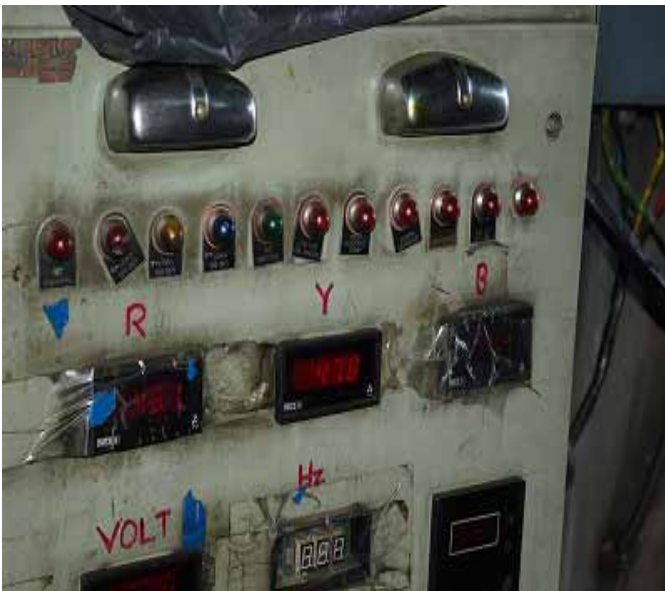
The monitoring panel of the power generator

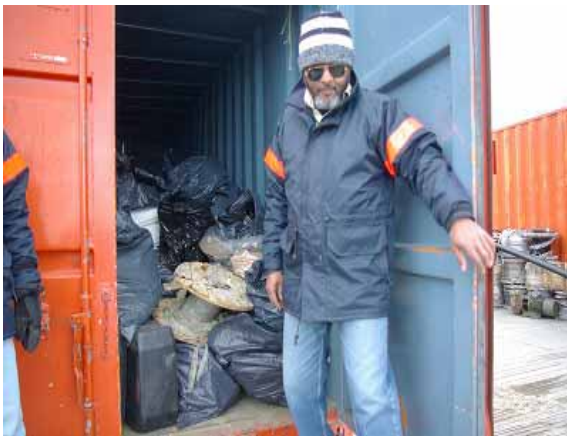
In terms of the storage of wastes in the containers, the inspection team was briefed on but could not confirm whether that rule was fully implemented.

Waste stored in one of the containers

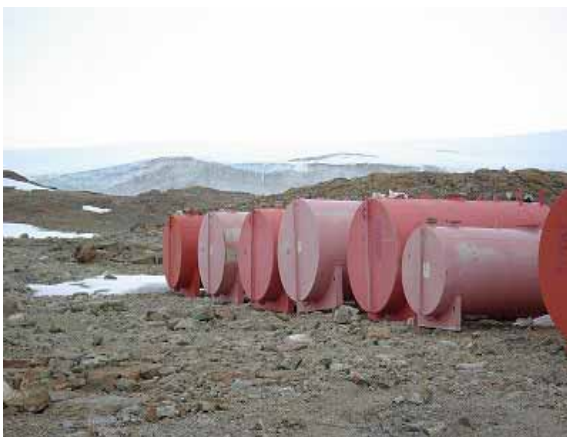
Oil tanks

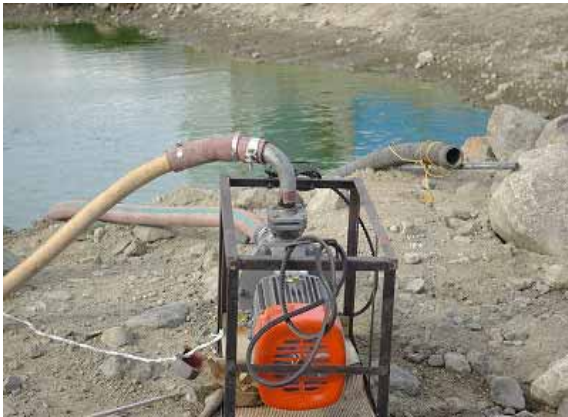
Next to the temporary reservoir, there seemed to be an artificially made pond that appeared to contain wastewater, but no one knew the exact purpose of the pond.

The station informed the inspection team that water quality was examined on an annual basis.

Pump at the temporary reservoir

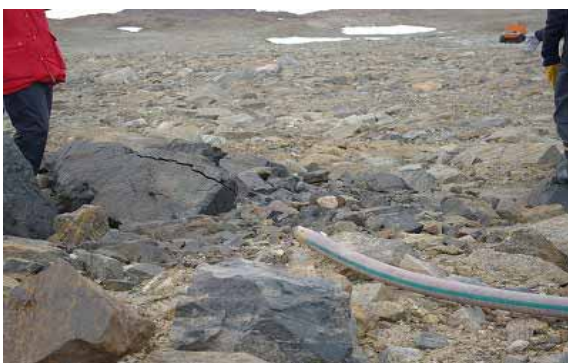
Drain outlet

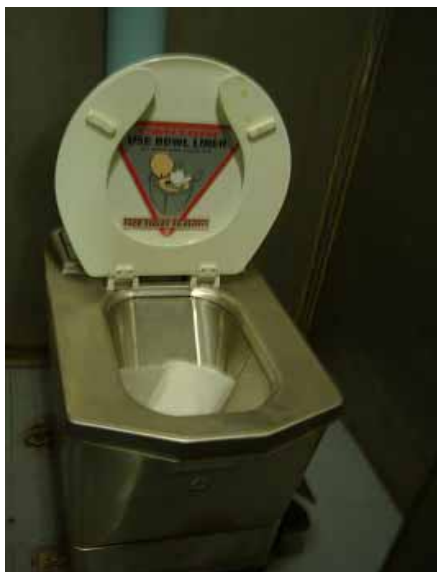
The station informed the inspection team that solid human waste was treated by incinerating toilets, and that, due to limitations in incineration speed, one toilet was assigned to only 2 to 3 people.

Incinerating toilet

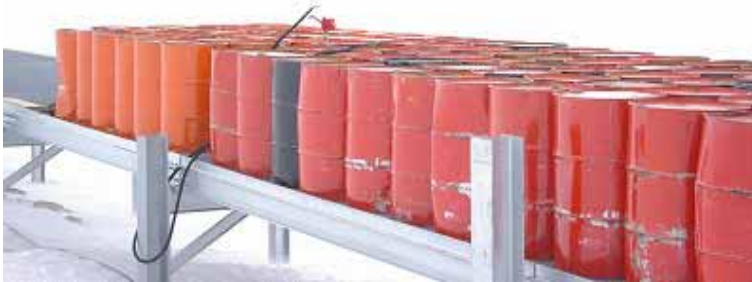
The inspection team found that the station personnel were well aware that fueling can cause accidents and that fueling vehicles is riskier than fueling generators. For this reason, measures against fuel and oil spill such as use of secondary containment (e.g.drip tray) and absorbent material were taken and there have been no fuel or oil spill incident so far.

Fuel is stored in drums on a platform outside

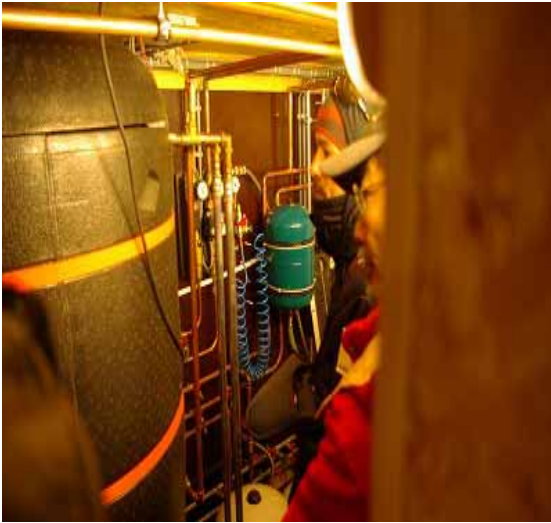
According to the station, 70 liters of water per person per day are used (the average number of 16 to 18 personnel is supposed). 20 liters of water for drinking are newly made by melting snow, while remaining 50 liters are recycled water. Repeated recycling of water reduces the need of melting snow to make fresh water. (The team was briefed that 450 liters of water were produced on January 31st). Antifreeze fluid in two solar heating panels on the rooftop is warmed up to 60 degrees Celsius, and then the heated fluid was put in heat exchangers to melt snow. Water is also heated to 60 degrees Celsius (90 degrees at the maximum) in solar heating panels on the rooftop, and stored in two 300 liter tanks placed in the attic for shower and the kitchen.

Hot-water tank and pump for making water

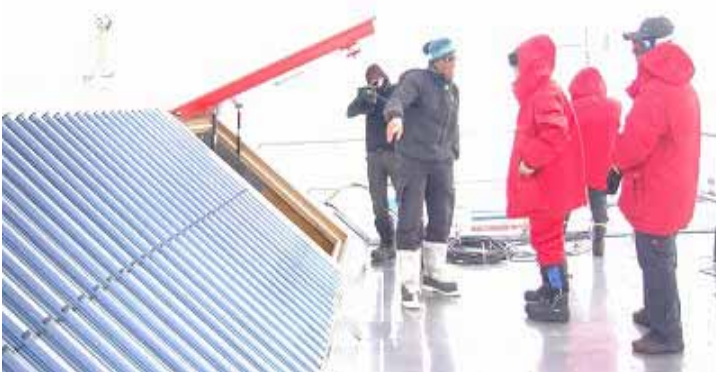
Solar panel for water heating

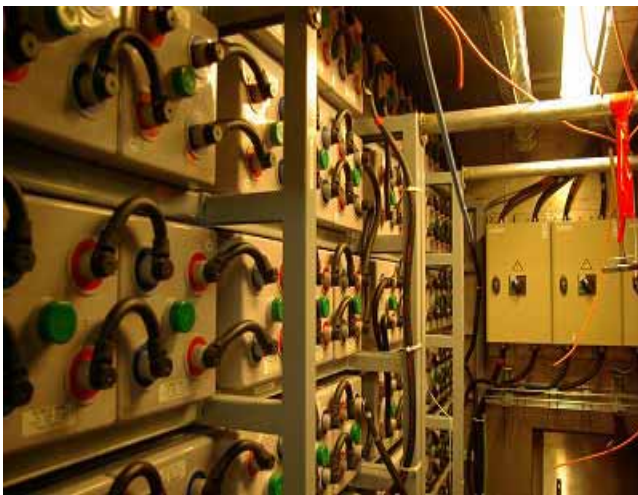
Electricity generated by wind and solar powers is stored in large amount of batteries, each of which is managed by respective control units. The battery's life cycle is ten years.

Battery room

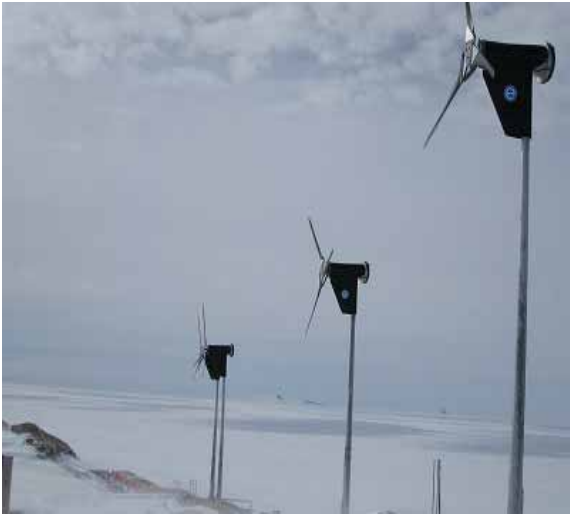
Wind turbines

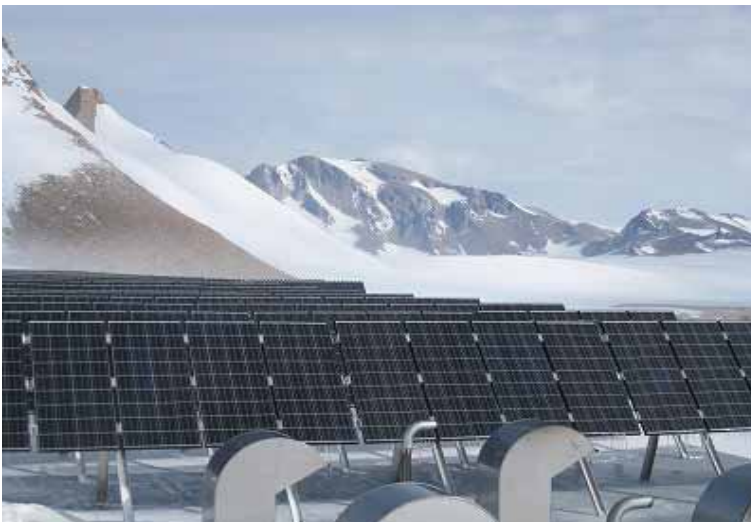
Solar panels

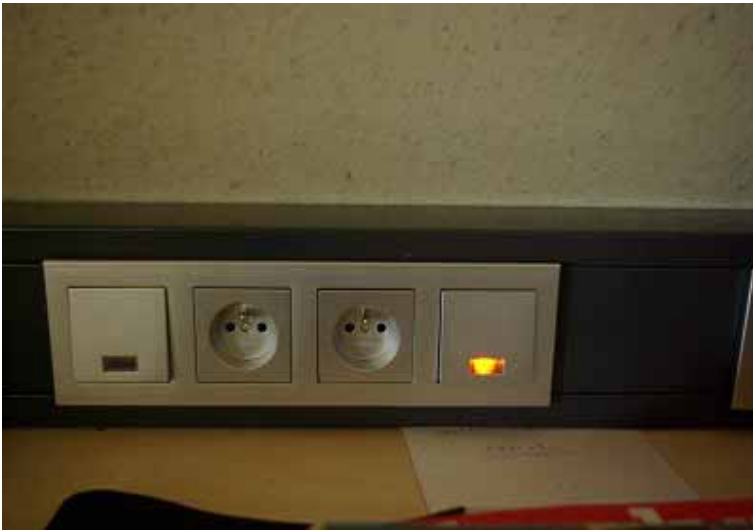
The “ smart grid ” optimizes the station with minimum electricity use and reduces power consumption to one-tenth of an ordinary station. Insulations are installed within wooden panels thicker than 50 centimeters, in order to enhance air heating efficiency.

Outlets controlled by the smart grid (When energy is available, the light turns on after pressing the outlet button)

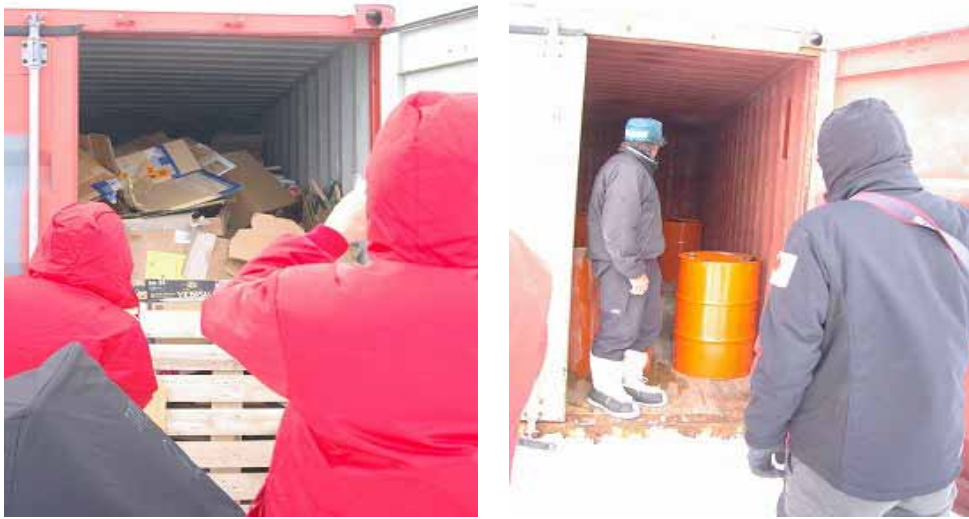
The inspection team was briefed that waste was being sorted into human excrement, organic waste, oil, aluminum, and combustible waste including cardboards. Sorted wastes were stored in 20-foot containers. According to the station, all the wastes will be taken to Cape Town when station fully starts to operate.

Containers to keep waste

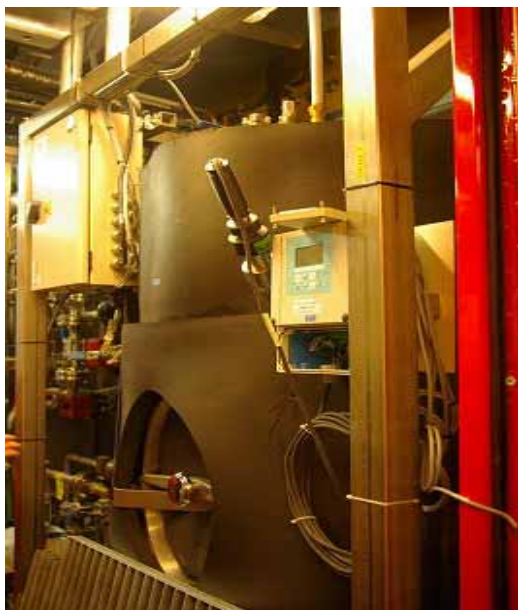
According to the station, the processed water is normally reused about five times. After that, the water is treated and released into an approximately 100 meter deep crack between the rocks and ice (Bergschrund). Membrane filters used to clean the water are replaced with new ones every three years. The amount of sludge is about one bucket per month. The drainpipe was being worked on and could not be inspected.

Sewage treatment tank

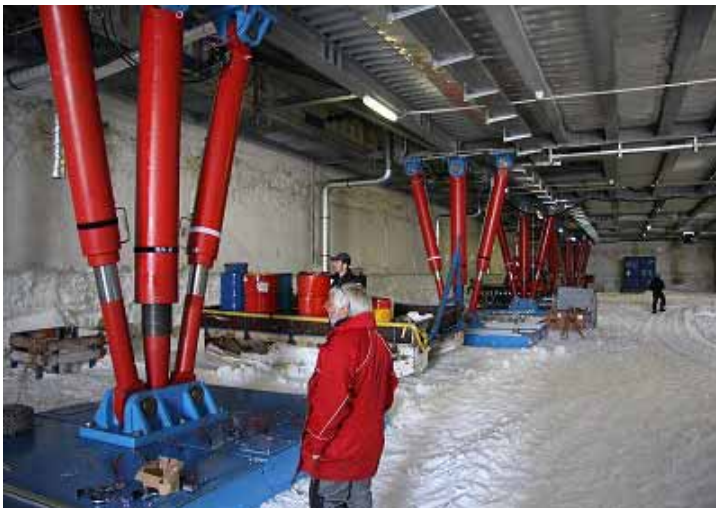
Supporting legs of the foundation of the station

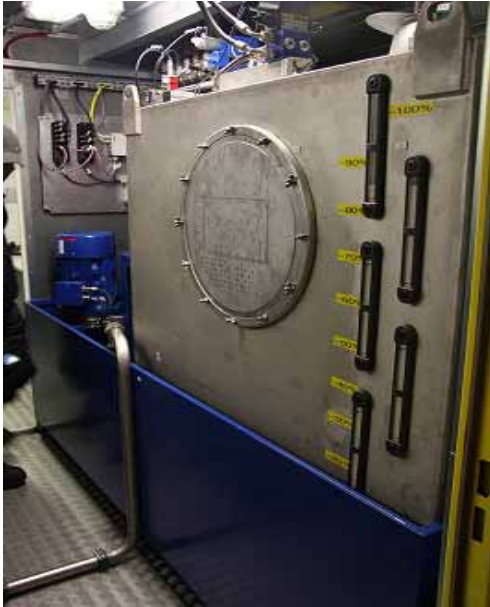
Oil tank for the hydraulic jacks in the foundation

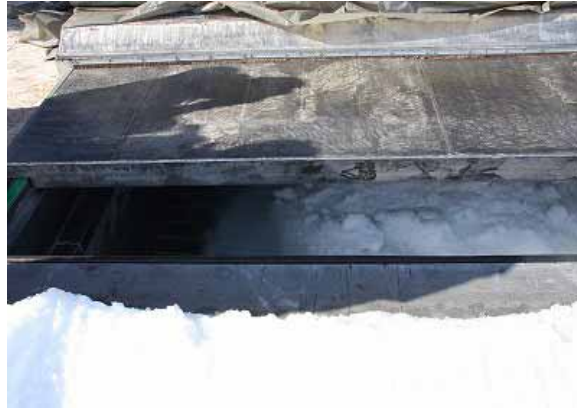
The station also consumes approximately 3 tons of water per week to

maintain the indoor humidity level of 30 -40%.

Snow intake for water supply

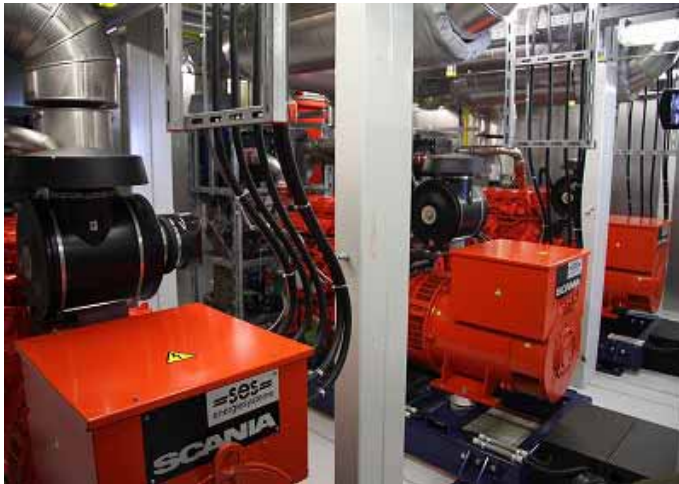
The electric power consumption of the station was 120 kilowatts, with the summer peak reaching 220 kilowatts. The peak heat demand was 212 kilowatts, including 40 kilowatts for melting snow, and 30 kilowatts for heating water.

The inspection team was briefed that the station was planning to self-supply all of its energy requirements by introducing 10 to 15 wind turbines and producing hydrogen. If the plan is implemented, the existing generators will be used as a backup system.

Power generators

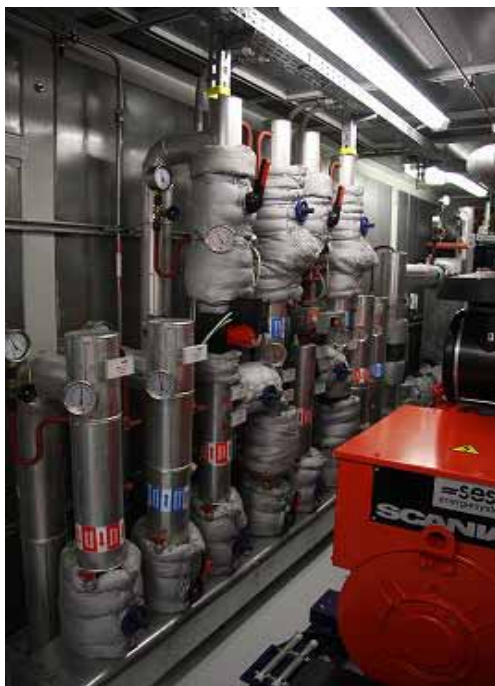
Water heating pipes using the exhaust heat from the generators

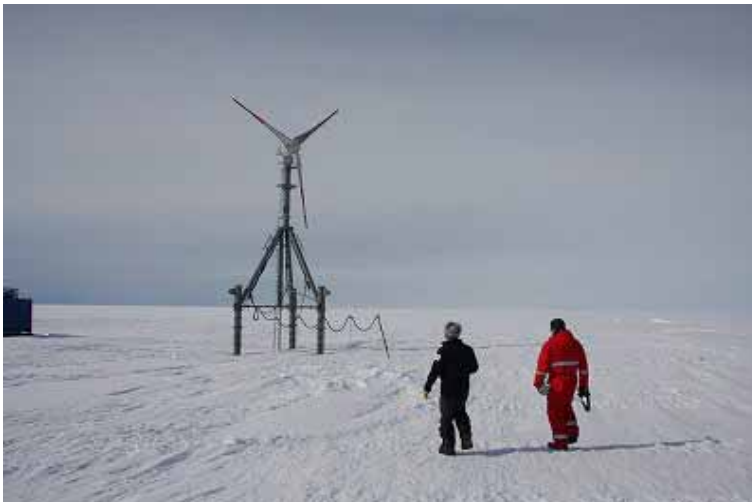
The station is built on an ice shelf and faces various challenges. The team was informed that the wind power generators that would withstand the environment were being developed. The plan was to install 5 wind turbines first, and install additional 5 turbines at a later stage. The planning and

construction is based upon a concept of an optimized cogeneration plant which can be augmented by renewable energy (preferably windpower). The one windturbine in operation at present is an experimental setup to find an optimum energy mix between renewable and conventional energies at this location. When all wind turbines are installed, either wind power generation facility that produces hydrogen and converts it into energy or additional equipment for energy generation (such as flying wheel, synchronized machine, etc.) will be introduced as well. A research has found that winds are blowing around the station at the velocity of about 10 meters per second most of the time, and that the station is favorably located for the use of wind power.

Wind turbine

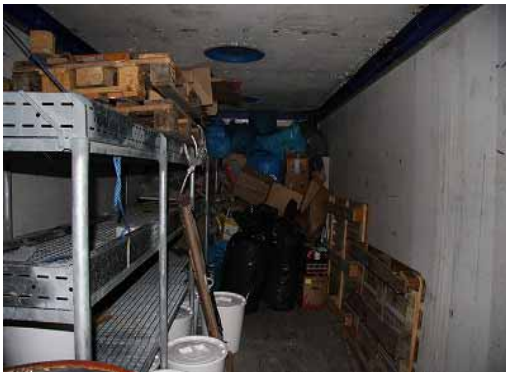
At the time of the inspection, organic wastes from the kitchen were sealed in white medical pails (capacity of 30 liters) and frozen for storage. According to the station, approximately 400 of such pails (which fill about three fourths of a container) were shipped to Germany per year. Other wastes were compacted and stored in containers. Recyclable glass wastes were disposed of in Cape Town, and other waste was being shipped to Germany.

Inside a container where waste is stored

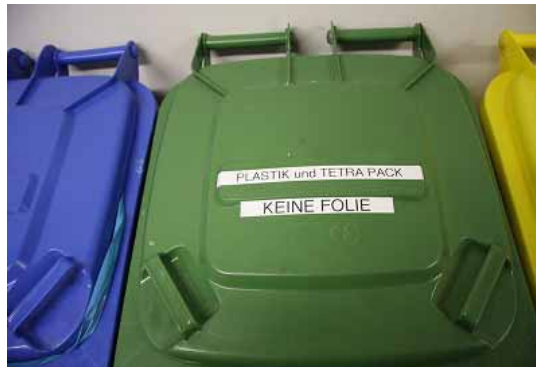
Waste bins that are color-coded for sorting

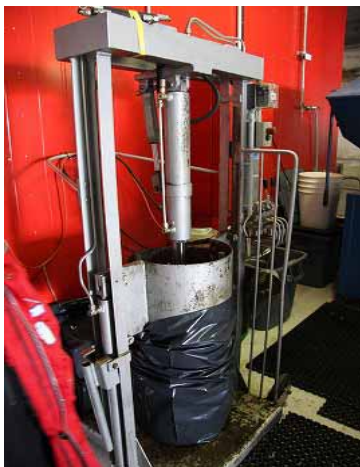
At the time of the inspection, the station was also working to reduce the use of cans and increase the use of reusable paper containers. Glasses were being pulverized and cans being compacted to reduce the volume of waste. Used fuel drums are shipped out with waste oil inside.

Glass pulverizer

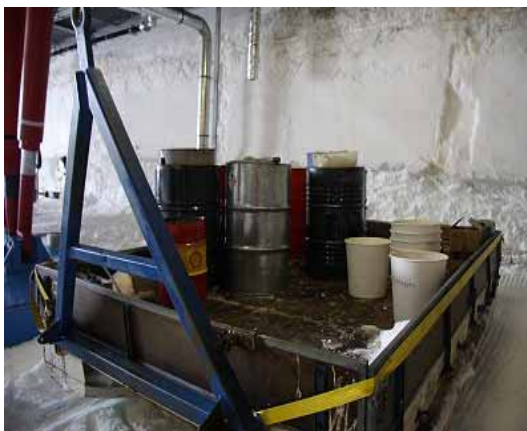
Waste oil

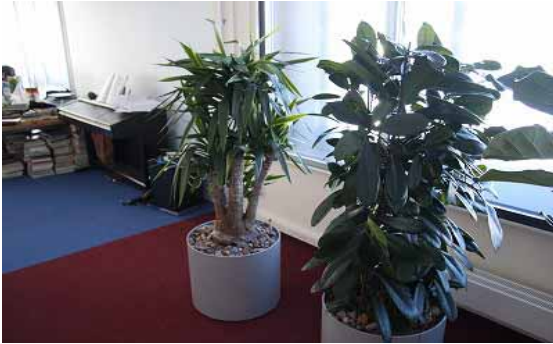
Hydroponic plants, which were found in the lounge of the station, had been brought in not necessarily with prior permission, though the station plans to follow relevant domestic procedures. The station had an intention to include information on these plants upon the completion of construction when they would have to report the station's equipment.

The station explained the inspection team that there was no environmental impact, as the station is located on an ice shelf and no soil was used for these foliage plants.

Foliage plants seen in the station

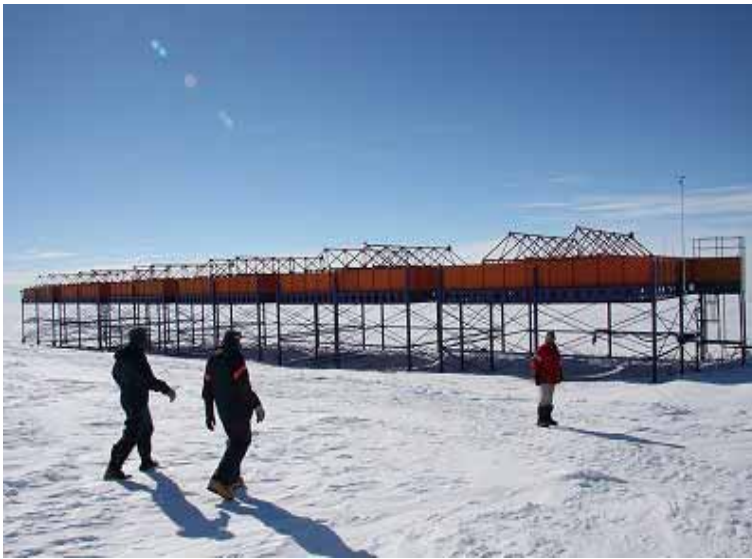
Inspection team observed six 100,000-liter rubber bladders for polar diesel kept in metal storage reservoirs, with the total storage capacity of 600,000 liters.

Oil storage tanks

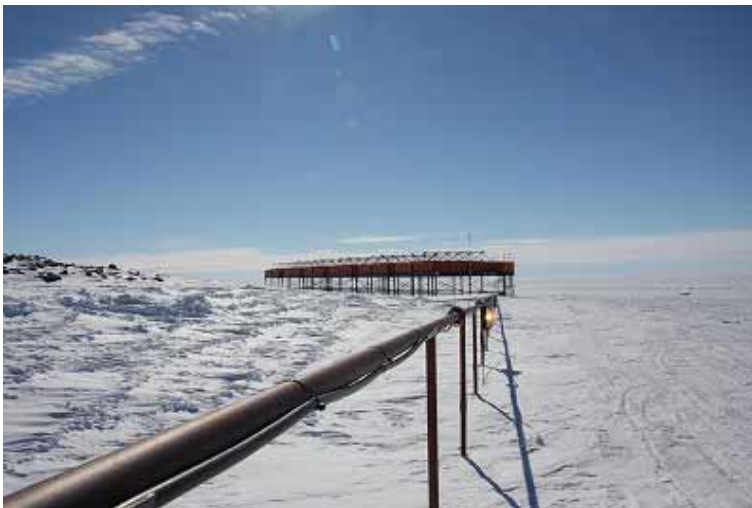
Oil supply pipes

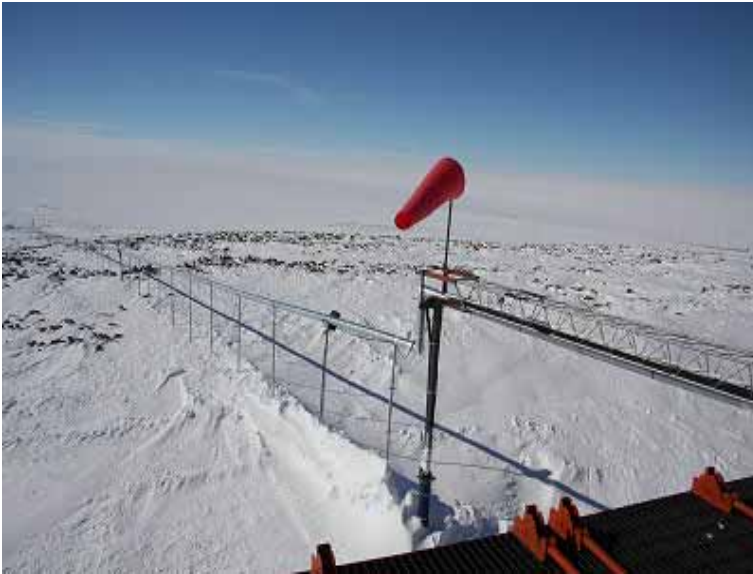
An immersion heater is placed in a hole in the snow, and the melted snow is pumped up into a 42,000 liter tank for storage and use. Snow is melted on a daily basis. Per capita water use is 50 to 200 liters per day.

Water intake pipe

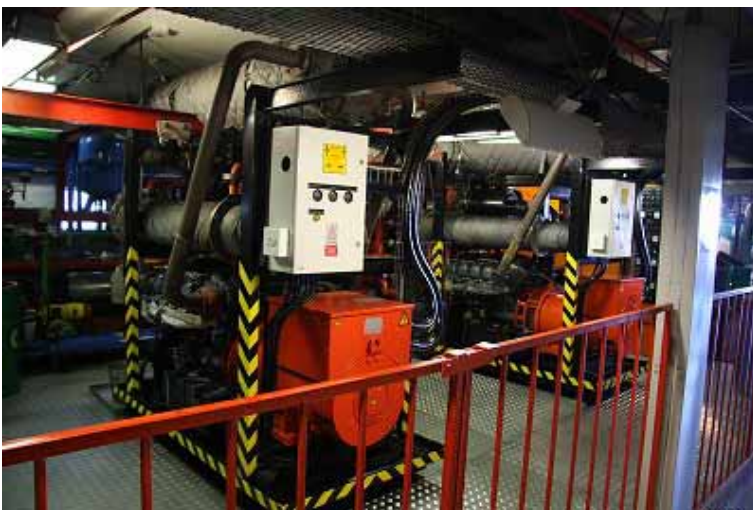
The inspection team observed that three diesel engine generators (225 kVA) were being used simultaneously. The waste heat was used for air conditioning of the station.

It was briefed that approximately 280,000 liters of diesel fuel were annually used for the generators.

Diesel power generators

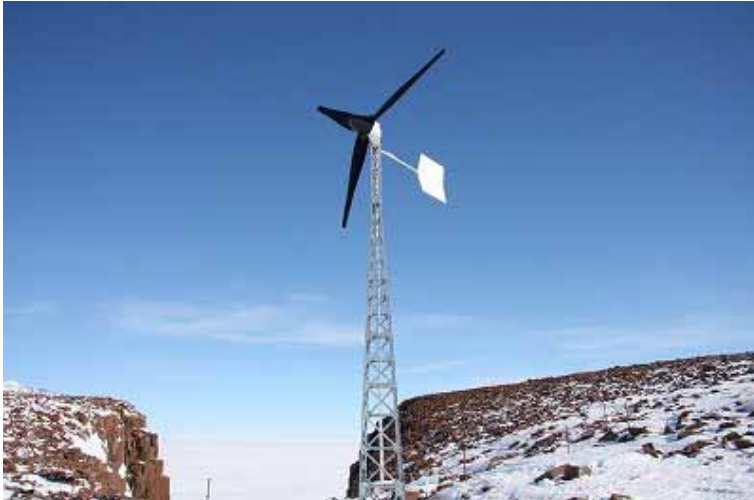
At the time of inspection, three wind turbines (rated power output for the system is 20 kW with the wind speed of 12.5 m/s) installed in January 2010,

were under test operation. It is planned that by 2011 the three wind turbines will be linked with the electric power network currently in use.

A wind turbine

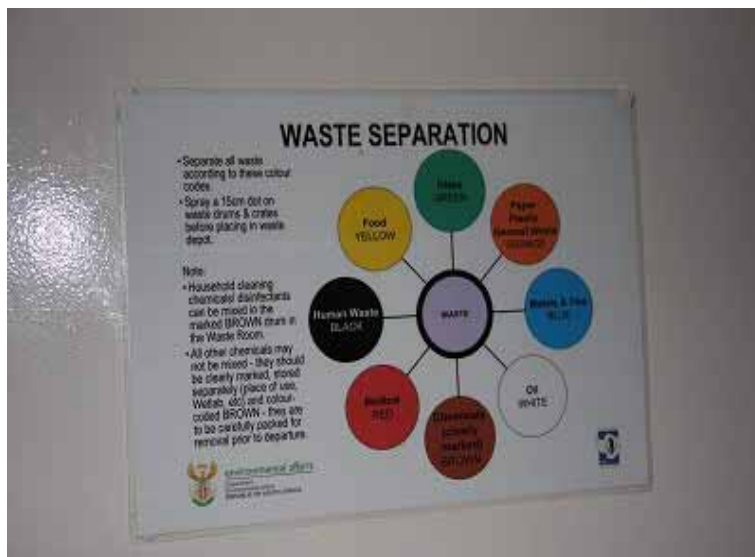
Instructions on waste separation at SANAE IV

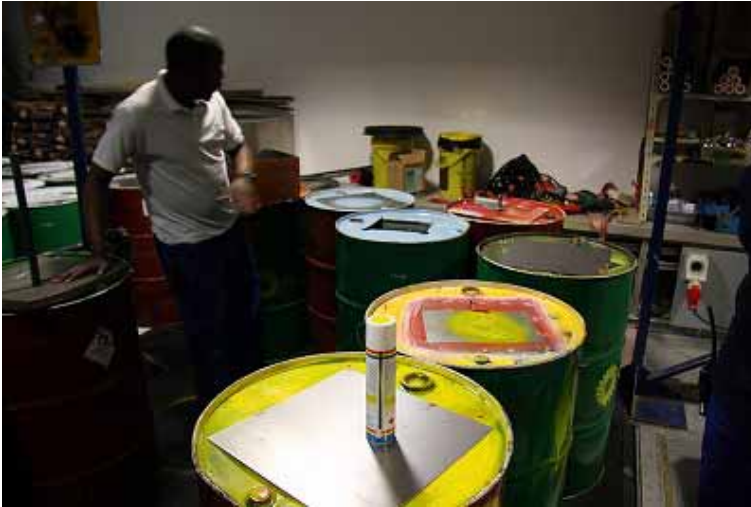
Color-coded waste storage drums

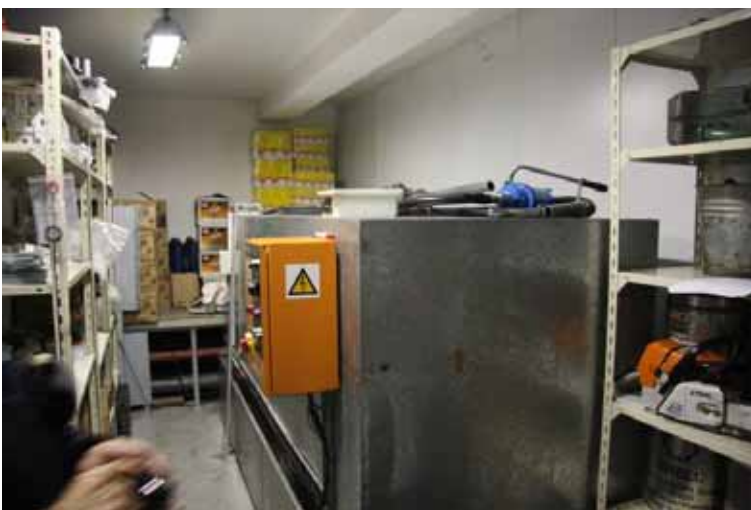
The oil storage tank used on a daily basis was being placed within the station. The station had double protection system for oil storage.

According to the station, there had been an oil spill accident near the station several years ago, and the contaminated snow was being collected this season as well. The inspection team observed that the collected oil was stored in empty drums in the waste storage site.

Oil tank (3,000 liters)

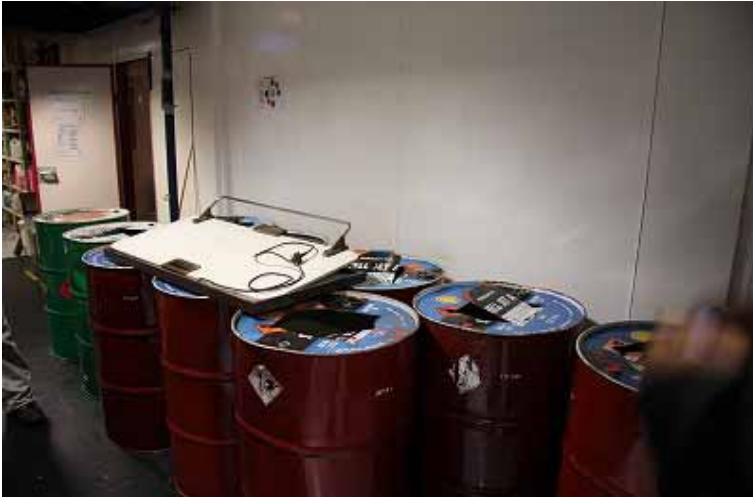
Drums stored with snow soaked with the past spilled oil

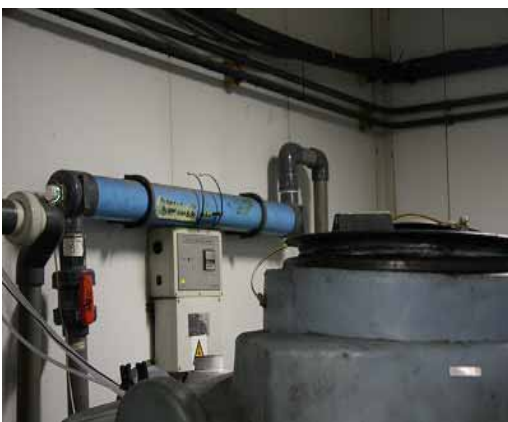
The inspection team observed that sewage was biologically treated and sterilized with UV irradiation, after which it was stored in a sewage tank near the helipad outside the station, and subsequently discharged onto a rock ledge. The filter is exchanged once a year. Ammonia levels, pH and other properties of the treated water in the tanks are examined every month.

UV irradiation equipment

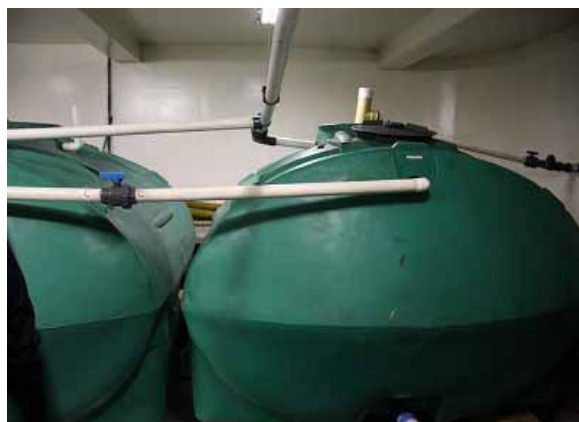
Sewage treatment tank

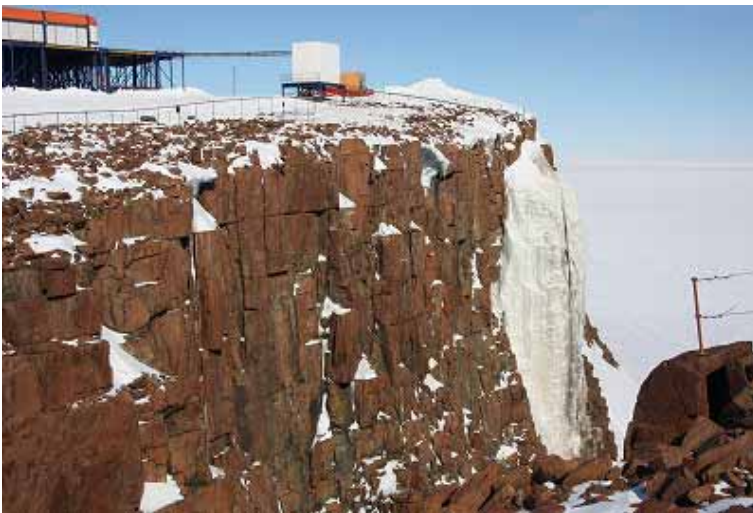
Drainage from sewage tank to the bottom of a cliff

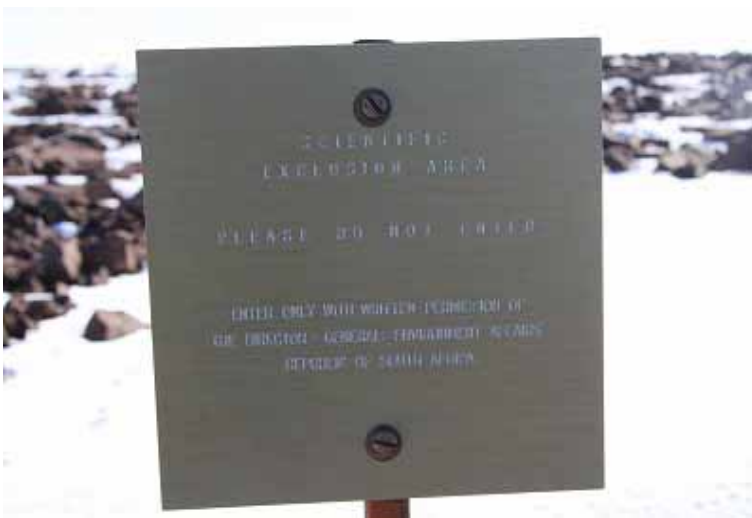
A signboard had been placed on a post in front of the area to indicate its boundary. Inspection team was briefed that only scientists and personnel concerned with environmental issues who have been given special permission are allowed to enter the area, and that they were considering to draft and file an application to make the area an ASPA under the Madrid Protocol .

Signboard of the protected area

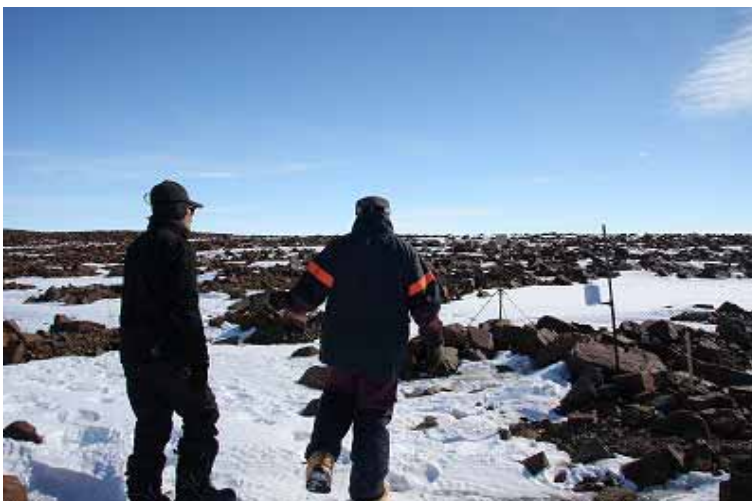
Protected area enclosed with posts

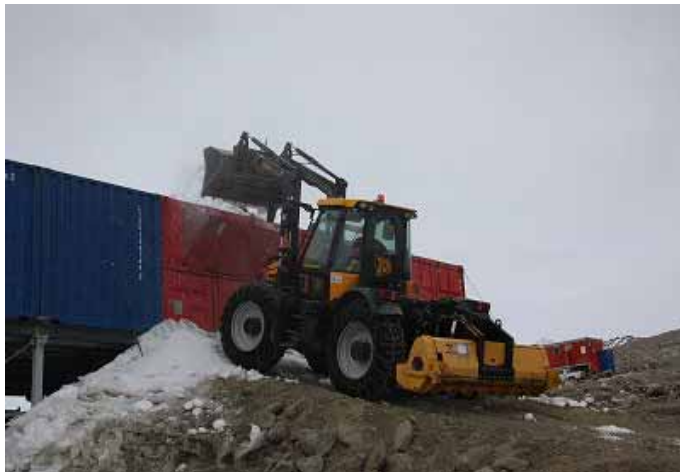
According to the station, ice and snow collected from the ice sheet near the station are melted in a snow melting system using heat from a generator, after which the water is filtered, sterilized with UV light, and kept in a 3,600 liter storage tank. Per capita water use is 80 to 100 liters per day.

Putting snow into the snow melting system

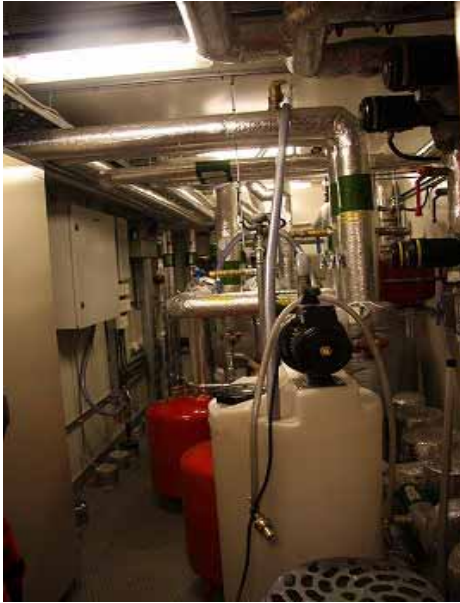
Generator heat exchanger

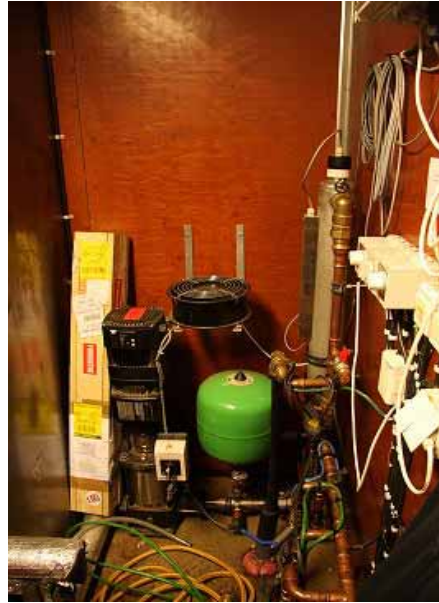
Water purification equipment

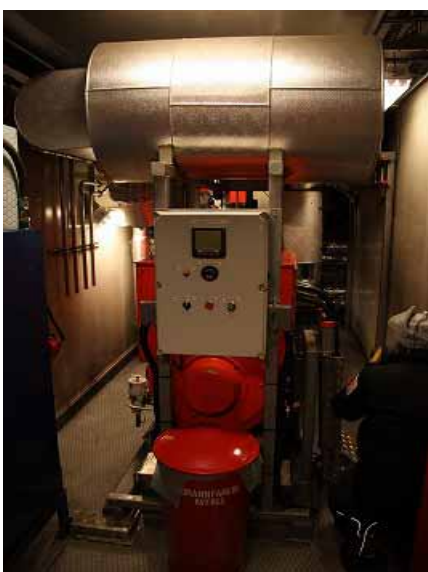
At the time of the inspection, two 300 kVA (240 kW) diesel generators were being used as the main power supply. There were two 80 kVA (64 kW) generators and one 60 kVA (48 kW) diesel generator for emergency use. According to the station, annually 250,000 liters of fuel are used for power generation. The generators were installed in a container, which appeared to have an automatic fire extinguishing system for emergencies.

Power Generator

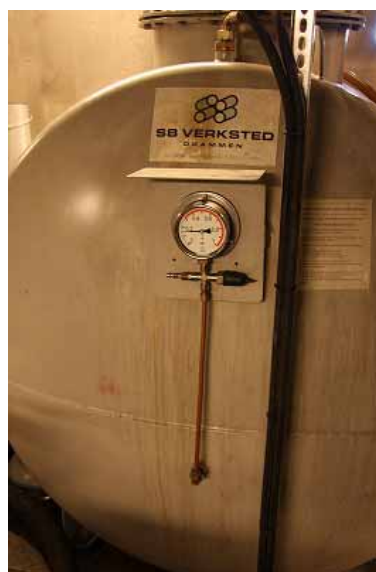
Fuel tank for generators

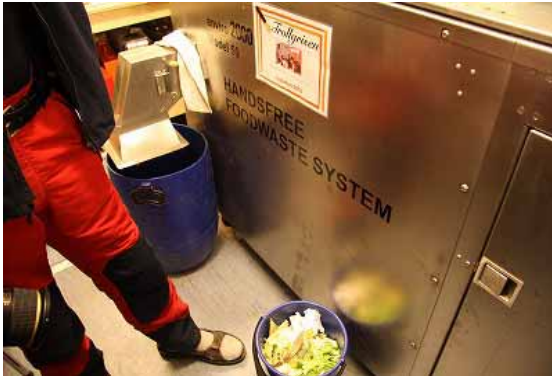
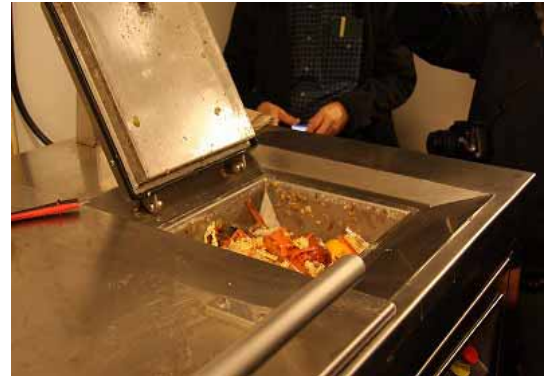
The inspection team observed that a waste management plan was being implemented with thorough management of the separation, reduction, and collection of wastes. According to the station, equipment to convert food waste from the kitchen into compost is used to reduce its volume to about one tenth. The compost is placed in buckets for this purpose and transported

Equipment to convert kitchen food waste to compost

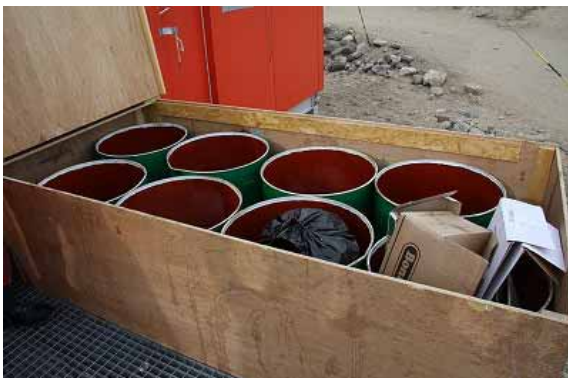
Containers with sorted waste

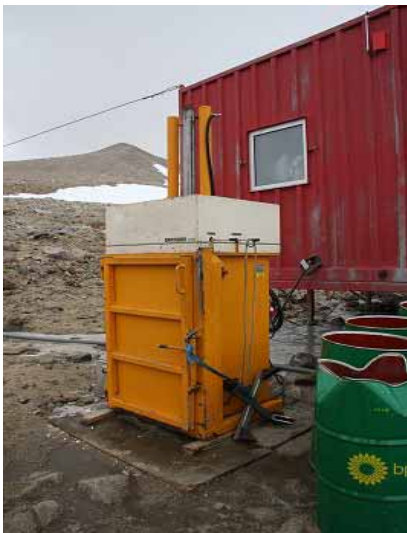
Used drum Compactor

According to the station, small amounts of oil remaining in used drums are sucked out and collected in a separate drum. The empty drums are washed and reused. Drums are compressed, stored in a container, and transported away for disposal. Used drums in the field are cut into pieces to reduce their volume, and brought back to the station. Drums used on expeditions to coastal areas are brought back to the station.

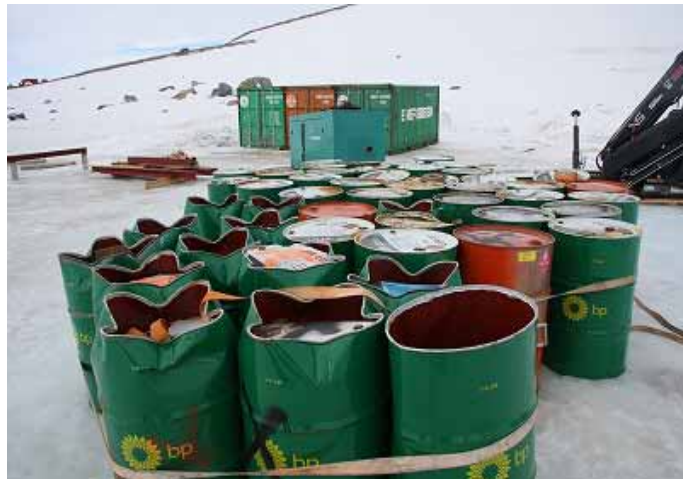
Drums are reused for storage of wastes, or compressed for transport out of Antarctica.

Used drums

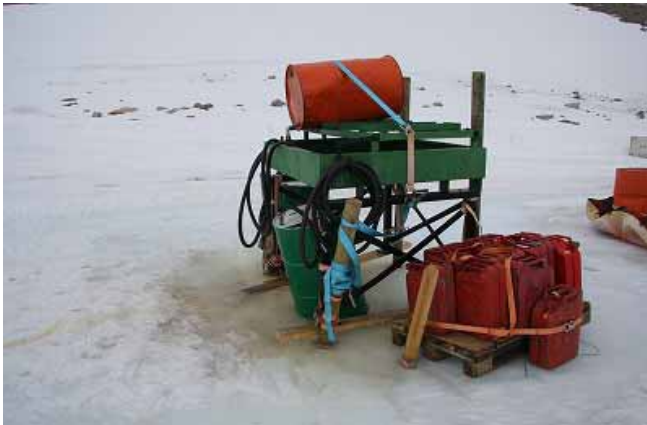
Outdoor oil dispenser (there were signs of accumulation of small amounts of oil that had leaked during oil supply)

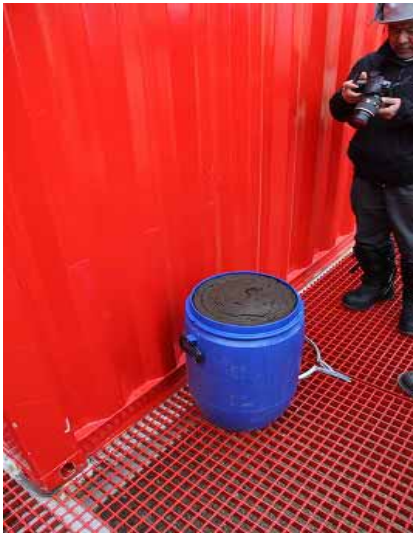
Sludge separated by sewage treatment

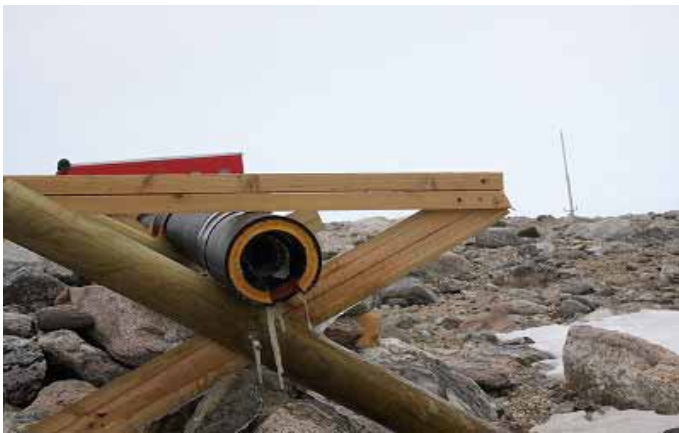
Drain outlet

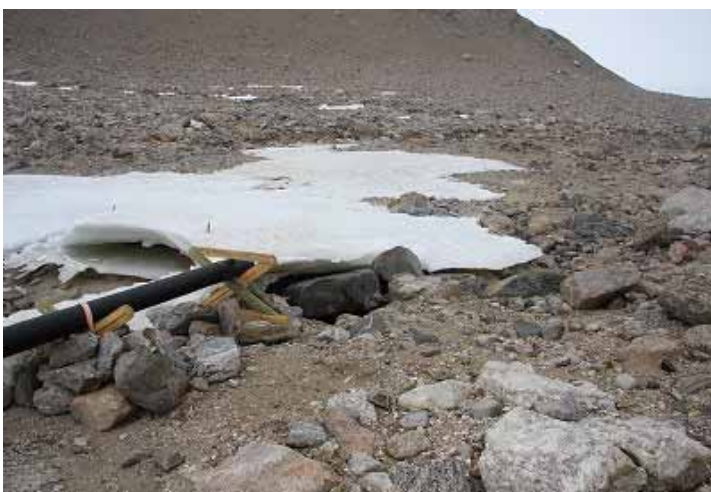
Area of discharge

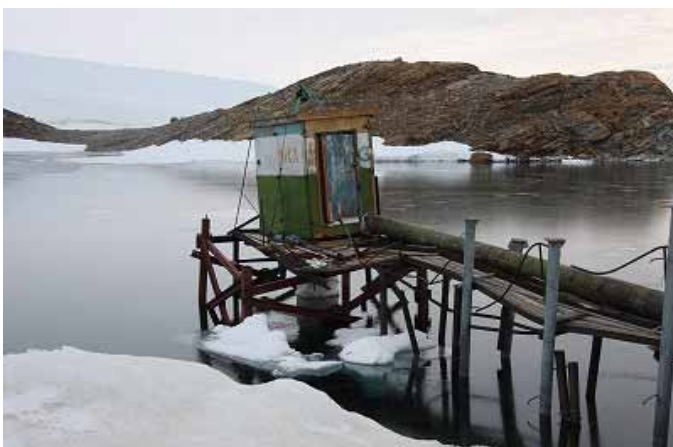
The station uses 30 liters of water per person per day. The inspection team observed that the station was drawing water from a nearby lake and it is concerned that the water quality might be deteriorated by steel panels, which appeared to be abandoned in the lake, as well as by possible oil leakage, which left traces on the upper bank area.

Water intake

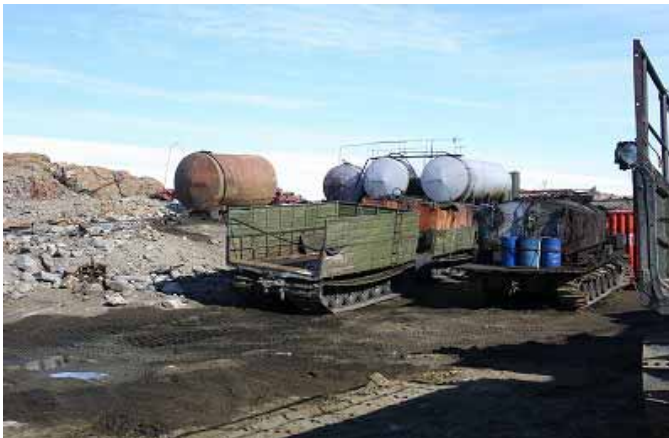
Because the station provides equipment and machinery to support DROMLAN, shortage of these seemed to be causing serious impact. At the time of inspection, only 5 of 12 snow vehicles at the station were usable, including the oldest one made in 1983. The lack of containers was causing inefficiency, as each drum must be lifted from the trucks by a crane one by one.

Fuel transporters

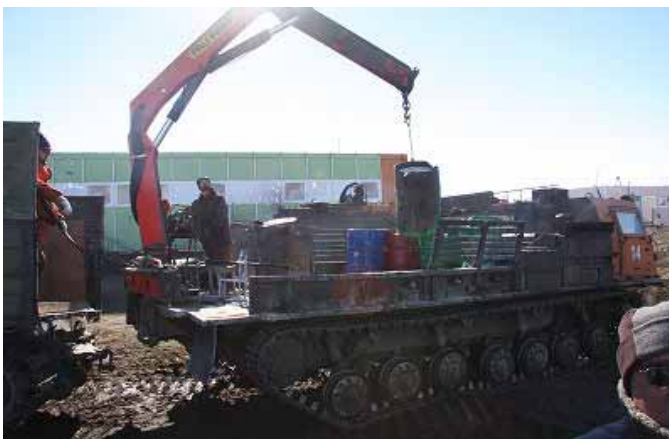
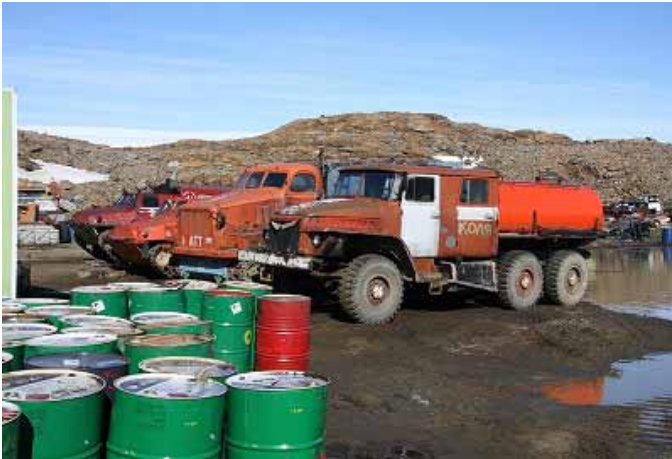
Vehicles at car park

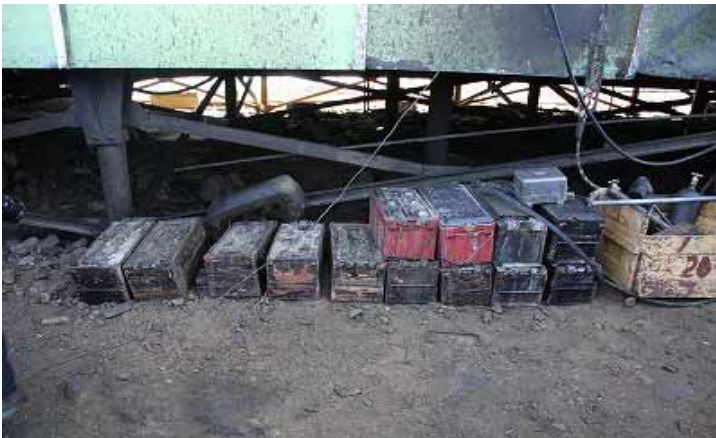
It was briefed that sulfuric acid (H_2SO_4) was used for battery fluid and it was being removed only in restricted areas. X-ray film developer was being used and disposed along with the waste from the weather monitoring station. The consumption of X-ray film developer in winter amounts to approximately 3 photos.

Used batteries

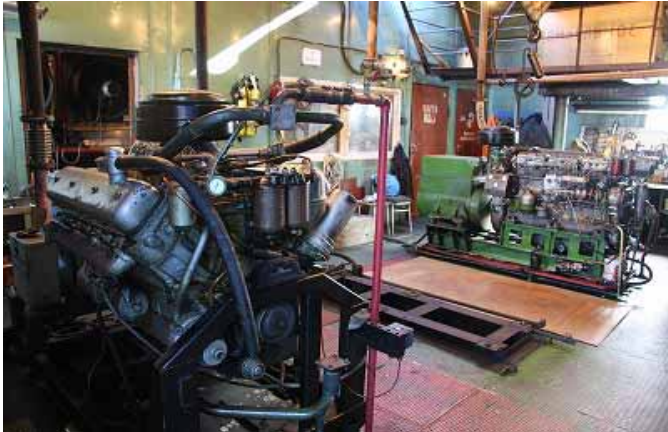
Various types of power generators were being used, many of which were outdated. The station leader told the inspection team that he knew these old generators were inefficient to maintain and produce energy. The inspection team was explained that although the station has proposed AARI (Arctic and Antarctic Research Institute) to standardize the specification of these generators, it has not been realised yet. The station will replace one

Power generators

old generator soon and another in the future.
