XXXIV ANTARCTIC TREATY CONSULTATIVE MEETING - BUENOS AIRES JUNE 20TH - JULY 1ST, 2011

Japanese Inspection Report 2010

Inspections under Article VII of the Antarctic Treaty and Article 14 of the Protocol on Environmental Protection

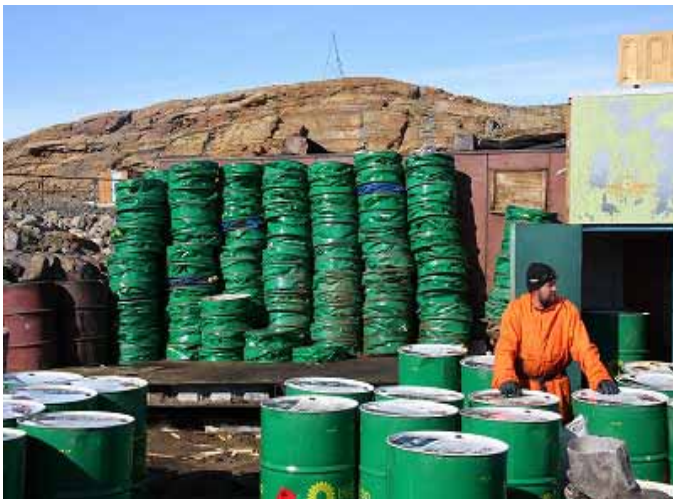
This year, the station transported 1,700 drums but only small portion of them were being used at the station (80 drums: 70 for engine oil and 10 for antifreeze). The rest were used by DROMLAN. After refueling, 100 drums had been pressed by the station staff in a peak day.

Drum disposal site

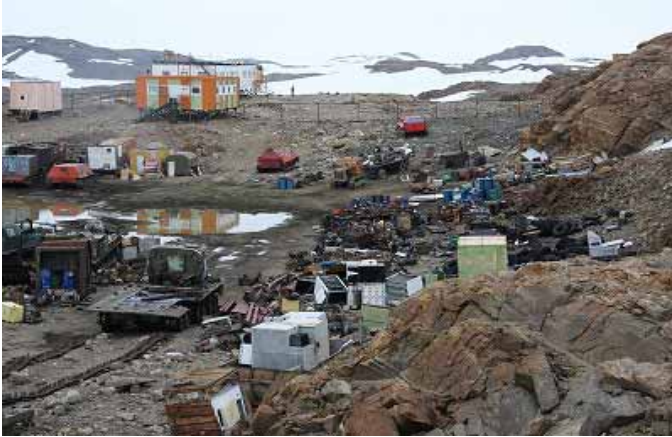
The Norwegian 2001 inspection noted a large area filled with operational and non-operational vehicles and equipment, and most of them were still there at the time of this Japanese inspection. The station was aware of the need to remove waste from Antarctica promptly and had been conducting cleaning campaign for 16 years. The inspection team was also informed that all the expedition members collected trash twice a week. According to the station, removing bulk waste is difficult due to the lack of the means of transportation, including vehicles. This year, 90 tons of wastes were planned to be shipped out, including 33 tons of compressed drums.

Used equipment left outs

On the other hand, more work needs to be done to protect the environment. For example, soil contaminated by oil was found in many areas (large amount of contaminated soil was found in one area). Sewage from facilities without treatment system was released into the sea through a crack in the ice. Furthermore, large sized wastes including broken vehicles were left seemingly for a long time.

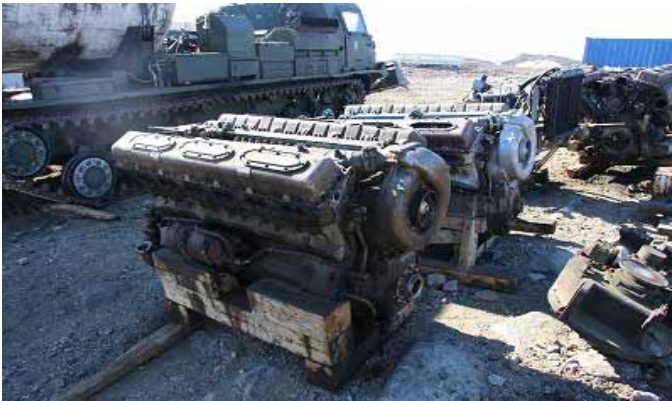
Reused engines

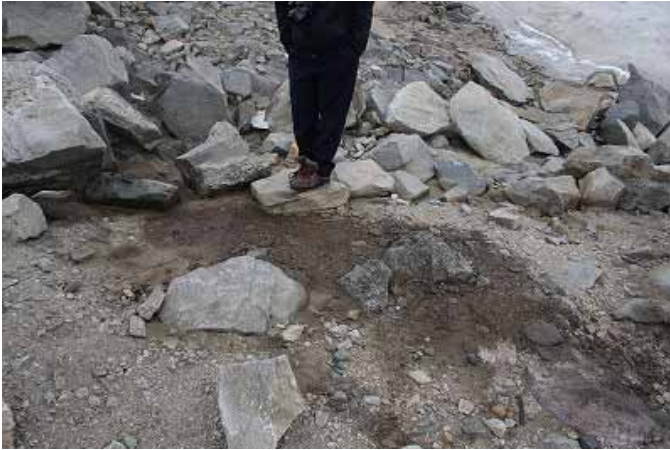
The team was explained that when fuel spills take place, pumps are used to collect most of the fuel and remaining areas are cleaned manually. Station personnel in charge of environmental conservation were responsible for oil and fuel spills. Russian guidelines require that spilled oil and fuel should be kept in a barrel, marked in white, and removed from Antarctica.

Traces of oil spills on the soil

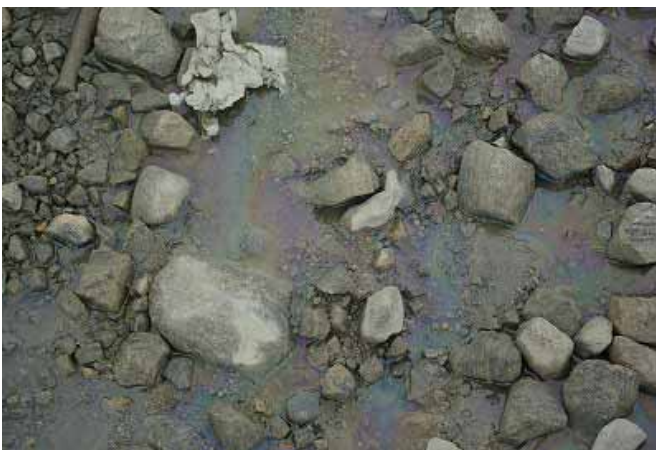
During the interviews, the inspection team asked the station personnel about clean-up plans and found that no specific measures seemed to be taken so far.

A fuel puddle that seeped up from the ground

There also seems to be a scope to reduce the risk of oil leaks and spills through preventive measures, such as installation of oil weirs around oil storage tanks in accordance with the guidelines of Council of Managers of National Antarctic Programs (COMNAP). Thus, preventive measures are of utmost importance. Furthermore, disposal of soil already contaminated with oil is an urgent task; the station where such contamination has occurred should be proactive in removing the contaminated soil and related materials.

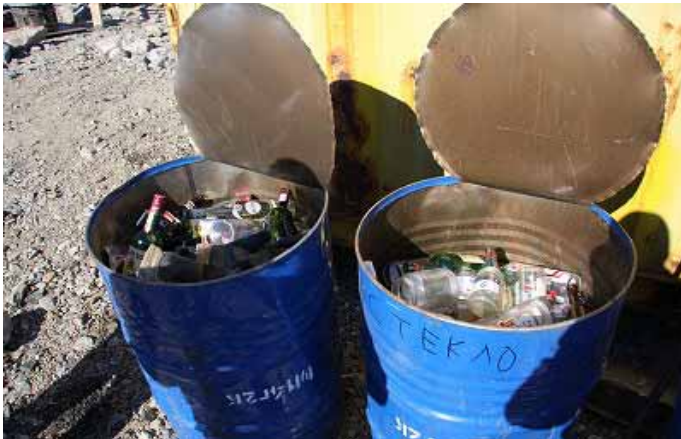
It was briefed that wastes were sorted into seven categories: burnable waste, glass, metal, plastic, ash, oil, and batteries. Paper and combustible plastic were burned in a double-stage incinerator, metals were compressed and inflammable plastic, ash, oil and batteries were removed from Antarctica. Glass, garbage, and metals were disposed in Cape Town.

Sorted waste glass

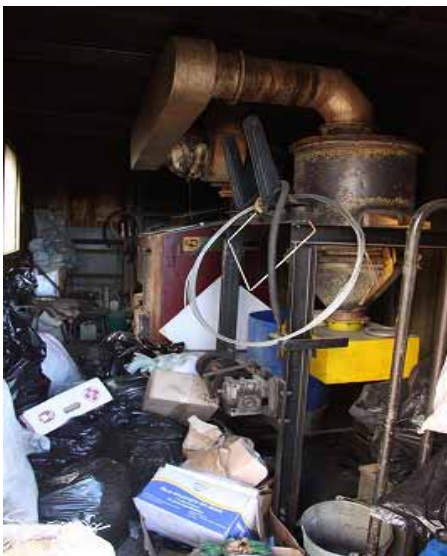
Incinerator

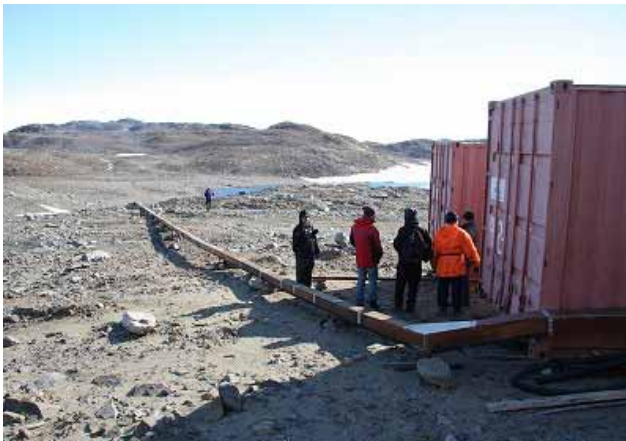
At the time of inspection, the station facilities were going through refurbishment, and new containers with sewage treatment system were installed. As a result, the inspection team was informed that waste water from certain buildings was being treated with bioreactors. The station had a plan to have all fresh water be treated in the future.

Water treatment plant

The wastewater is filtered through charcoal and sand, processed in an ozone treatment system. The ozone processed water is temporarily stored in a tank and automatically discharged every 10 cubic meters. There is a report that a water treatment system using magnesium ammonium phosphate ($\text{MgNH}_4\text{PO}_4 \cdot 6\text{H}_2\text{O}$) has been developed in Russia.

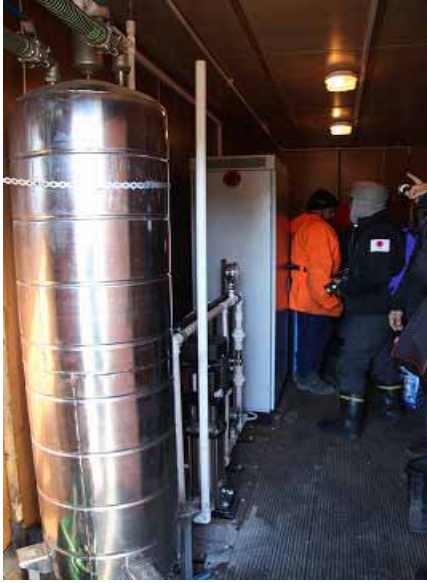
Ozone treatment unit for sewage water

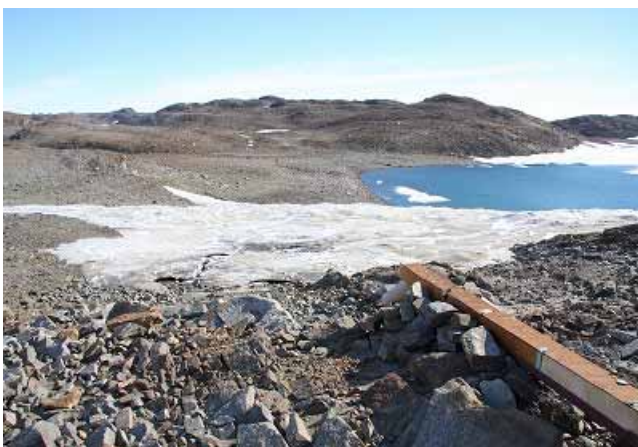
No records of the amount of sewage have been kept and no water quality monitoring has been conducted.

Drain outlet

The stations that were not monitoring water quality at the time of the inspection are recommended to start doing so. It is also recommended that such issues as waste water quality, and treatment methods be discussed at ATCM in the future. An option could be for COMNAP to adopt practical guidelines on waste water quality as necessary, in light of what is "to the maximum extent practicable" (Article 2 (2) of Annex III to the Protocol) and "the only practicable option" (Article 4 (2) of Annex III to the Protocol).
