Current Status and Recent Topics of Fukushima Daiichi NPS

May 30th, 2014

TOKYO ELECTRIC POWER COMPANY

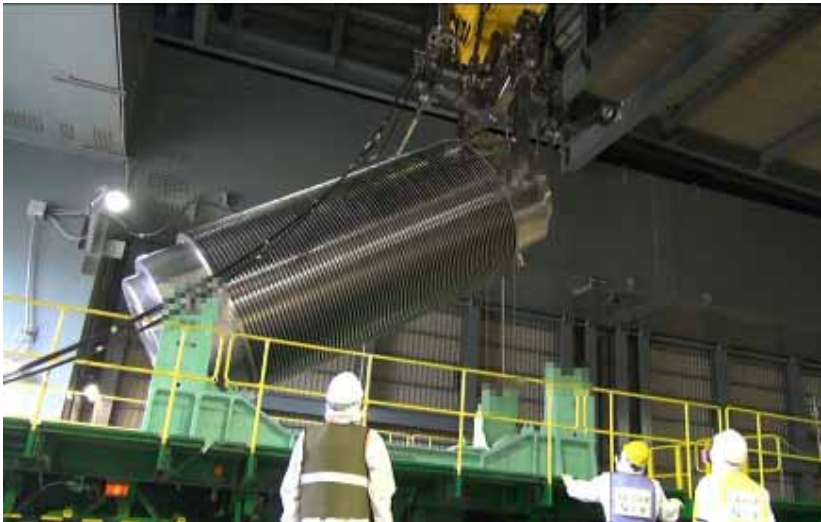
Fuel Removal from SFP

Number of Transferred Assemblies **924/1533** (As of May 26th, 2014)

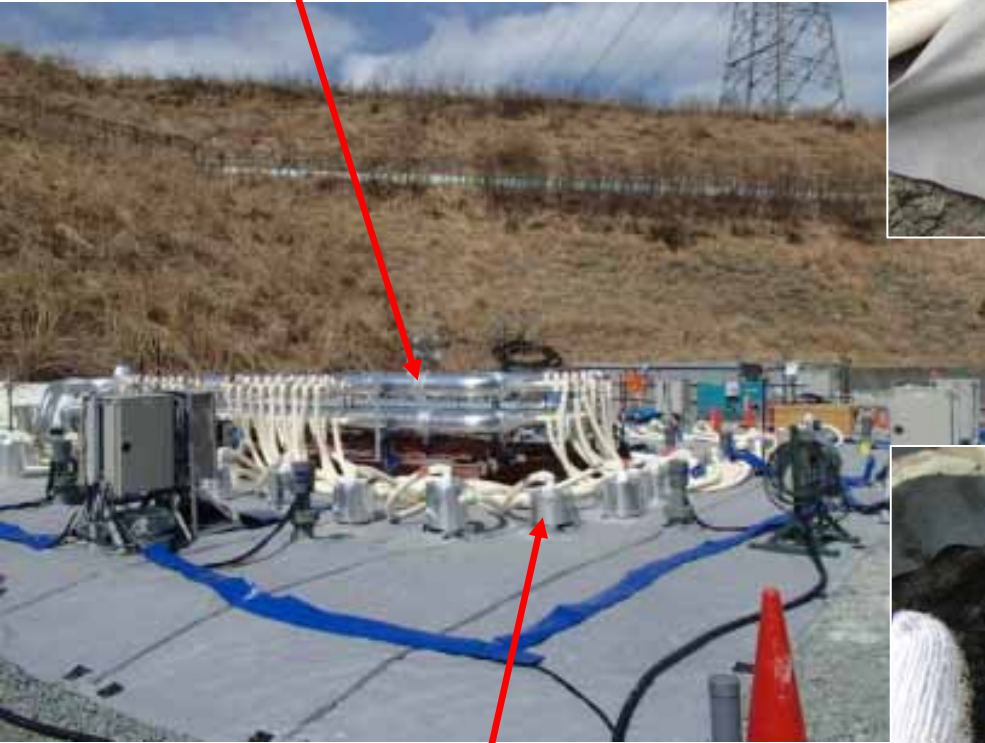
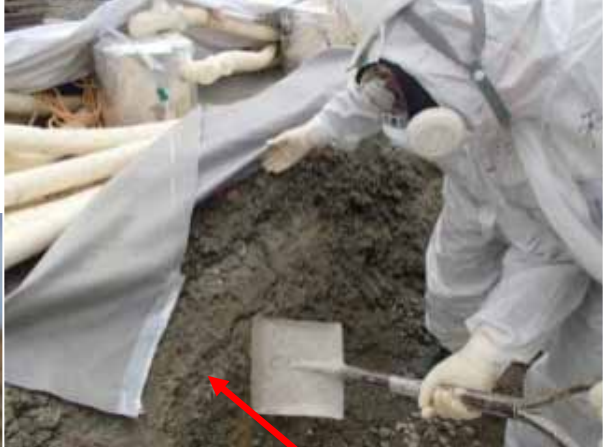
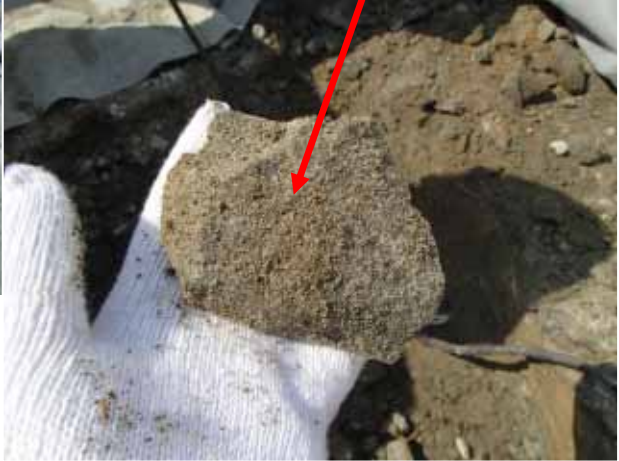
Small Scale Frozen Wall Successfully Produced

Coolant circulation pipe

Frozen Soil

Freezer Pipe

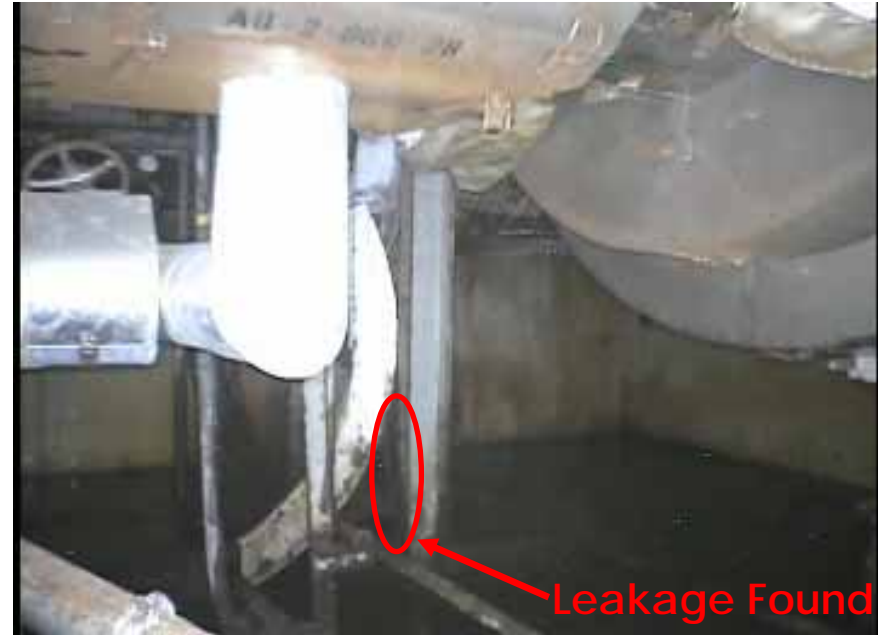
Leakage Found

Photo of Main Steam Line (D)

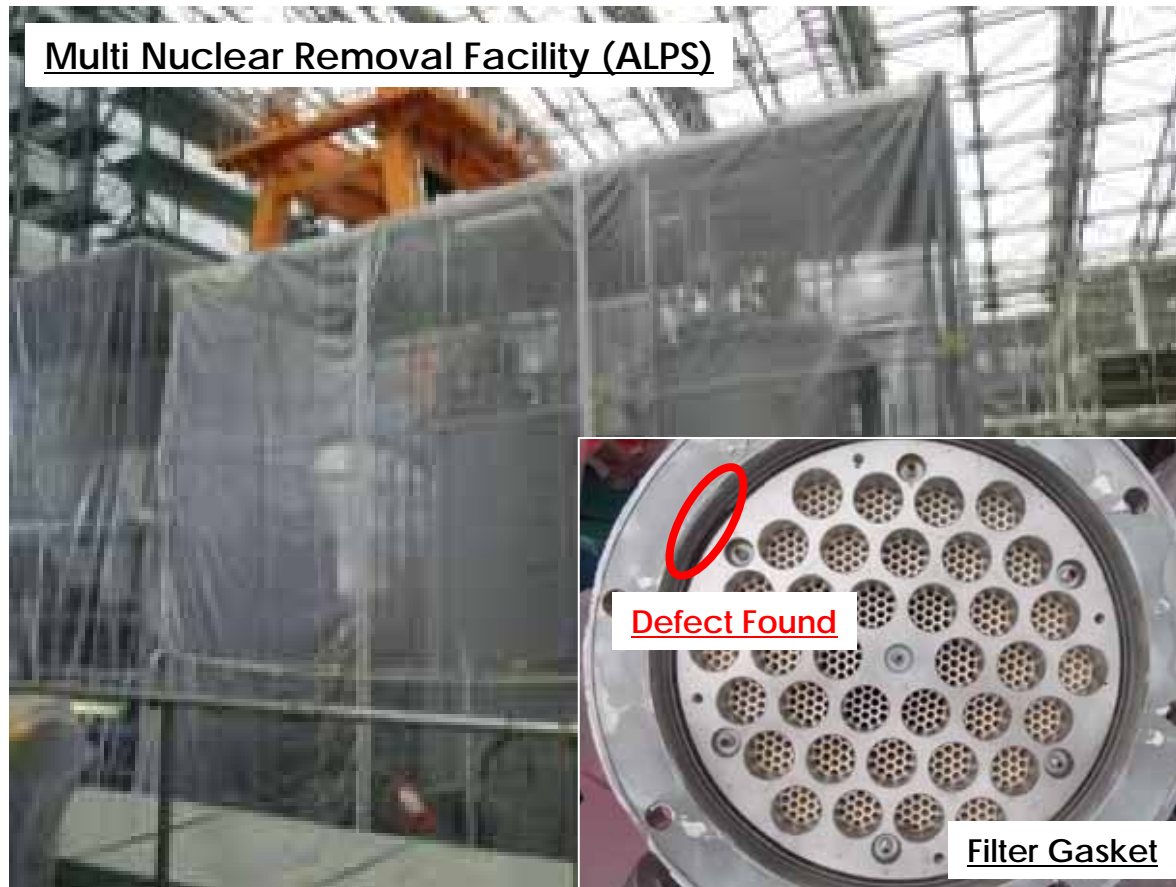
Status of Multi Nuclide Removal Facility (ALPS)

- All 3 trains experienced preprocessing filter defects due to radiation embrittlement
- Train B already equipped with radiation resistant filters and restarted on May 23rd
- Other two trains still shutdown and waiting for filter exchange

- Augmenting current ALPS (250m³/day x 3 trains)
- Installation of mobile Sr-removal system (300m³/day)
