Current Status and Recent Topics of Fukushima Daiichi NPS

September 10th, 2014

TOKYO ELECTRIC POWER COMPANY

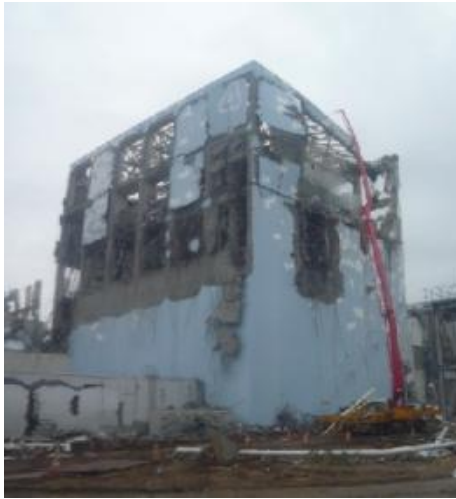
**Water Injection by
Concrete Pumper (3/22/2011)**

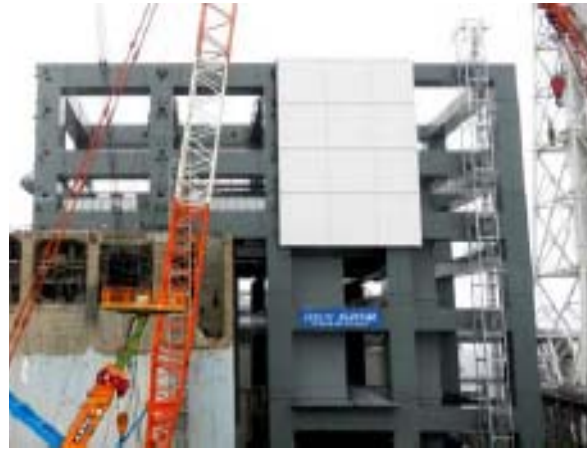
**Crane setting completed
(May.2013)**

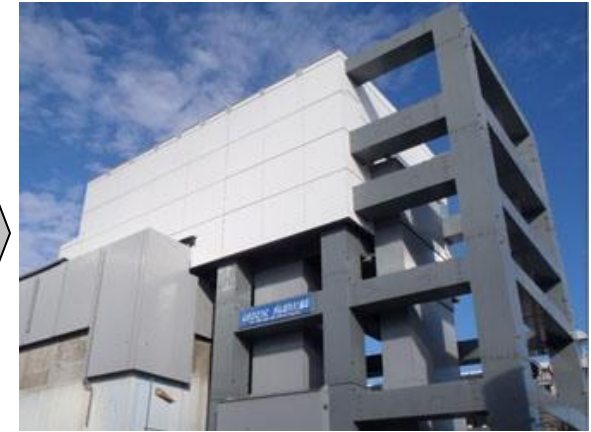
**Fuel Removal Structure
(Nov. 2013)**

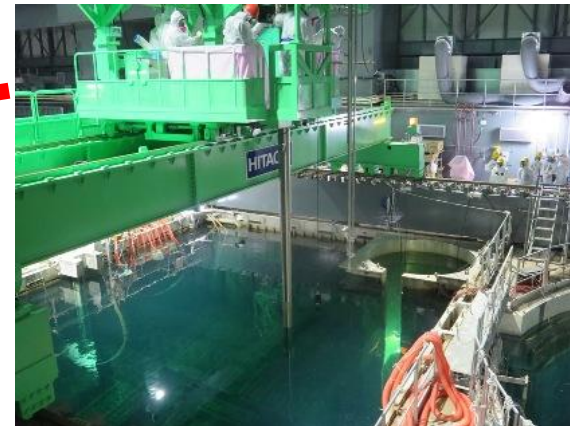
Fuel Removal from SFP (11/18/2013)

1,210/1,533 fuel assemblies transferred to common pool
<http://www.tepco.co.jp/en/decommision/planaction/removal-e.html> (as of 9/9/2014)

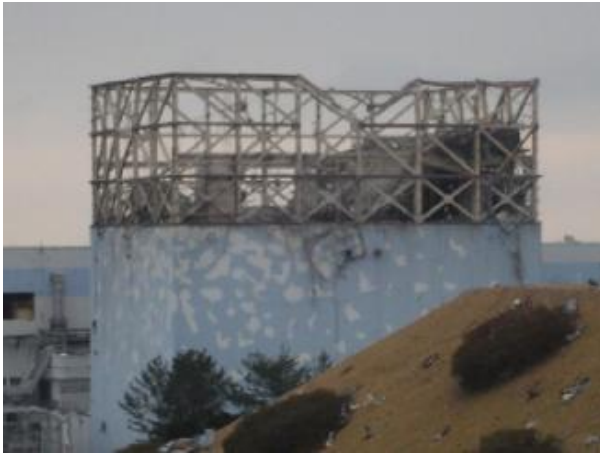
**Reactor Building
(3/15/2011)**

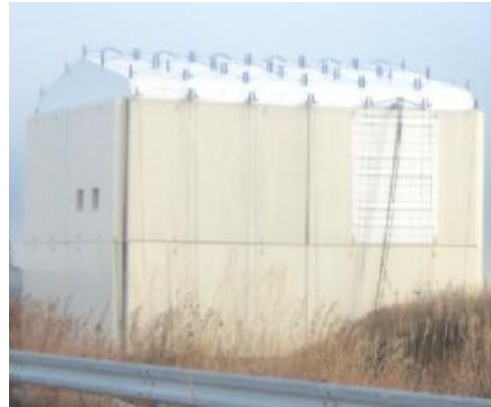
**Reactor Building Cover
(installed in Oct. 2011)**
