April 3, 2011

Nuclear and Industrial Safety Agency

Seismic Damage Information (the 71st Release)
(As of 15:30 April 3rd, 2011)

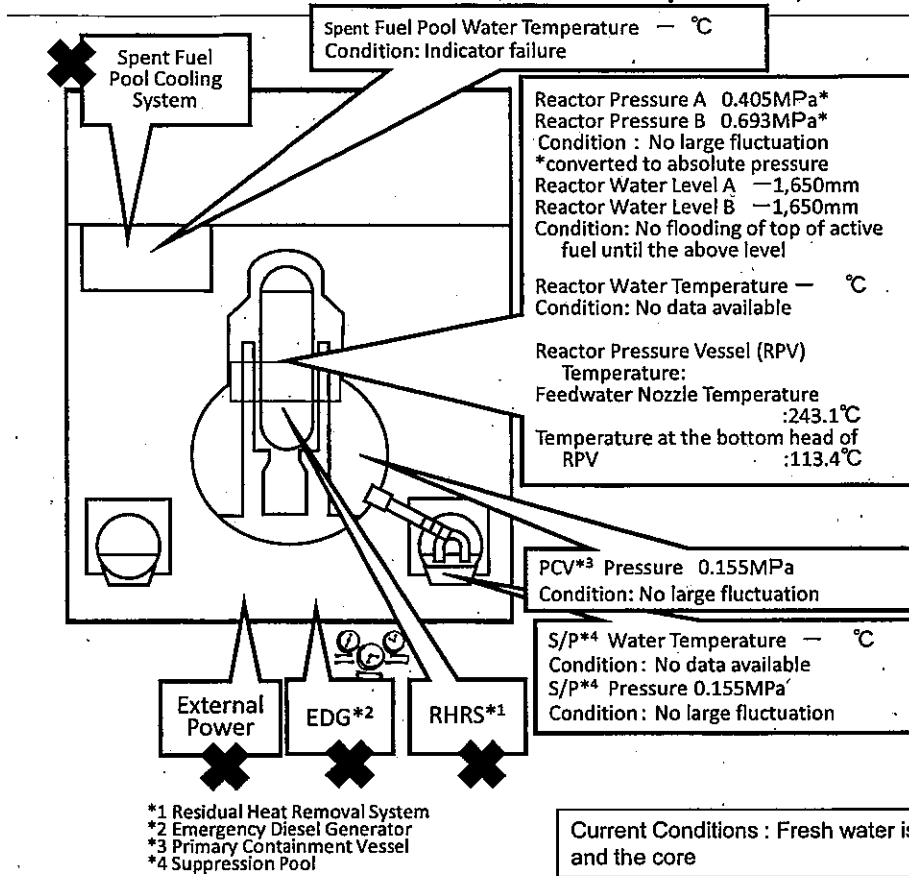
Conditions of Fukushima Dai-ichi Nuclear Power Station Unit 1 (As of 8:00 April 4th, 2011)

- 11th 14:46 Under operation, Automatic shutdown by the earthquake
- 11th 15:42 Report based on the Article 10 (Total loss of A/C power)
- 11th 16:36 Occurrence of the Article 15 event (Inability of water injection of the Emergency Core Cooling System)

- 12th 01:20 Occurrence of the Article 15 event (Unusual rise of the pressure in PCV)
- 12th 10:17 Started to vent.
- 12th 15:36 Sound of explosion
- 12th 20:20 Started to inject seawater and borated water to core.

Current Conditions: Fresh water is being injected to the Spent Fuel Pool and the core

- 23rd 02:33 The amount of injected water to the Reactor Core was increased utilizing the Feedwater Line in addition to the Fire Extinguish Line. (2m³/h → 18m³/h)

- 09:00 Switched to the Feedwater Line only. (18m³/h → 11m³/h)
- 24th 11:30 Lighting in the Central Control Room was recovered.
- 25th 15:37 Started fresh water injection.

- 29th 08:32 Switched to the water injection to the core using the temporary motor-driven pump.
- 31st 12:00 ~ 2nd 15:26 Started to transfer the stagnant water from the Condensate Storage Tank (CST) to the Surge Tank of Suppression Pool Water (SPT)

- 31st 13:03 ~ 16:04 Fresh water spray by Concrete Pump Truck (Fresh water)
- 3rd 12:02 The power supply to the temporary motor-driven pump was switched from the temporary power supply to the external power supply.

- 3rd 13:55 Started to transfer the water from the condenser to CST.

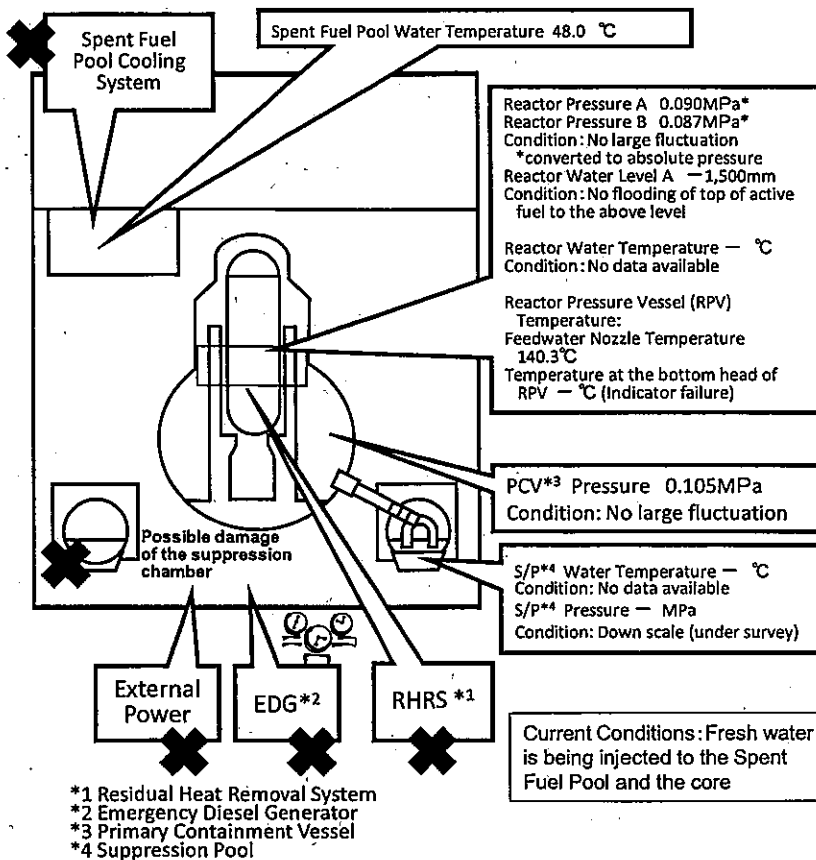
Conditions of Fukushima Dai-ichi Nuclear Power Station Unit 2 (As of 8:00 April 4th, 2011)

- 11th 14:46 Under operation, Automatic shutdown by the earthquake
- 11th 15:42 Report based on the Article 10 (Total loss of A/C power)
- 11th 16:36 Occurrence of the Article 15 event (Inability of water injection of the Emergency Core Cooling System)

- 13th 11:00 Started to vent.
- 14th 13:25 Occurrence of the Article 15 event (Loss of reactor cooling functions)
- 14th 16:34 Started to inject seawater to the Reactor Core.

- 14th 22:50 Occurrence of the Article 15 event (Unusual rise of the pressure in PCV)
- 15th 00:02 Started to vent.
- 15th 06:10 Sound of explosion
- 15th around 06:20 Possible damage of the suppression chamber

Current Conditions: Fresh water is being injected to the Spent Fuel Pool and the core

- 20th 15:05 ~ 17:20 Approximately 40 ton seawater injection to the Spent Fuel Pool (SFP) via the Fuel Pool Cooling Line (FPC)
- 20th 15:46 Power Center received electricity.

- 21st 18:22 White smoke generated. The smoke died down and almost invisible at 07:11 March 22nd.
- 22nd 16:07 Injection of around 18 tons of seawater to SFP

- 25th 10:30 ~ 12:19 Sea water injection to SFP via FPC
- 26th 10:10 Started to inject fresh water to the Reactor Core.
- 26th 16:46 Lighting in the Central Control Room was recovered.

- 27th 18:31 Switched to the water injection to the core using the temporary motor-driven pump.
- 29th 16:30 ~ 18:25 Switched to the temporary motor-driven pump injecting fresh water to SFP.

- 29th 16:45 ~ 1st 11:50 Transferred the water from the Condensate Storage Tank (CST) to the Surge Tank of Suppression Pool Water (SPT)
- 30th 9:25 ~ 23:50 Confirmed malfunction of the temporary motor-driven pump injecting fresh water to SFP(9:45). Switched to the injection using the fire pump Truck, but suspended as cracks were confirmed in the hose. (12:47, 13:10) Resumed injection of fresh water(19:05)

- 1st 14:56 ~ 17:05 Injection of fresh water from FPC to SFP using the temporary motor-driven pump.
- 2nd 17:10 Started to transfer the water from the condenser to the Condensate Storage Tank (CST).

- 3rd 12:12 The power supply to the temporary motor-driven pump was switched from the temporary power supply to the external power supply.
- 3rd 13:47 ~ 14:30 20 bags of sawdust, 80 bags of high polymer absorbent and 3 bags of cutting-processed newspaper were put into the Pit close to the Bar Screen.

- 4th 7:08 ~ 7:11 Approximately 13kg of tracer (bath agent) was put in from the Pit for the Duct for Seawater Pipe.

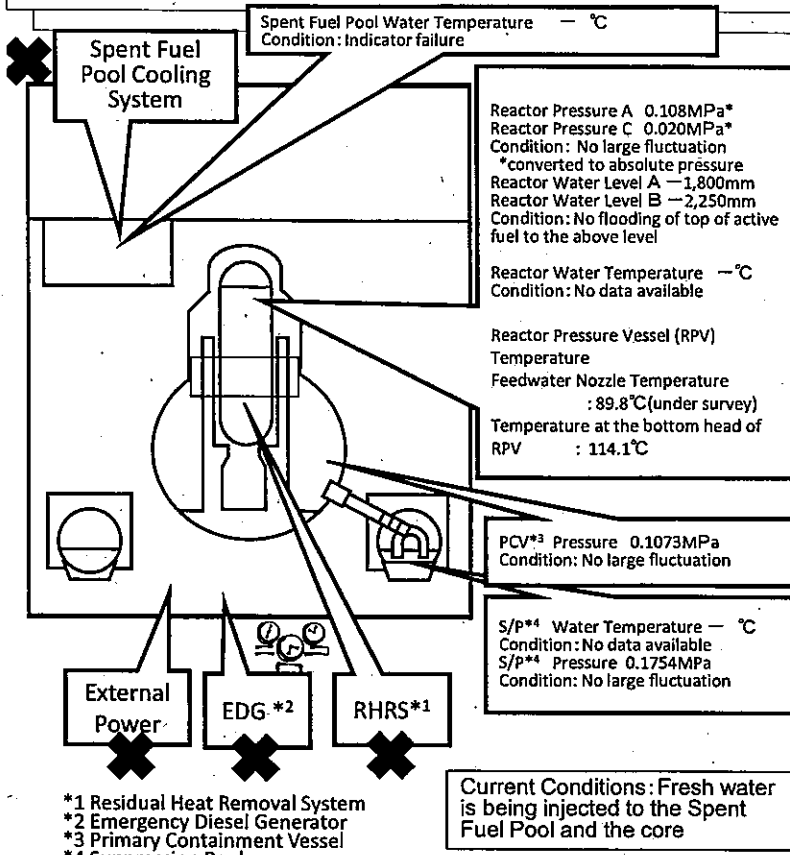
Conditions of Fukushima Dai-ichi Nuclear Power Station Unit 3

- 11th 14:46 Under operation, Automatic shutdown by the earthquake
- 11th 15:42 Report based on the Article 10 (Total loss of A/C power)
- 13th 05:10 Occurrence of the Article 15 event (Inability of water injection of the Emergency Core Cooling System)

- 13th 08:41 Started to vent.
- 13th 13:12 Started to inject seawater and borated water to core.
- 14th 05:20 Started to vent.
- 14th 07:44 Occurrence of the Article 15 event (Unusual rise of the pressure in PCV)

- 14th 11:01 Sound of explosion
- 16th around 08:30 White smoke generated.
- 17th 09:48~10:01 Water discharge by the helicopters of Self-Defense Force
- 17th 19:05~19:15 Water spray from the ground by High pressure water-cannon trucks of Police

- 19th 14:10 ~ 20th 03:40 Water spray by Hyper Rescue Unit of Tokyo Fire Department
- 20th 11:00 Pressure of PCV rose(320kPa). Afterward fell.
- 20th 21:36 ~ 21st 03:58 Water spray by Hyper Rescue Unit of Tokyo Fire Department

- 22nd 22:46 Lighting in the Central Control Room was recovered.
- 23rd 11:03 ~13:20 Injection of about 35ton of sea water to the Spent Fuel Pool (SFP) via the Fuel Pool Cooling Line (FPC)

- 23rd around 16:20 Black smoke generated and was confirmed to be died down at around 23:30 and 24th 04:50.
- 24th 05:35~16:05 Approximately 120 ton sea water injection to SFP via FPC

- 25th 13:28~16:00 Water spray by Kawasaki City Fire Bureau supported by Tokyo Fire Department
- 25th 18:02 Started fresh water injection to the core.
- 27th 12:34~14:36 Water spray by Concrete Pump Truck

- 28th 17:40~31st around 8:40 Transferring the water from the Condensate Storage Tank (CST) to the Surge Tank of Suppression Pool Water (SPT)
- 28th 20:30 Switched to the water injection to the core using a temporary motor-driven pump.

- 29th 14:17~18:18 Fresh water spray by Concrete Pump Truck
- 31st 16:30~19:33 Fresh water spray by Concrete Pump Truck
- 2nd 09:52~12:54 Fresh water spray by Concrete Pump Truck

- 3rd 12:18 The power supply to the temporary motor-driven pump was switched from the temporary power supply to the external power supply.

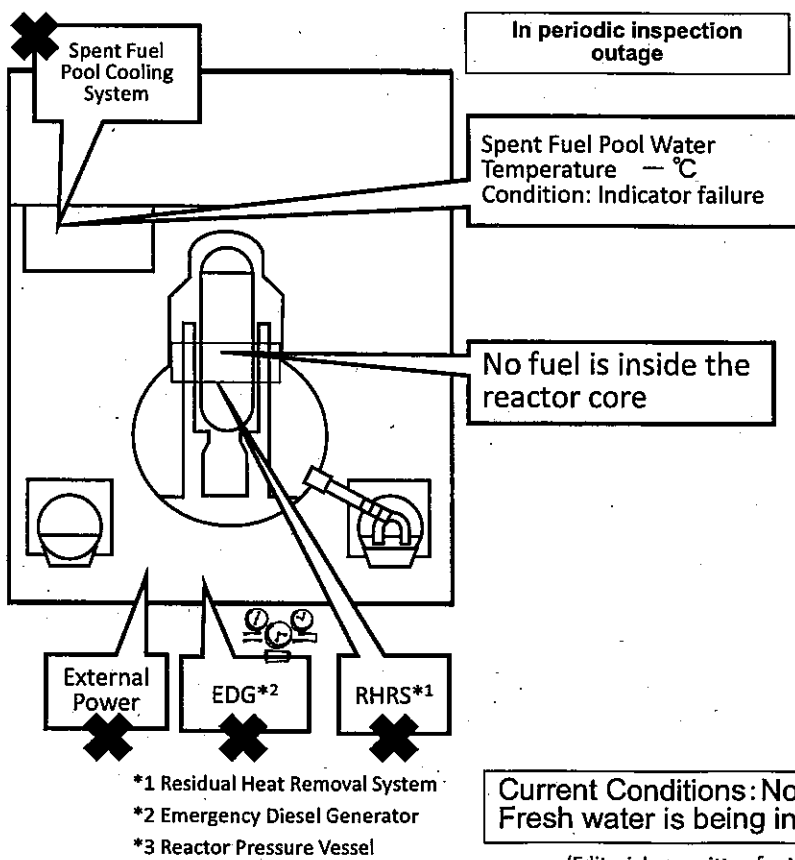
Conditions of Fukushima Dai-ichi Nuclear Power Station Unit 4

- In periodic inspection outage when the earthquake occurred
- 14th 04:08 Water temperature in the Spent Fuel Pool (SFP), 84°C
- 15th 06:14 Confirmed the partial damage of wall in the 4th floor.

- 15th 09:38 Fire occurred in the 3rd floor. (12:25 extinguished)
- 16th 05:45 Fire occurred. TEPCO couldn't confirm any fire on the ground. (06:15)
- 20th 08:21~09:40 Water spray over SFP by Self-Defense Force

- 20th around 18:30~19:46 Water spray over SFP by Self-Defense Force
- 21st 06:37~08:41 Water spray over SFP by Self-Defense Force
- 21st around 15:00 Work for laying cable to Power Center was completed.

- 22nd 10:35 Power Center received electricity.
- 22nd 17:17~20:32 Water spray by Concrete Pump Truck
- 23rd 10:00~13:02 Water spray by Concrete Pump Truck

- 24th 14:36~17:30 Water spray by Concrete Pump Truck
- 25th 06:05~10:20 Sea water injection to SFP via the Fuel Pool Cooling Line (FPC)
- 25th 19:05~22:07 Water spray by Concrete Pump Truck

- 27th 16:55~19:25 Water spray by Concrete Pump Truck
- 29th 11:50 Lighting in the Central Control Room was recovered.
- 30th 14:04~18:33 Water spray by Concrete Pump Truck (Fresh water)

- 1st 8:28~14:14 Water spray by Concrete Pump Truck (Fresh water)
- 3rd 17:14~22:16 Water spray by Concrete Pump Truck (Fresh water)
