Conditions of Fukushima Dai-ichi Nuclear Power Station Unit 1

(As of 6:00 April 9th, 2011)

Seismic Damage Information (the 82th Release)
(As of 08:00 April 9th, 2011)

Nuclear Accident at the Fukushima Dai-ichi Nuclear Power Station

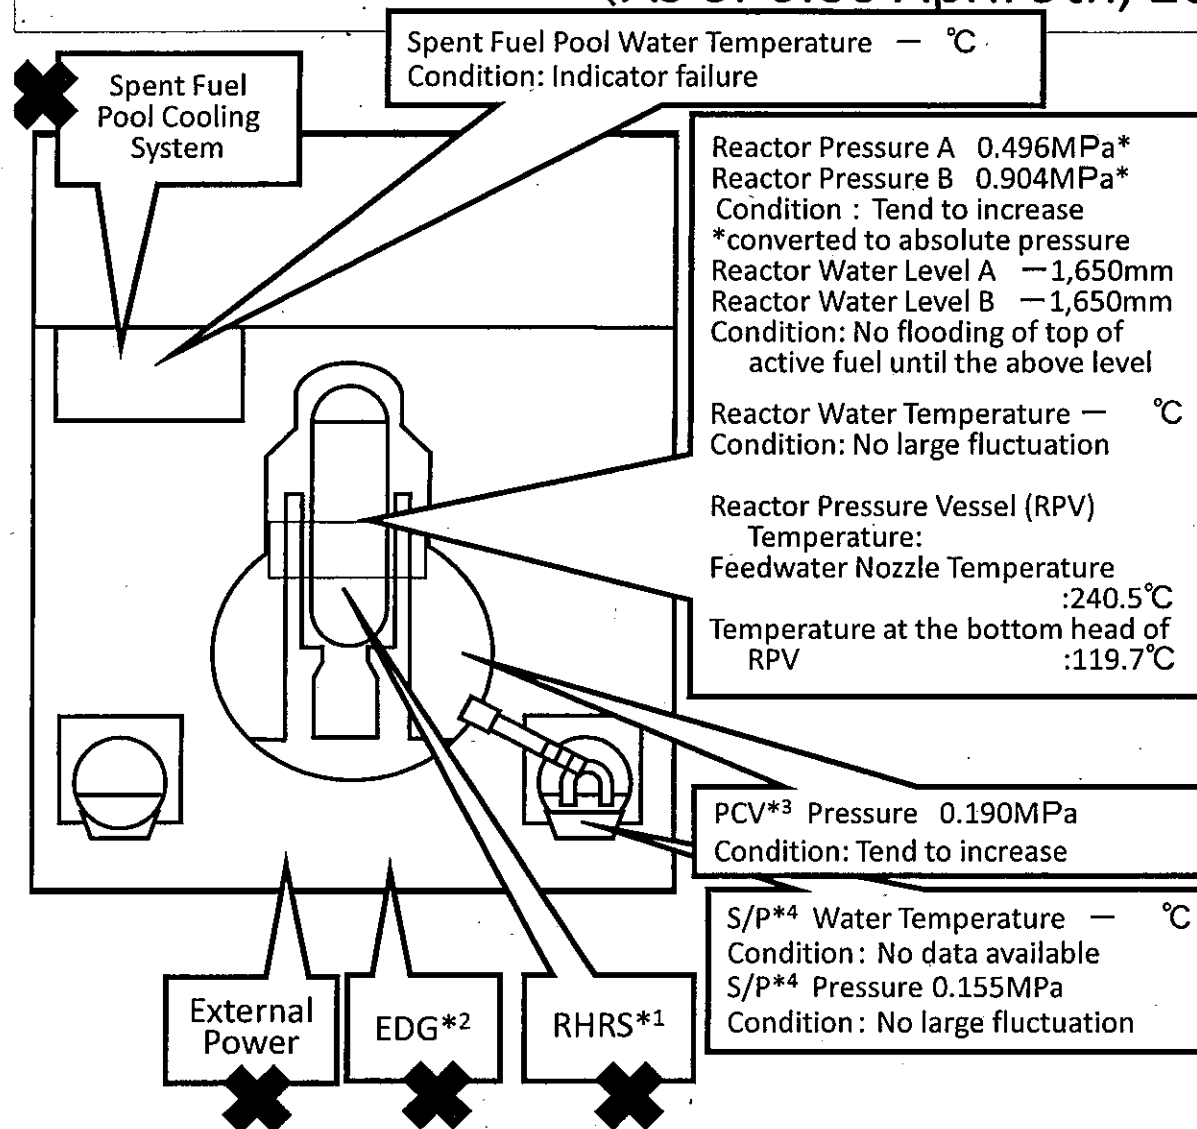
- 11th 14:46 Under operation, Automatic shutdown by the earthquake
- 11th 15:42 Report based on the Article 10 (Total loss of A/C power)
- 11th 16:36 Occurrence of the Article 15 event (Inability of water injection of the Emergency Core Cooling System)

- 12th 01:20 Occurrence of the Article 15 event (Unusual rise of the pressure in PCV)
- 12th 10:17 Started to vent.
- 12th 15:36 Sound of explosion
- 12th 20:20 Started to inject seawater and borated water to core.

- 23rd 02:33 The amount of injected water to the Reactor Core was increased utilizing the Feedwater Line in addition to the Fire Extinguish Line. (2m³/h → 18m³/h)

- 09:00 Switched to the Feedwater Line only. (18m³/h → 11m³/h)
- 24th 11:30 Lighting in the Central Control Room was recovered.
- 25th 15:37 Started fresh water injection.

- 29th 08:32 Switched to the water injection to the core using the temporary motor-driven pump.
- 31st 12:00 ~ 2nd 15:26 Started to transfer the stagnant water from the Condensate Storage Tank (CST) to the Surge Tank of Suppression Pool Water (SPT)

- 31st 13:03 ~ 16:04 Water spray by Concrete Pump Truck (Fresh water)
- 3rd 12:02 The power supply to the temporary motor-driven pump was switched from the temporary power supply to the external power supply.

- 3rd 13:55 Started to transfer the water from the condenser to CST.
- 6th 22:30 Started the operation for the injection of nitrogen to PCV.
- 7th 01:31 Confirmed starting the injection of nitrogen to PCV.

Current Conditions : Fresh water is being injected to the Spent Fuel Pool and the core
