F1 (Fukushima Daiichi Nuclear Power Station) Issues

**As of 5 September, 2013
Nuclear Regulation Authority (NRA), Japan**

I. Current situation of contaminated water leakage

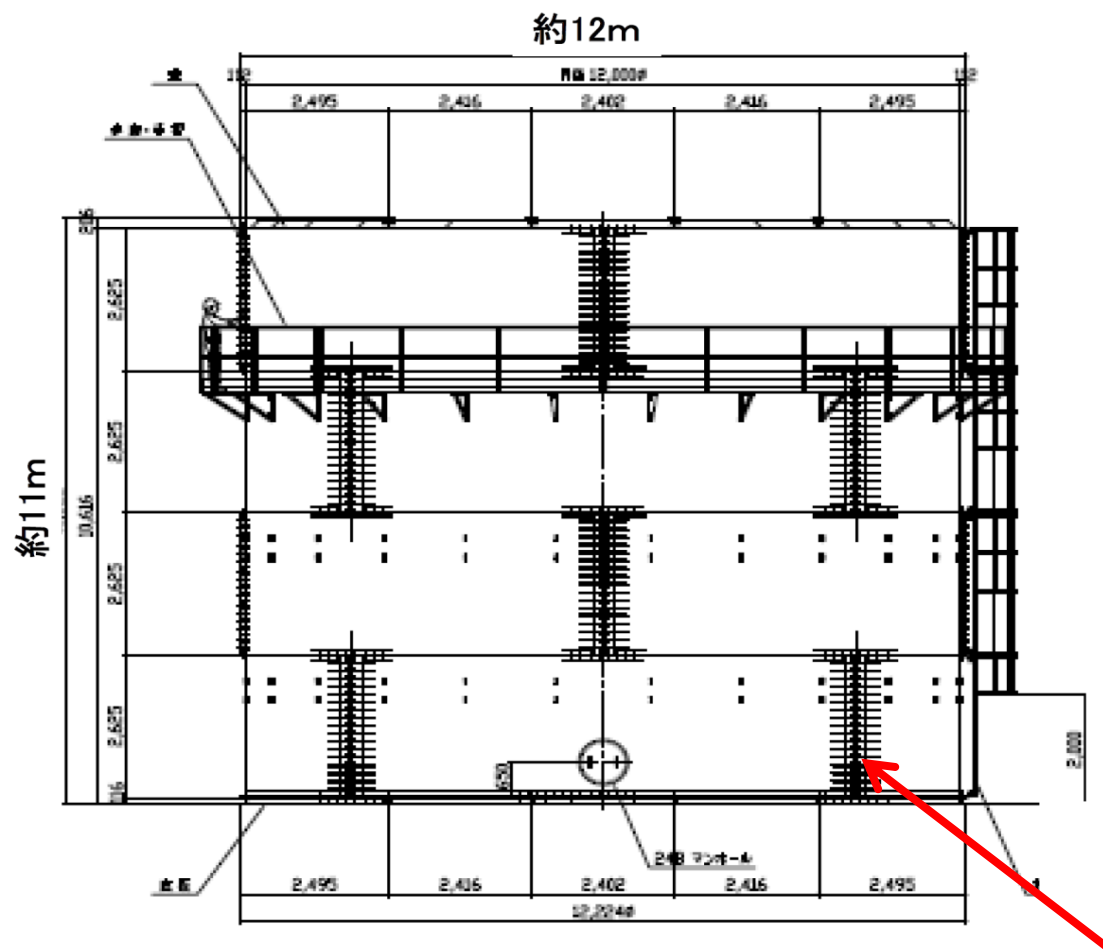
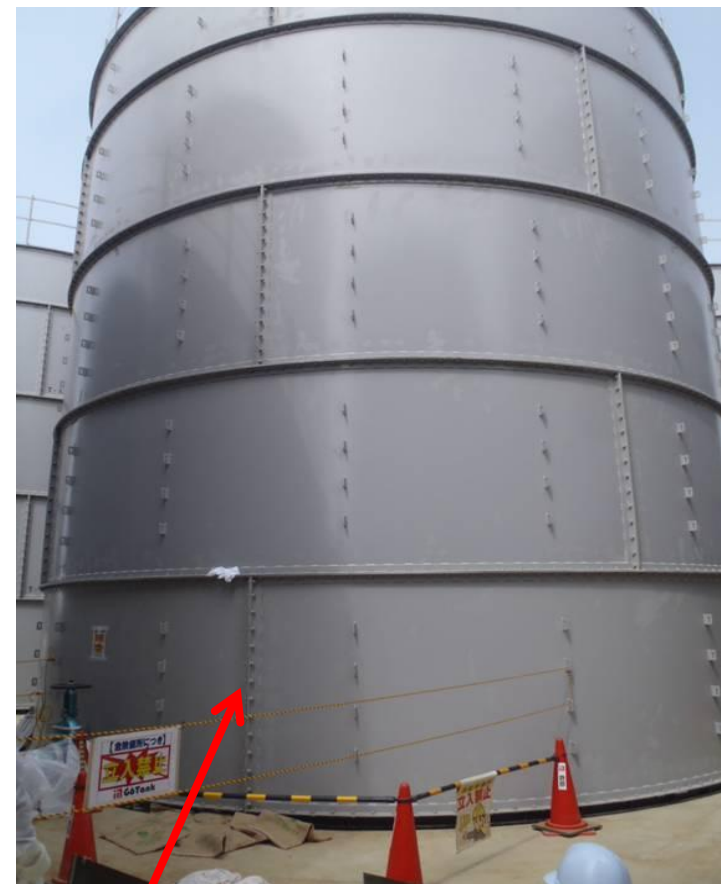
Bolted-joint storage tank
cf. Weld-bonding storage tank

There are 305 bolted-joint storage tanks for contaminated water at the Fukushima Daiichi Nuclear Power Station. According to the TEPCO's reports to the NRA, one of 305 bolted-joint storage tanks had an incident of water leakage, four storage tanks have the high possibility of water leakage, and one connection pipe between bolted-joint storage tanks had an incident of water leakage. **[Attachments 1 and 2]**

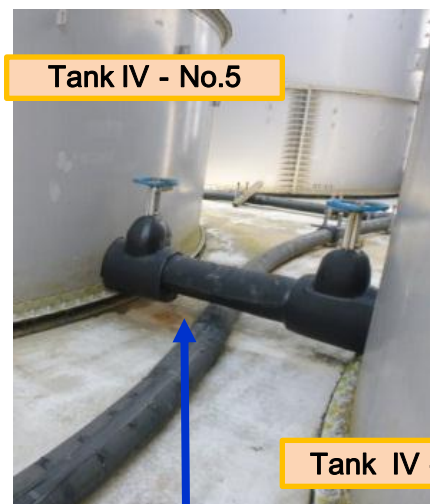
Water Leakage from Connection Pipe between Storage Tanks (H5 Tank Area)

Contaminated water leakage (approximately 300 tons) in H4 Tank Area was found by TEPCO on 19 August, and falling-down of drops of contaminated water from the connection pipe between storage tanks in H5 Tank Area was found by TEPCO. **[Attachment 3]**

It was found by TEPCO that one drop of contaminated water fell every 90 seconds after the cover stuff of the flange was removed, and then this water drop has stopped by TEPCO's tightening up the bolts of flange on 1 September.
