Current Status and Recent Topics of Fukushima Daiichi NPS

March 4th, 2015

TOKYO ELECTRIC POWER COMPANY

Unit 2 Reactor Building and Large Carry-in Entrance Rooftop Accumulated water Quality Results

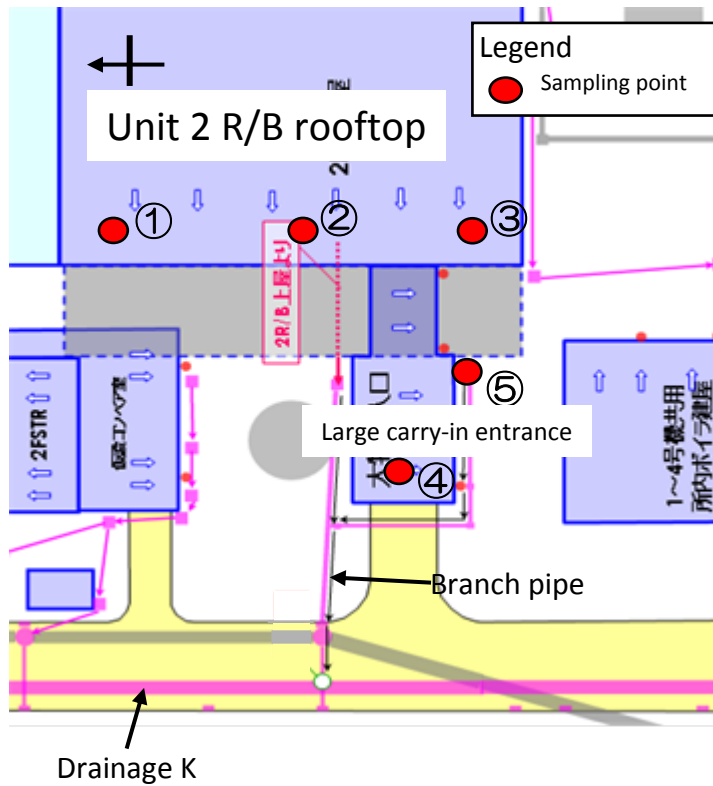
Sampling location map

- Rainwater on the rooftop of the reactor building, located upstream of the branch pipes which flow into "Drainage K", were analyzed.
- Because of the high dosage in the reactor building roof and concern over the radiation exposure to workers in a comprehensive investigation, the analysis was limited to the 2 R/B rooftop and large delivery rooftop, which were chosen based on accessibility and atmospheric radiation.
- As a result of the investigation, the rainwater found on the large carry-in rooftop contained a relatively high density of radioactive materials.

No.	place	Cs134	Cs137	Gross β	Sr90	H-3	Sampling date
①	Unit 2 R/B rooftop (north)	200	650	920	10	ND(<100)	2015.1.16
②	Unit 2 R/B rooftop (center)	340	1,100	1,900	12	ND(<100)	2015.1.16
③	Unit 2 R/B rooftop (south)	300	990	1,900	20	ND(<100)	2015.1.16
④	Large carry-in entrance rooftop	6,400	23,000	52,000	Under analysis	600	2015.2.19
⑤	Vertical drainage pipe of carry-in (east)	920	3,200	9,700	Under analysis	ND(<100)	2015.2.18

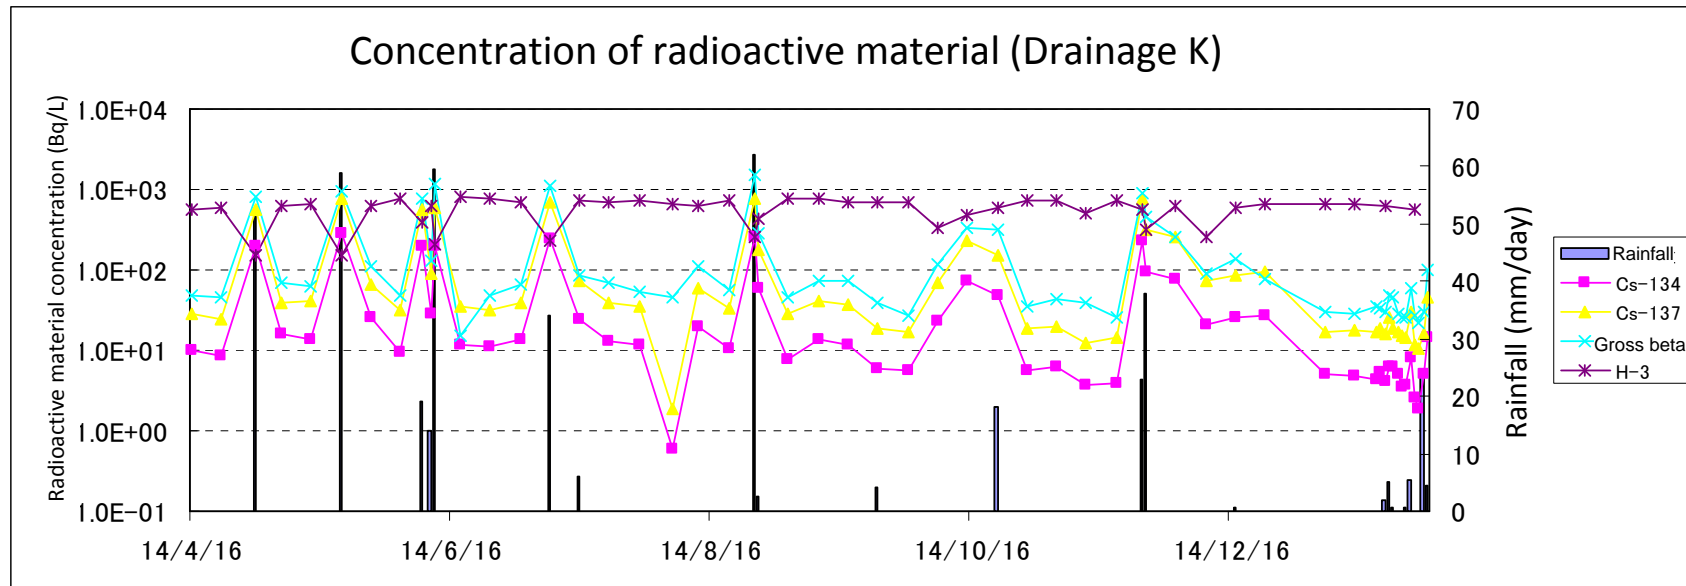
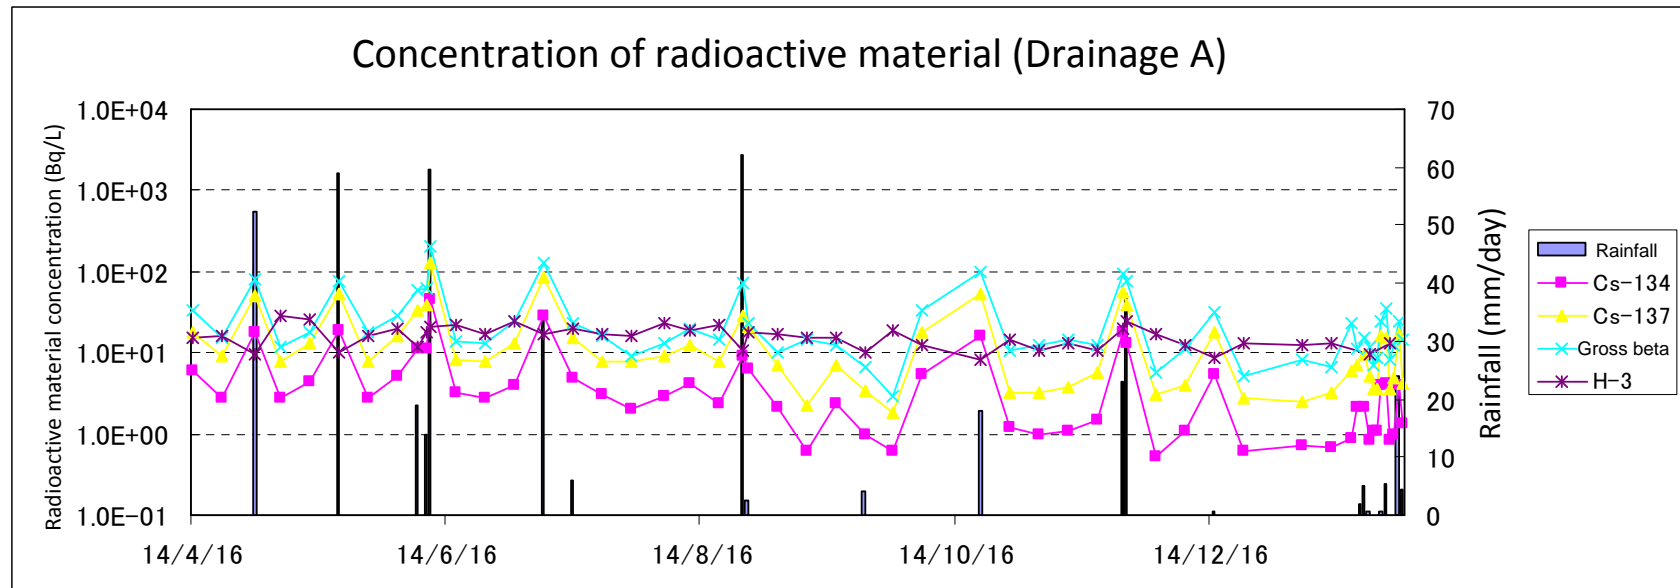
1-5. Water quality of the drainage channels (1/2)

The cleaning & decontamination task progressed and while the concentration at the outlet of the drainage channel showed a downward trend from around December 2014, the expected effect was not seen on the concentration at the outlet of drainage channel K.

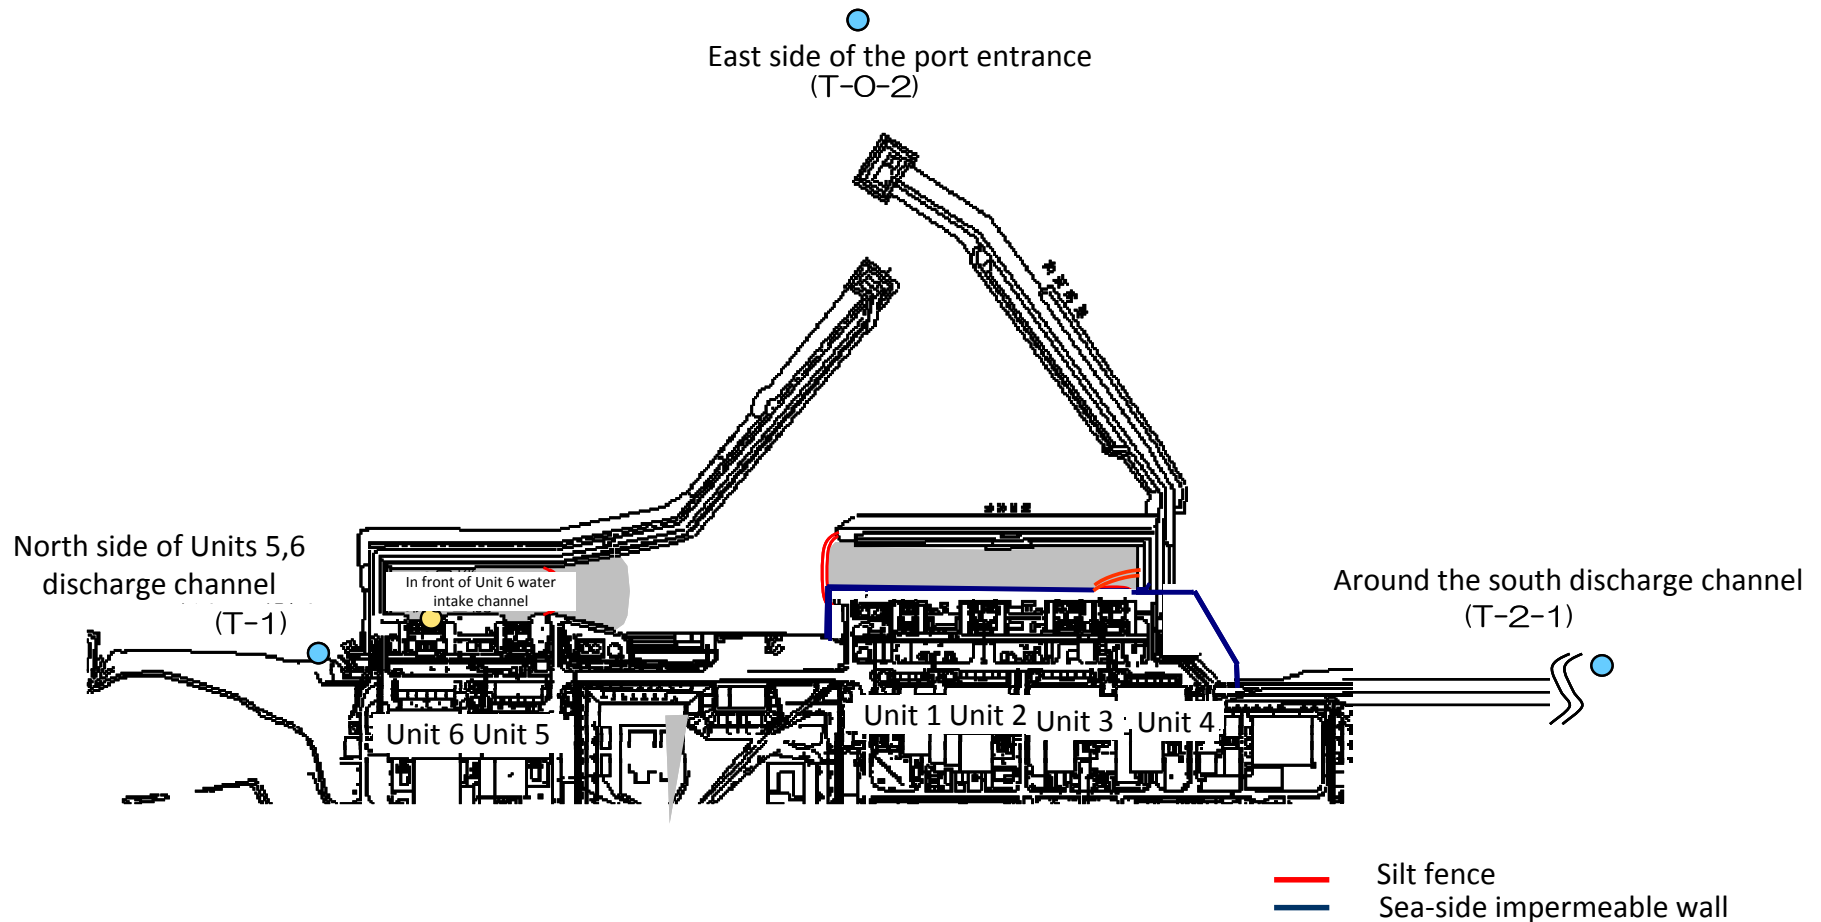
1-7. Ocean water condition (at sampling point)

■ Ocean water was monitored for dosage levels at the points below, but there have been no large changes seen in the condition.
