Current status of Fukushima Daiichi NPS

- Efforts for Decommissioning and Contaminated Water Control -

Agency for Natural Resources and Energy, METI

March 4, 2015

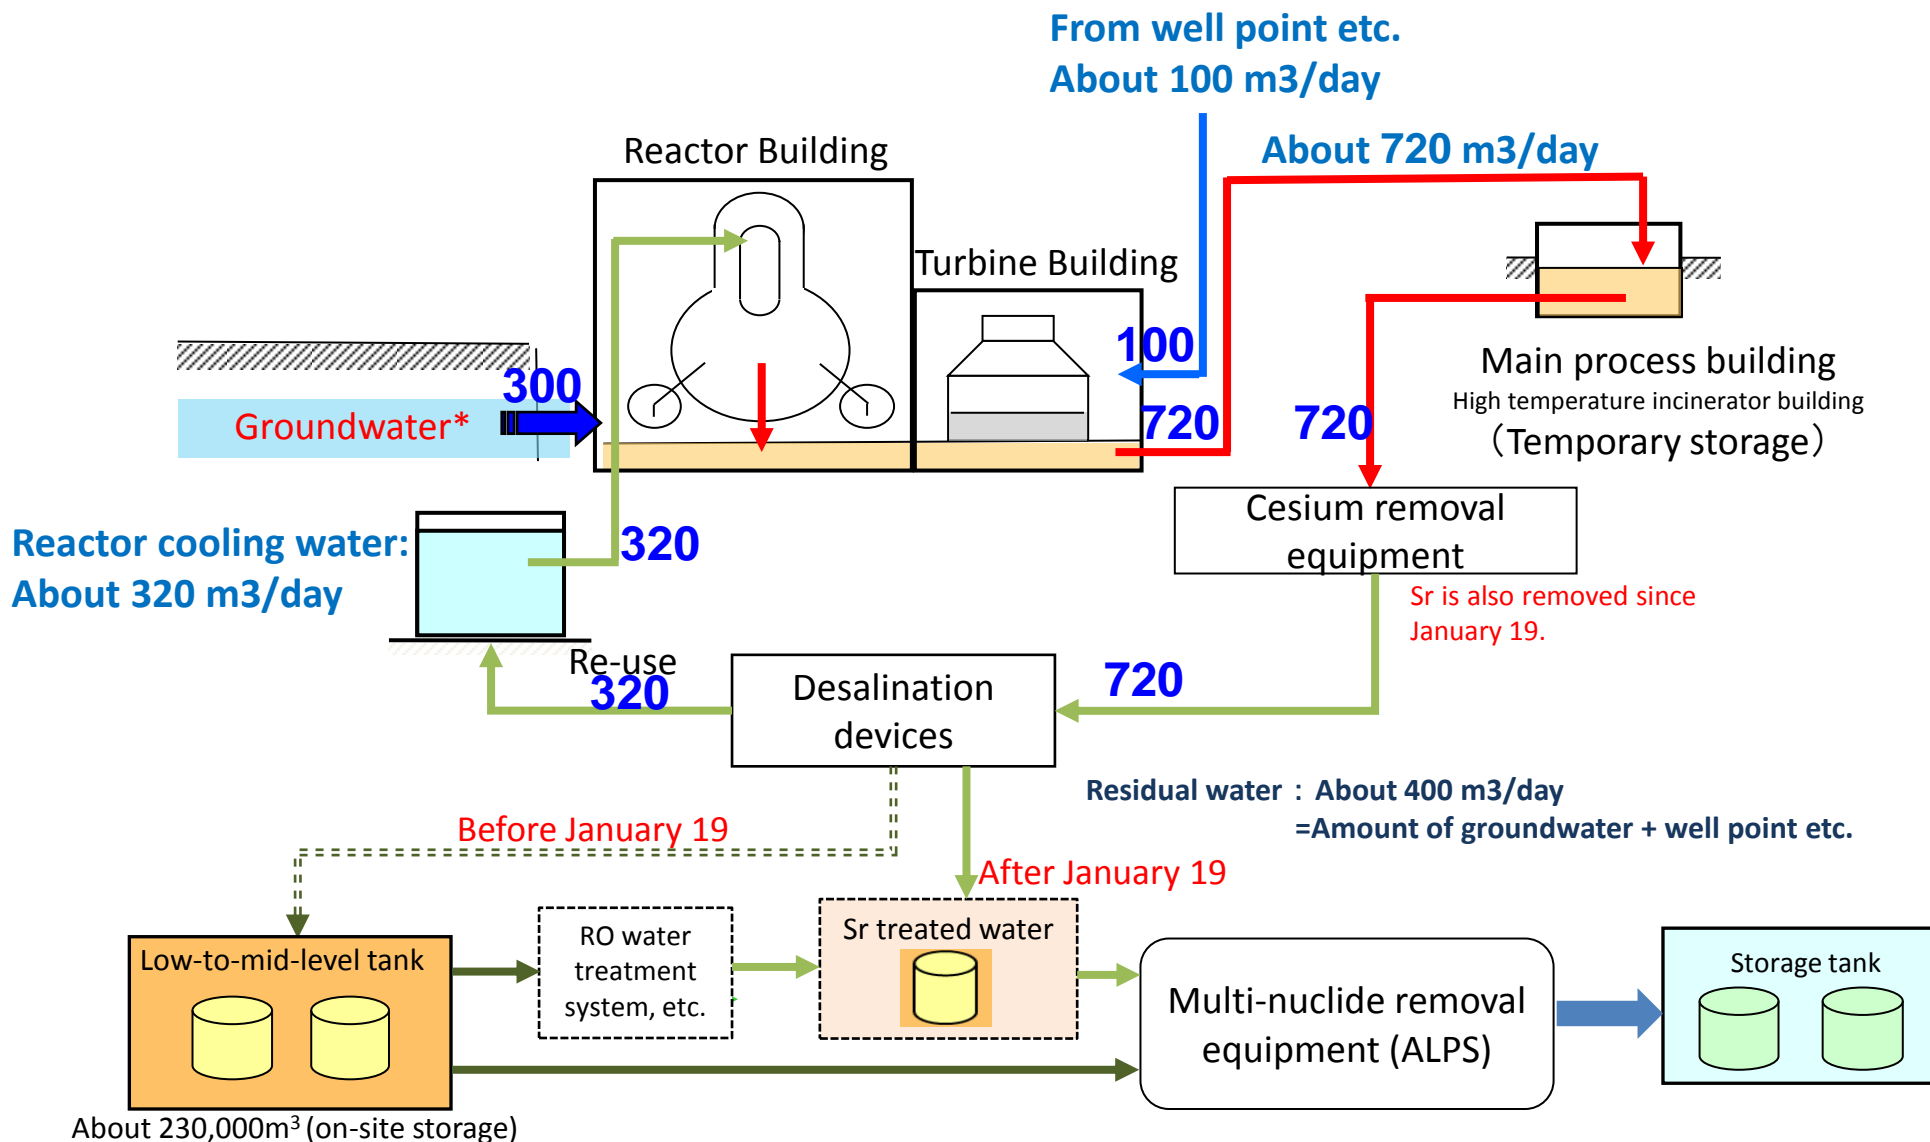
Management of Contaminated Water - Overview of the System -

* Groundwater inflow has decreased from about 400m³/day to about 300m³/day by the operation of groundwater bypassing system etc.

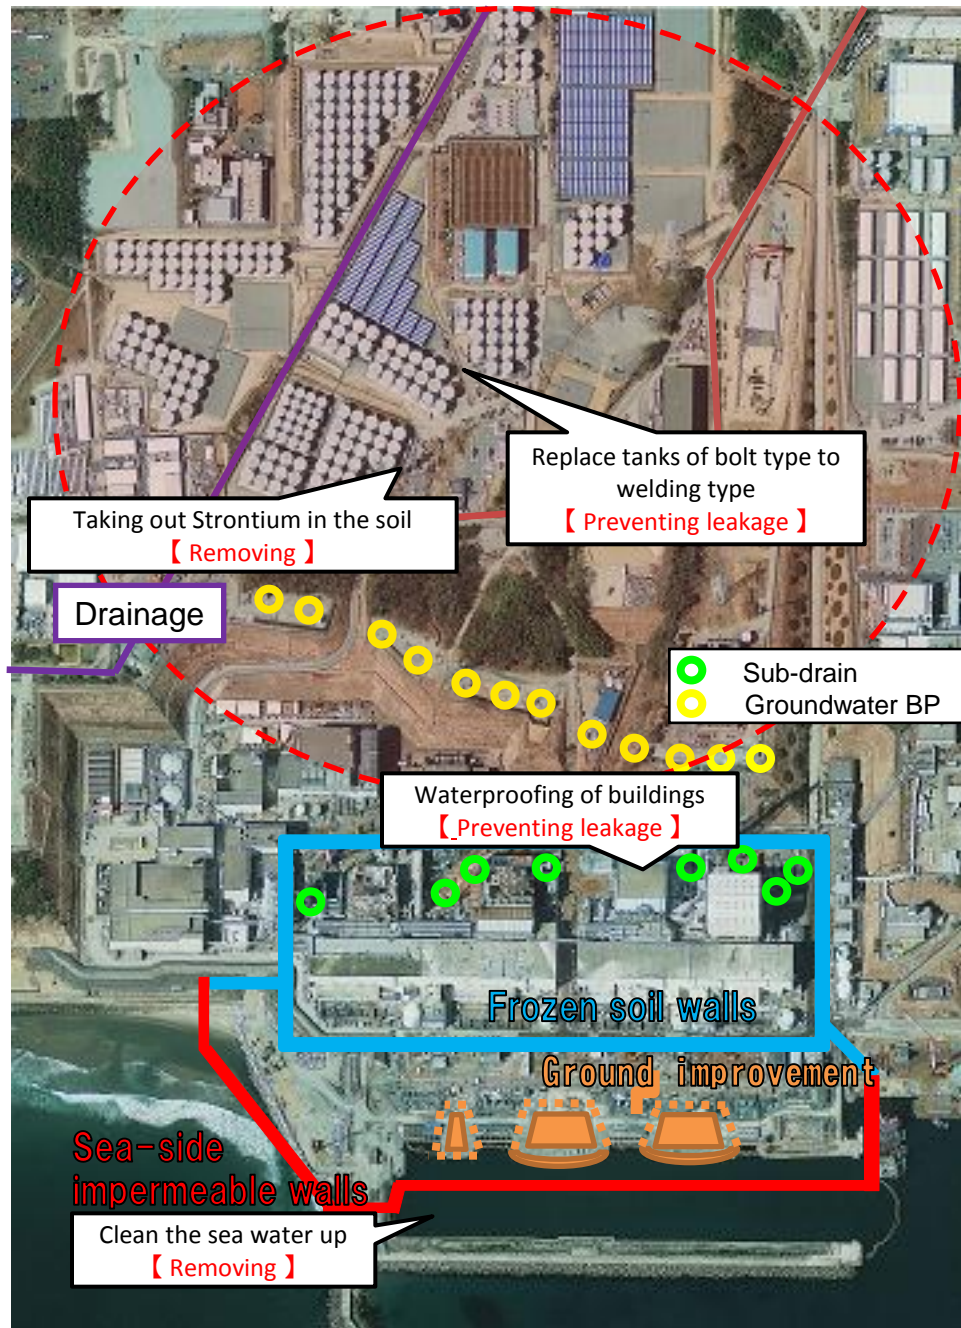
Comprehensive Countermeasures to Manage Contaminated Water

Three measure policy

1. Removing the contamination source

- ◆ Pump-up contaminated water from trench
- ◆ Clean up of contaminated water by ALPS (Multi-nuclide removal equipment)
- ◆ Additional and High-performance ALPS

2. Isolating groundwater from the contamination source

- ◆ Land-side frozen soil impermeable walls
- ◆ Groundwater bypassing system
- ◆ Pump-up from sub-drain around the reactor building
- ◆ Waterproof pavement wide area facing etc.

3. Preventing leakage of contaminated water

- ◆ Ground solidification by sodium silicate
- ◆ Sea-side impermeable walls
- ◆ Construction of welding type tanks including replacement from flange (bolt) type etc.

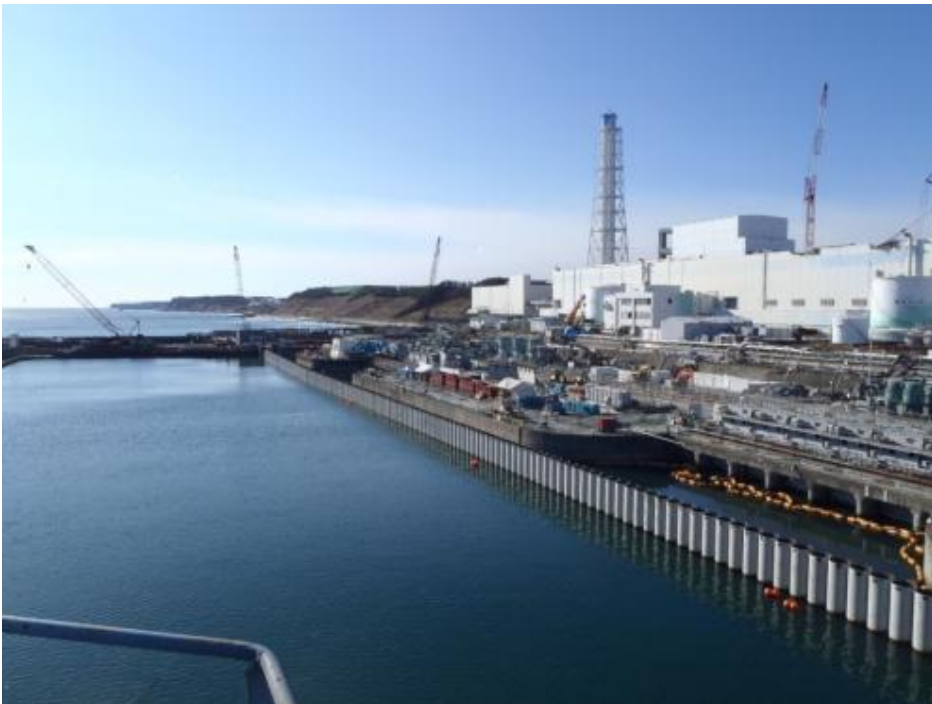
Recent situation of the sea-side impermeable walls

- Water shut-off walls will be installed outside of the shore protection in order to prevent contaminated groundwater flow into the sea.
- The construction work started in October 2011, and installation of steel sheet piles has almost been completed (approx. 98% completion).
- Explanation to stakeholders about the treatment and the discharge of pumped up groundwater is on going.

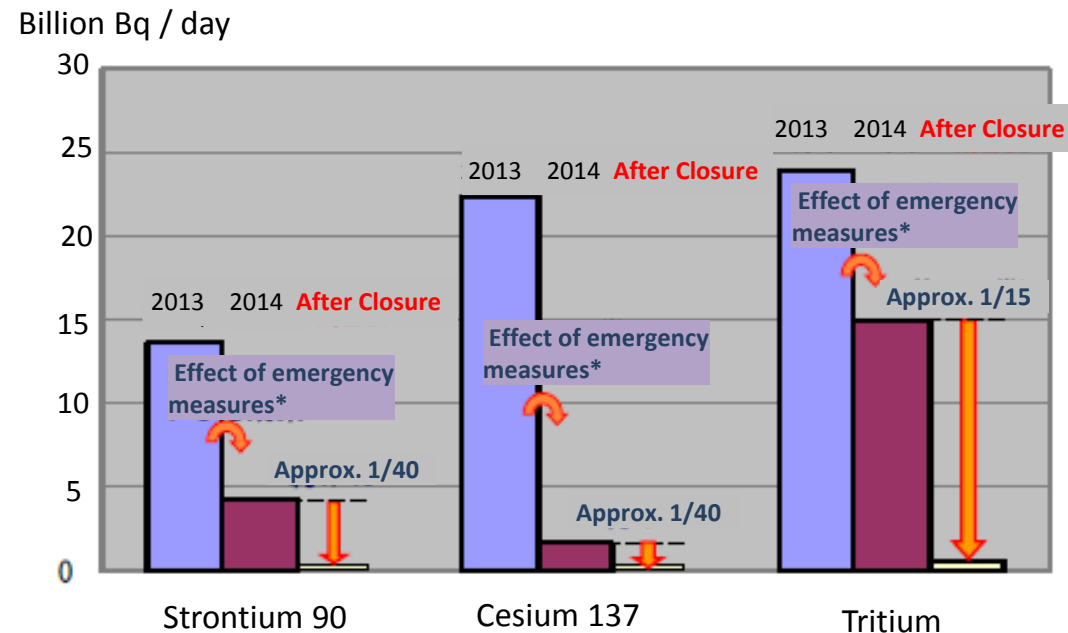
Suppressing effect for the radioactive material's outflow to the sea by Sub-drain, Groundwater drain and Sea-side impermeable wall

* Ground improvement of contaminated seawall and pumping up at well points, etc.

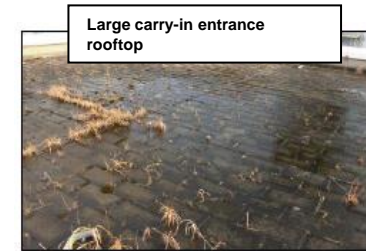
- Though TEPCO has implemented the measures which had been already announced (decontamination of the mountain side and clean-up of drainages), but Drainage K doesn't become low contamination level, so potential inlets to Drainage K have been additionally investigated. As the result of the investigation, relatively high dose level rainwater detected at roof of large carry-in entrance in Unit 2 on 24th Feb. 2015, so TEPCO reported the result to NRA and announced the public on the same day.

Cs134	6, 400
Cs137	23, 000
Gross β	52, 000
H-3	600

(Unit) Bq/L
