# How the disaster management technology of Japan, a disaster-prone nation, saved 5,000 villagers from flooding

— Japanese engineers struggle against natural dam collapsing in Indonesia

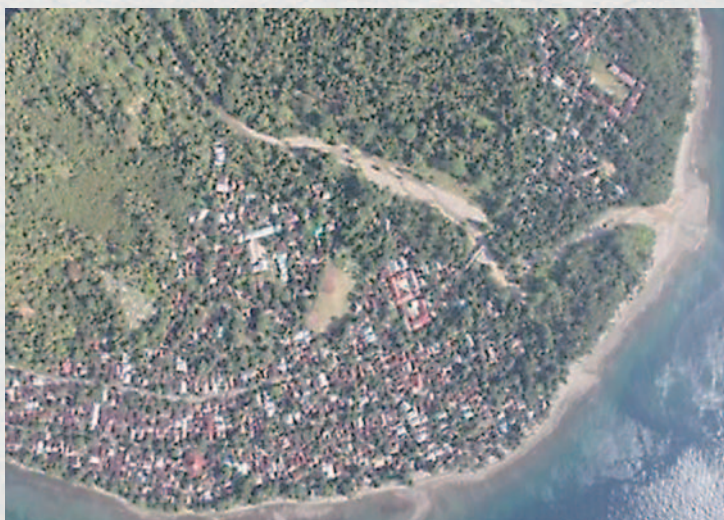
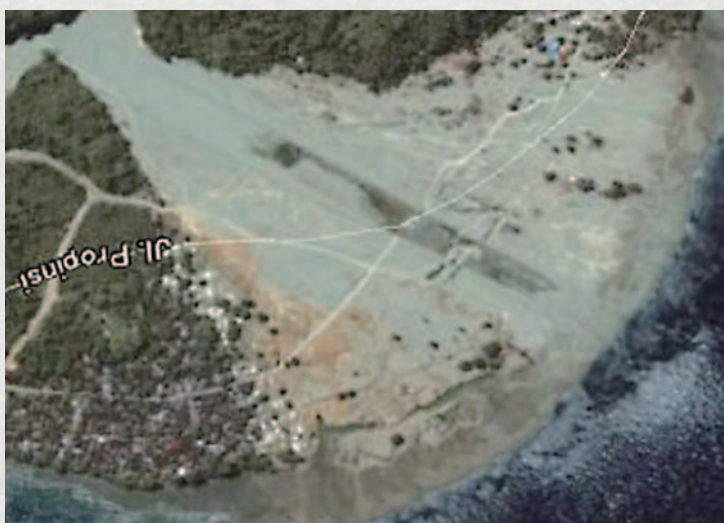
A natural dam created in the upper stream of the Way Ela River. Before (above) and after (below) the collapse of the dam. (Photo: Ministry of Public Works of Indonesia)

Torrential rains continuing on from the previous day caused a natural dam to collapse, and a flood of debris rushed down the river and slammed relentlessly into the village. It was July 25, 2013, when intense torrential rain upstream of the Way Ela River, running through the central part of Negeri Lima village in Maluku Province of Indonesia, caused a natural dam to burst, which let out huge amount of water and debris. This debris flood rushed downstream to the village, home to approximately 5,000 people. Around 13 million cubic kilometers of water, equivalent to the amount of water in 5,200 Olympic-size swimming pools, flowed through the area. 30 hectares – equivalent to half of the village – was affected, causing damage to 422 households, schools, and other buildings. Regrettably, three people lost their lives in this disaster. However, there could have been thousands of casualties

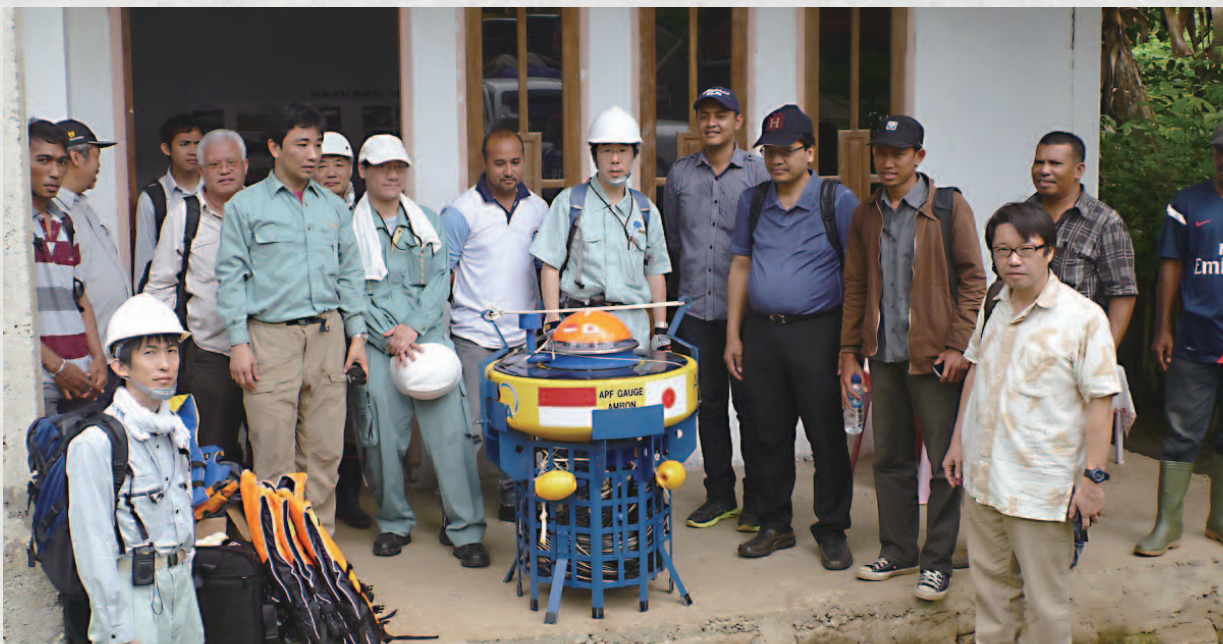
Experts, Mr. Tadanori Ishizuka (center) and Mr. Hisaya Sawano (right), in front of the PWRI's water stage gauging buoy. (Photo: Public Works Research Institute)

At the end of February 2013 – five months prior to the natural dam collapse – PWRI, which Mr. Ishizuka belongs to, signed an agreement with the Ministry of Public Works of Indonesia, and then set up a device (PWRI's water stage gauging buoy) in order to automatically measure the water level of the natural dam. Relevant parties from Japan and Indonesia continued to monitor the natural dam, and shared information on its water level. The
