April 28, 2011

Nuclear and Industrial Safety Agency

Seismic Damage Information (the 118th Release)
(As of 08:00 April 28th, 2011)

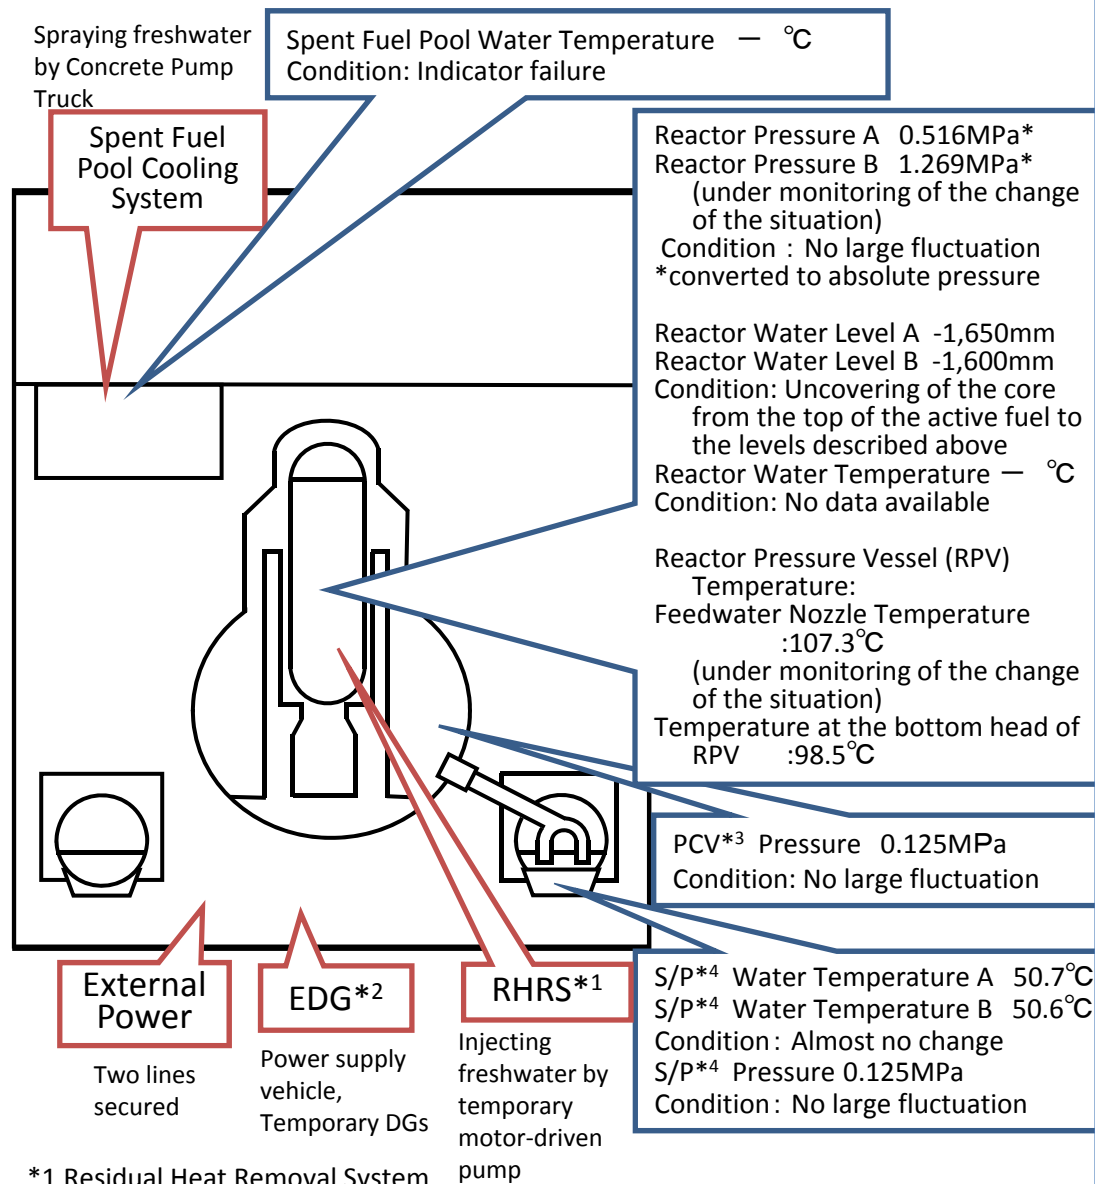
Conditions of Fukushima Dai-ichi Nuclear Power Station **Unit 1** (As of 6:00 April 28th, 2011)

Current Conditions : Fresh water is being injected to the Spent Fuel Pool and the Reactor Core

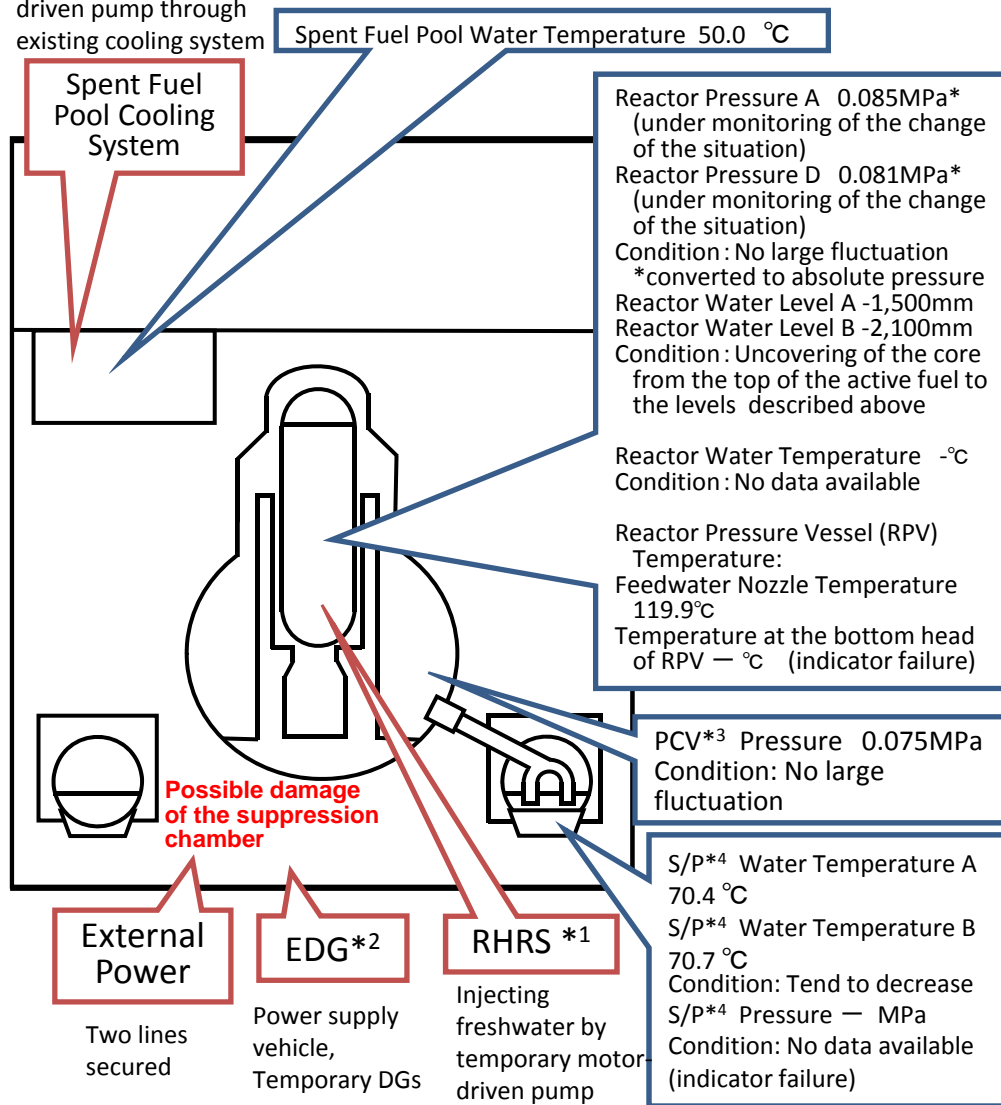
Conditions of Fukushima Dai-ichi Nuclear Power Station **Unit 2**

Spraying freshwater by temporary motor-driven pump through existing cooling system

Current Conditions: Fresh water is being injected to the Spent Fuel Pool and the Reactor Core

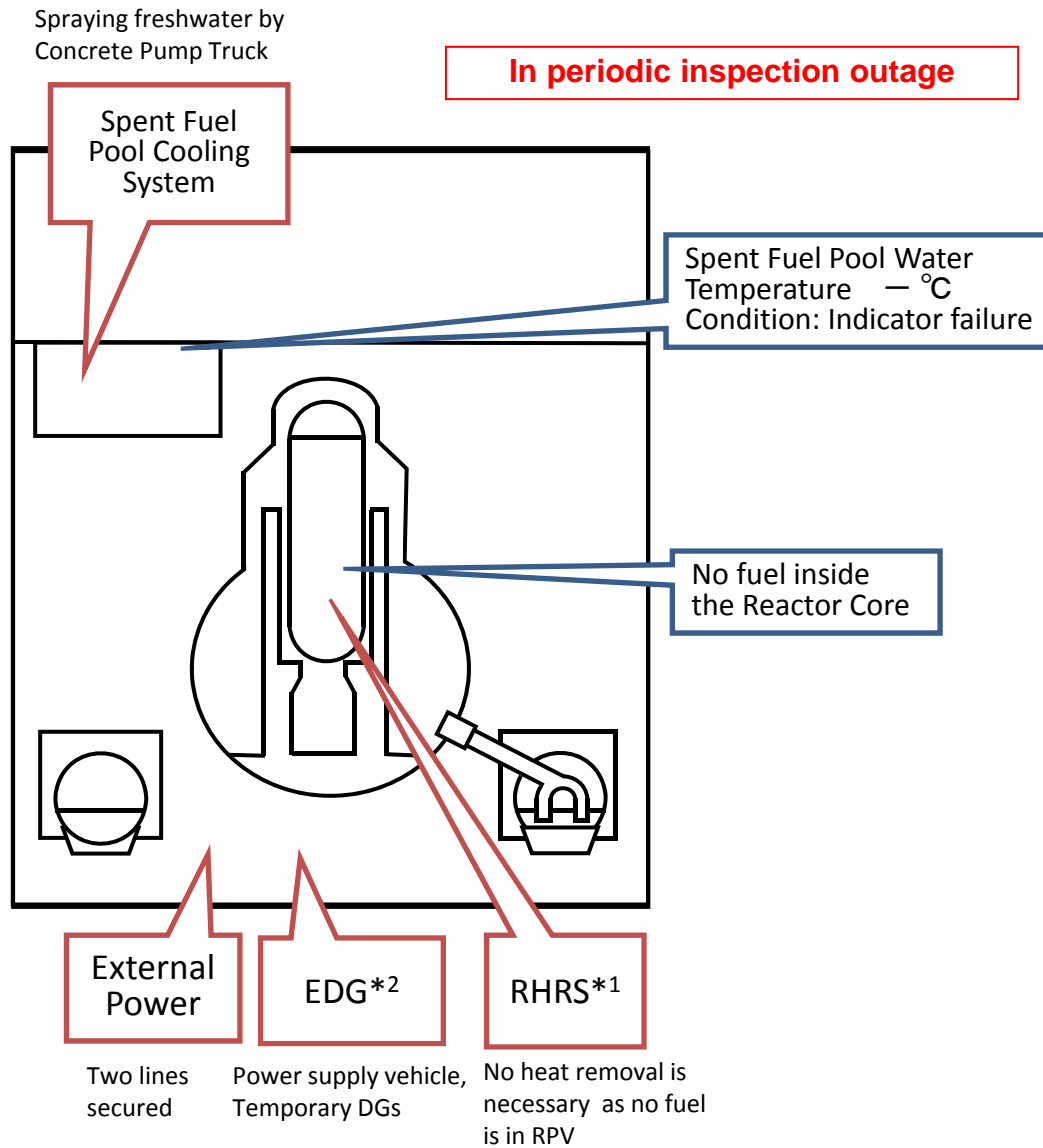
Conditions of Fukushima Dai-ichi Nuclear Power Station **Unit 4**

**Current Conditions: No fuel is in RPV*3.
Fresh water is being injected to the Spent Fuel Pool.**

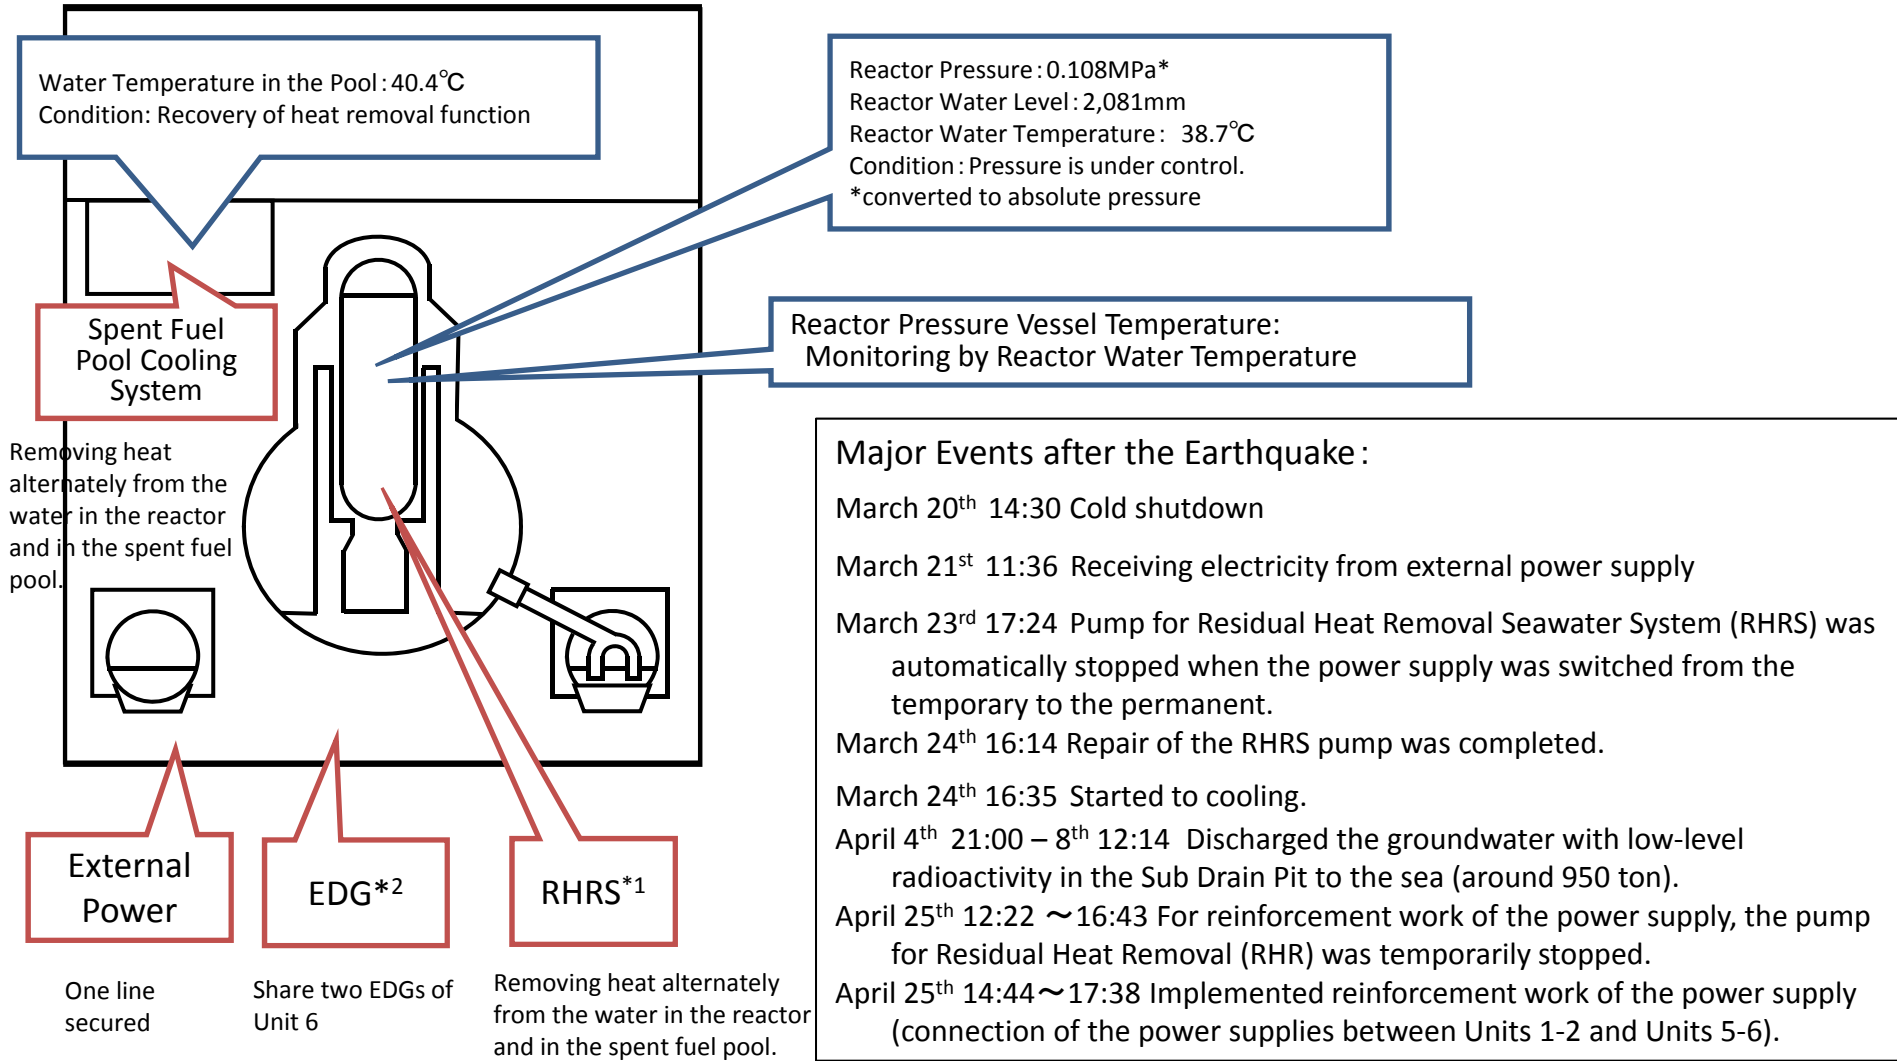
Conditions of Fukushima Dai-ichi Nuclear Power Station **Unit 5**

In periodic inspection outage
